## Product Notice

**PN 657**

**Models Affected:** LT

**SUBJECT:** Upper boom cover interference

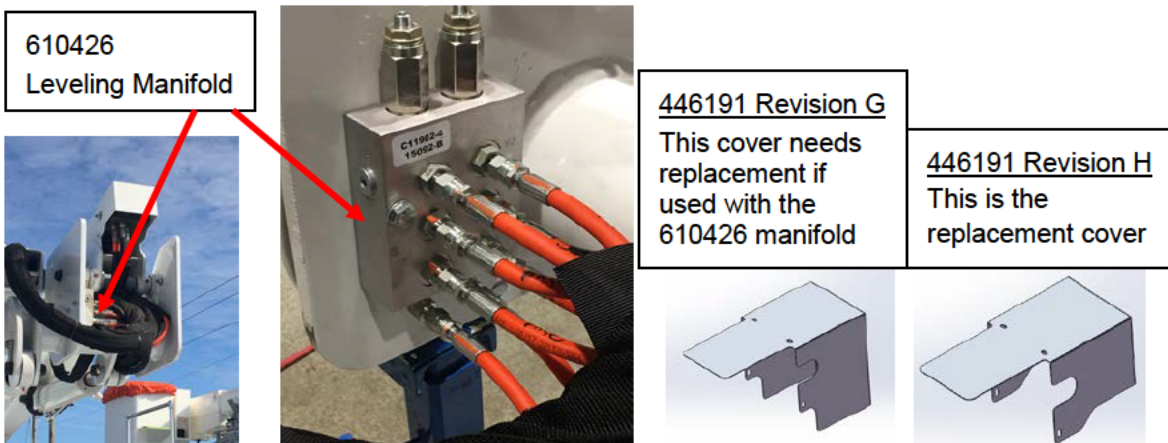
Terex Utilities has become aware of a possible cover inference, on units built from April 19, 2013 to February 9, 2017, which may cause the extension cylinder cover to contact the leveling hoses. This can occur when the upper boom is fully raised. Repeated contact may cause failure of the leveling hoses or fittings. **Failure of the leveling hoses will cause the platform to lock in position and stop leveling.**

1. If your unit has 446191 revision G cover and 610426 leveling manifold, your unit is subject to this bulletin. If your unit does not have the 446191 revision G cover and manifold shown below, it is not subject to this bulletin.

2. Perform a visual inspection of the leveling hoses on the manifold for interference damage. If damage is detected, remove the machine from service and contact your local Terex dealer.
3. If no damage is found, the unit can be returned to service provide the continued use requirements are followed.
4. If your unit is subject to the bulletin, order a replacement cover through Terex Warranty by emailing machine information to [utilities.warranty@terex.com](mailto:utilities.warranty@terex.com) or by calling 1-800-982-8975.
5. After identifying that no action is required or the replacement cover is installed, fill out the completion form enclosed with the owner letter and return it to the Terex Utilities Warranty Department at [utilities.warranty@terex.com](mailto:utilities.warranty@terex.com) or fax to 1-605-882-5579.

1. Inspect leveling hoses at the manifold daily.
2. If there is no damage to the hoses the cover can be removed and the unit can be returned to service without it until the replacement is installed.
3. Once the replacement cover is installed, these continued use requirements no longer apply.
4. Always follow all maintenance and inspection requirements as specified in the manuals.

Terex will provide a replacement cover at no cost.
