Date: Jan-2017

TECHNICAL

Subject: Call Using OnStar Hands Free Calling Message Played When Scrolling from Page 1 to Page 2 of OnStar Menu

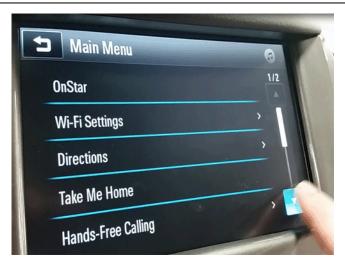
Involved Region or Country	North America			
Additional Options (RPOs)	Equipped with Radio RPO IOA or IOB			
Condition	Some customers may comment that a "Call Using OnStar Hands Free Calling Message" is played when they scroll from page 1 to page 2 of the OnStar menu.			
Cause	When audible touch feedback is turned on in the radio settings, an audible beep will occur when scrolling from page 1 to page 2 of the OnStar menu, which may be interpreted as a hands free OnStar call request.

If this concern is encountered, the audible touch feedback option can be turned off in the radio settings menu. To prevent this concern from occurring, follow the path in the radio menu below:

Settings>>Radio>>Audible Touch Feedback
