Bulletin No.: PI1408D

Subject: Musty Odor from HVAC Vents on Startup

Models: 2013-2015 Cadillac ATS

2014-2015 Cadillac CTS Sedan (VIN A)

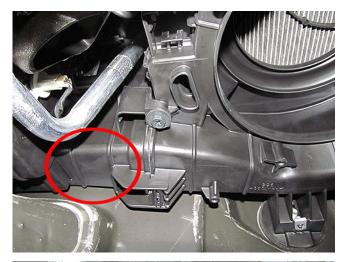
9. On the lower HVAC case, scribe an "X" in the area shown.

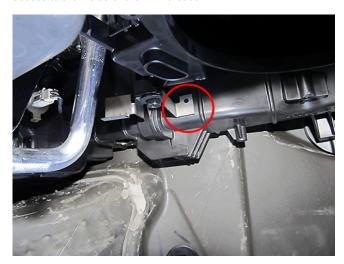
12. Using the supplied ionizer bracket as a template, drill a 1/8" pilot hole as shown. Remove the bracket. It will be used at step 18 of the Ionizer Installation

Note: Some HVAC cases may or may not have the shown case mounting bolt. If the case does not have one, use the supplied bolt in the ionizer kit to mount the bracket.

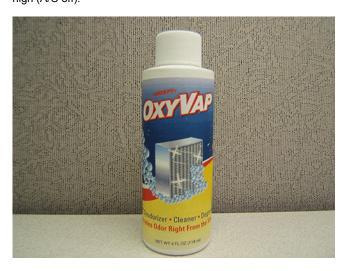
- **17.** Insert the application tool into the drilled hole. Apply OxyVap™ at 65 psi (448 kPa).
 - Apply the OxyVap to the evaporator core using applicator tool P/N 23372329. Move the wand up and down to obtain good coverage to the fin area. Turn the HVAC system to off.
 - Allow the core to soak for 5 minutes.
 - Rinse the empty bottle of OxyVap and fill with clean water. Rinse the evaporator core moving the applicator tool up and down with clean water until the bottle is empty with the blower turned on "High."
 - Using the applicator tool, blow compressed air on the evaporator core for one minute moving the applicator tool up and down to help remove excess water.

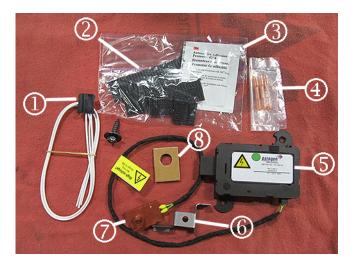
- 1. Wire Harness
- 2. 3M Dual Lock Mounting Strip
- 3. 3M Adhesion Promoter
- 4. Splice Sleeves
- 5. Ionizer Controller
- 6. Ionizer Bracket
- 7. Ionizer Emitter
- 8. Double Sided Adhesive Gasket

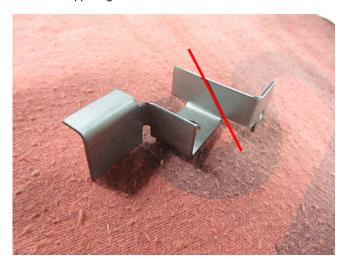
- **20.** Using tin snips or equivalent, trim the mounting bracket as shown.
- 21. Install the ionizer emitter to the HVAC case. The adhesive from the gasket will hold it in place until the bracket can be installed.
