SERVICE BULLETIN

Classification: RS17-025a	Reference: NTB17-035a	Date: August 10, 2017
------------------------------	--------------------------	--------------------------

2013 – 2016 LEAF; OCCUPANT CLASSIFICATION SYSTEM RETROFIT

APPLIED VEHICLES: 2013 – 2016 LEAF (ZE0)

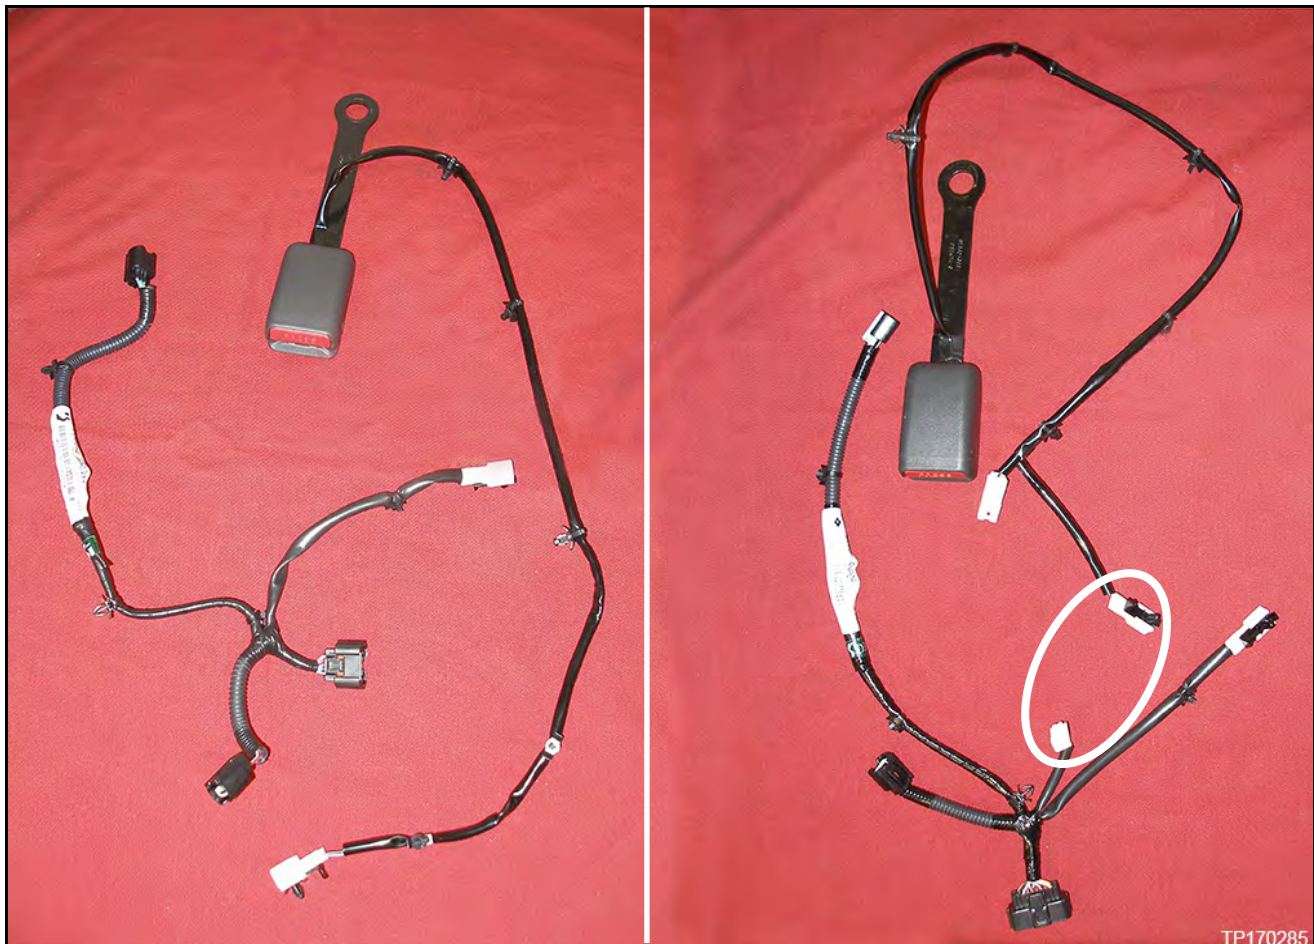
- In the next steps you will be replacing the seatbelt buckle and the OCS harness.
- Figure 1 shows the old and new parts.
- The new seatbelt buckle and OCS harness are listed in the Parts Information.

EXAMPLE	EXAMPLE
<p>Old OCS harness and seatbelt buckle are removed from the seat.</p>	<p>New OCS harness and seatbelt buckle to be installed</p> <p>Notice the new harness and buckle have a new branch with connector</p>

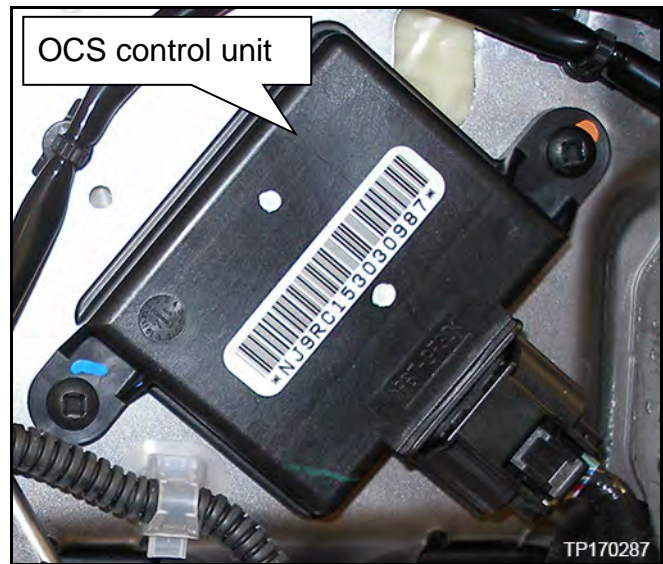
Figure 6

- OCS control unit is held on with 2 screws.
- The OCS control unit is located under the front edge of the seat.

11. Replace the OCS control unit with the new one.

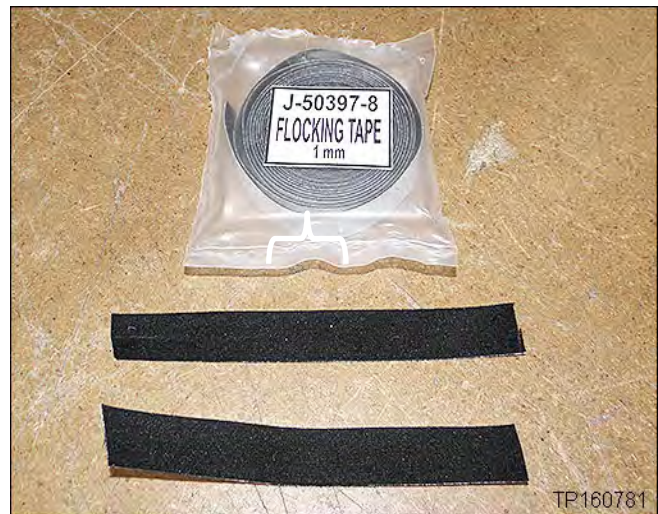
Figure 7

- Flocking tape is part of the squeak and rattle kit – J-50397.

12. Cut 2 strips of flocking tape (J-50397-8); each strip about 5 inches long.

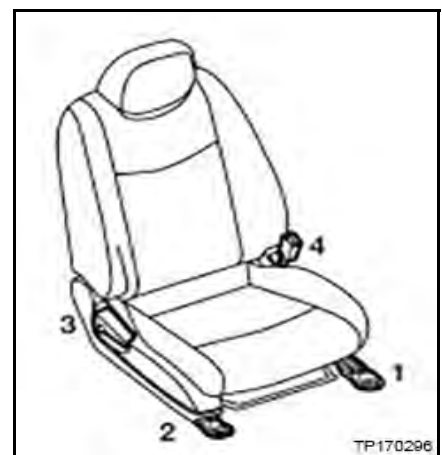
- Reconnect all electrical connectors that were disconnected during seat removal.
- Torque passenger seat mounting bolts to: 40 N•m (4.1 kg-m, **30 ft-lb**)
- Refer to Figure 10 for torque sequence.

15. Reinstall the seat into the vehicle in reverse order of removal.
