# Technical product information

<b>Topic</b>	Mulsanne steering shimmy/vibration - 21 Inch wheels only (USA)
<b>Market area</b>	United States E05 Bentley USA and rest America (6E05)
<b>Brand</b>	Bentley
<b>Transaction No.</b>	2030349/2
<b>Level</b>	EH
<b>Status</b>	Approval
<b>Release date</b>

## Customer statement / workshop findings

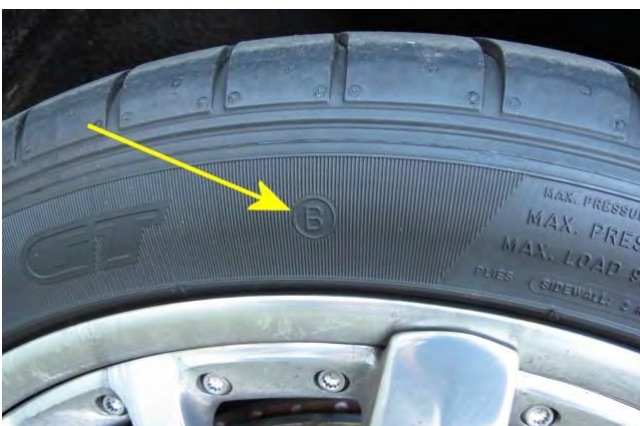
- Dunlop SP Sportmaxx GT 265 / 40 / 21 with the part number 3Y0601313H or higher
- To ensure correct specification the Bentley Mulsanne tyre has a 'B' stamped on the sidewall as shown in Figure 2

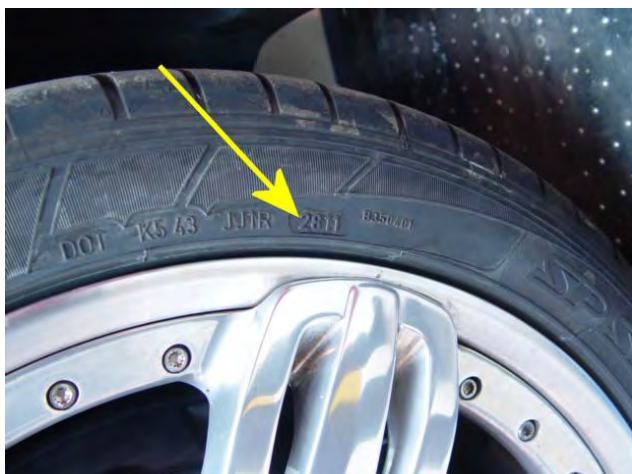
**Referring to Figure 3, check the date of manufacture code, the code must be on or after 2011, this code translates as week 20 of the year 2011 hence 2011, Figure 3 shows 2811 which is week 28 year 2011.**

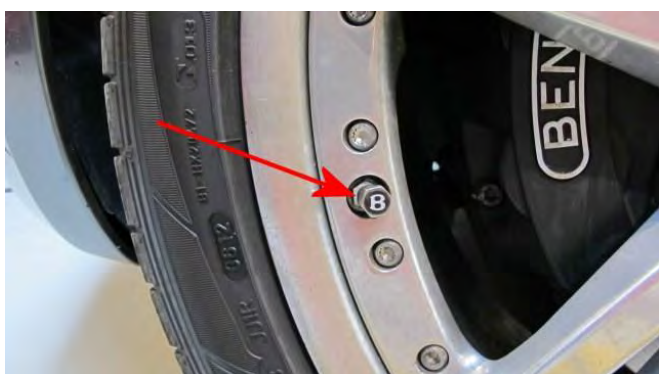
Figure 4

**Does the vehicle have accessory valve caps fitted as shown in Figure 4? If Yes please ensure the force match and balance process is always conducted with accessory valve caps fitted**

**IMPORTANT:** Apply a thin smear of silicon based grease for example Dow Corning high vacuum grease to the external threads of the valve stem prior to fitting the accessory valve cap. Grease should be applied any time the cap is removed and the grease is not evident

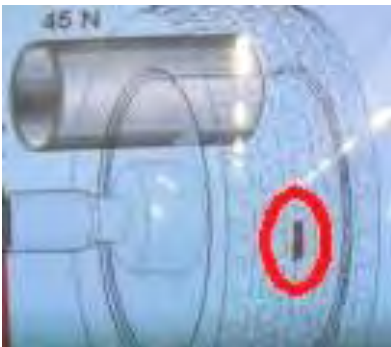
Figure 7

- Once the force matching process is complete, the assembly high spot is identified with a brown dash (Figure 7).

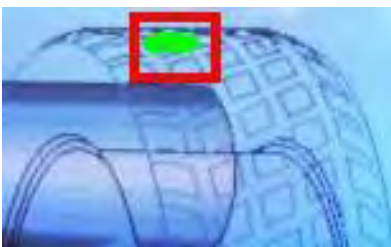
Figure 8

- Rotate the assembly on the spindle until the high point is at 12 o'clock and the Brown dash turns to Green (Figure 8).

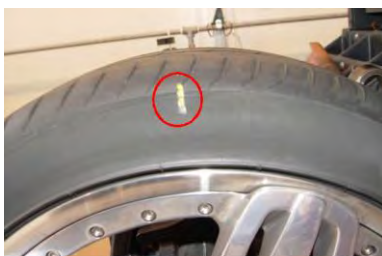
Figure 9

- Mark the RFV high point with a paint pen or similar (Figure 9) this will be required when refitting the wheels

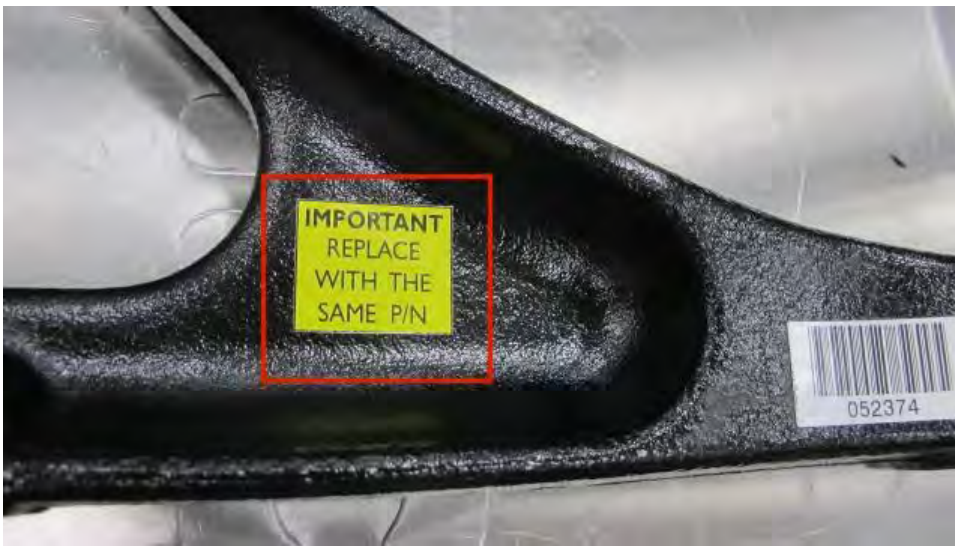
**Note:** Any vehicle authorised to have this bespoke lower lever fitted will require a label RH15238 applying to the lower lever ensuring only these levers are fitted in the future see Figure 11a

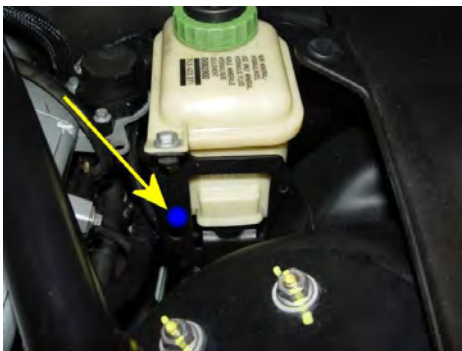
Figure 12

7. Place a Blue paint completion mark on the power steering reservoir bracket (Figure 12) to confirm the steering rack and the lower lever bushes (if pre VIN SCBBA63Y9BC016115) have been replaced.
