**HYUNDAI**NEW THINKING.
NEW POSSIBILITIES.**Technical Service Bulletin**

17-01-004

ACCENT (MC)**SUBJECT:**ACCENT (MC) UNDERBODY CORROSION PREVENTATIVE SERVICE
(SERVICE CAMPAIGN 944)*This bulletin supersedes TSB 16-01-047 to specify additional model years.**** IMPORTANT******* Retail Vehicles Only *****

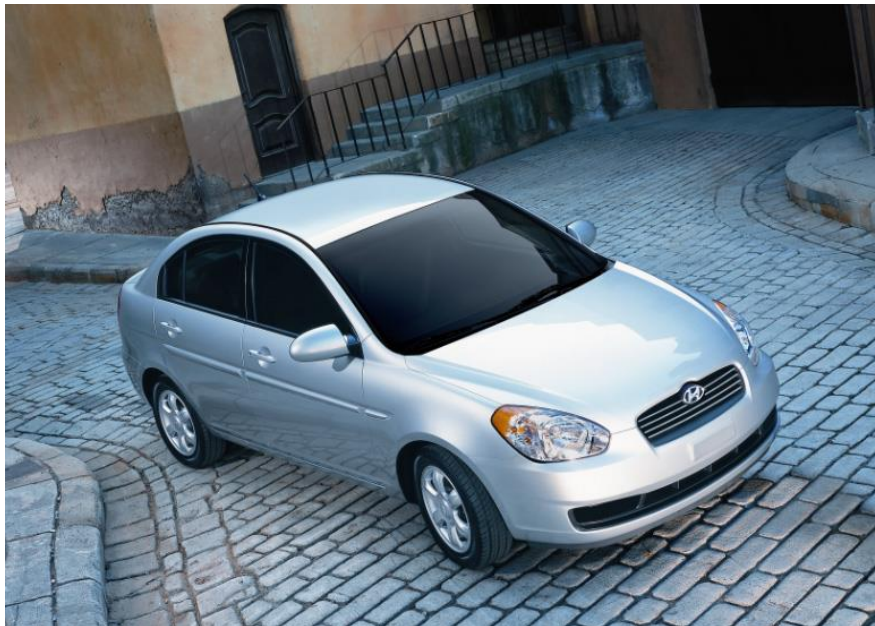
Description: In some areas, a vehicle's underbody may exhibit corrosion due to road salt usage. As a precautionary measure, cavity wax coating is applied to the internal surfaces of underbody components, and an undercoating spray is applied to the bottom exterior surfaces of specified underbody components. This bulletin describes the procedure to perform this preventative service on certain Accent (MC) vehicles.

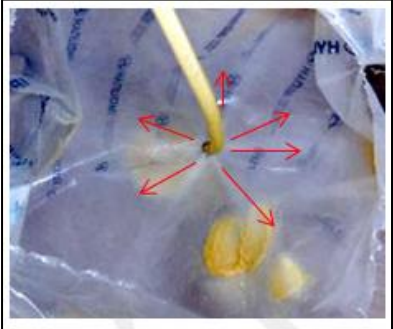
<p>“Inside” Nozzle</p>

<p>09624-2H101-QQH</p>	<p>This is a newly developed nozzle that has an improved wax application spray pattern.</p>

<p>The pink tubing is to signal the user to stop spraying when pulling the nozzle out.</p> <p><u>This nozzle must be used for this service procedure.</u></p>
<p>“Outside” Nozzle</p>

Generally for coating interior surfaces, insert the “inside” nozzle as deeply as possible at each point of entry. Spray the cavity wax while simultaneously rotating the nozzle, and slowly pulling the nozzle out. Continue this rotating/pulling motion until the pink tubing is seen coming out of the hole. The pink tubing indicates there is about 50mm of tubing left until the end of the nozzle. Stop spraying when the pink tubing is seen.

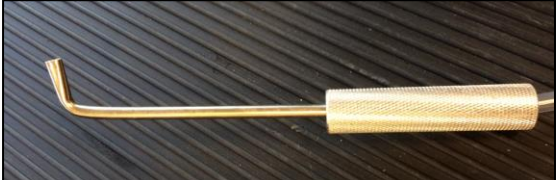
<p>This nozzle is supplied with the wax gun.</p>

Generally for coating exterior surfaces, use the “outside” nozzle, provided with the wax gun.

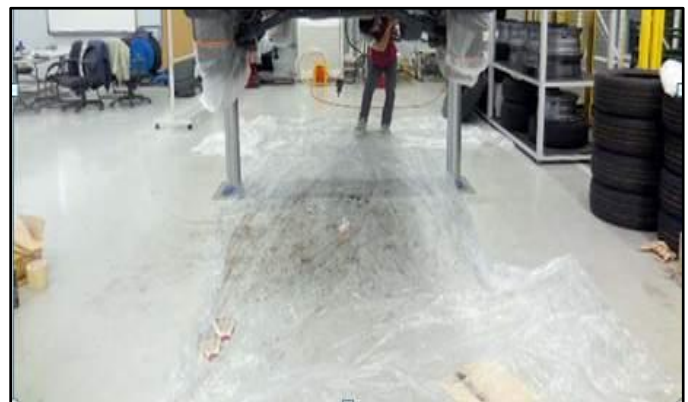
1. When applying the cavity wax, the floor might become contaminated. It is recommended to put a plastic vinyl sheet on the floor before applying wax.

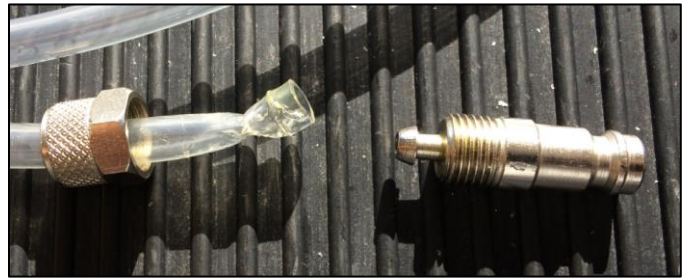
2a. Remove the compression fitting from the nozzle assembly that originally comes with the wax gun by unscrewing the nut, then removing the fitting from the tube.

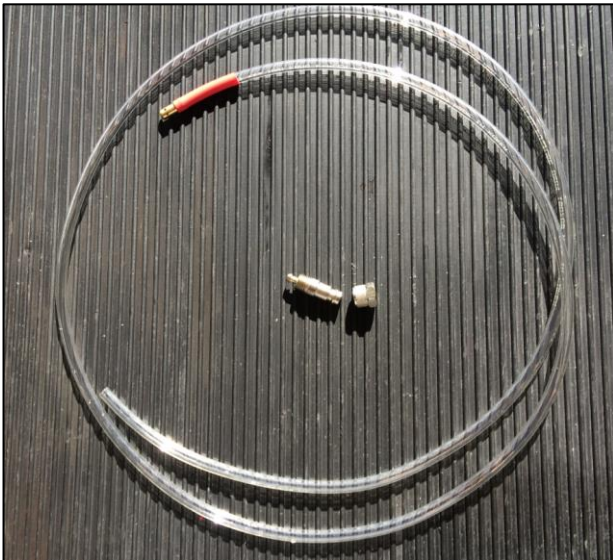
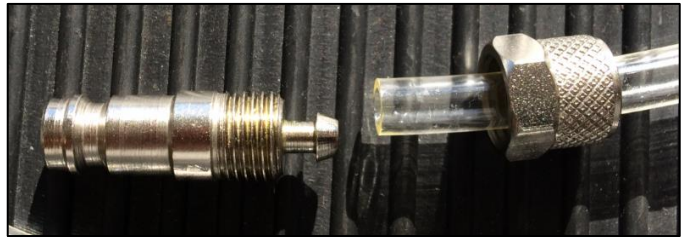
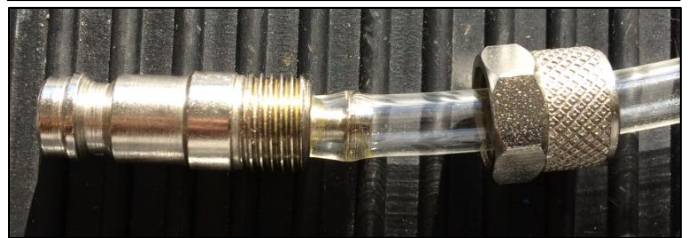
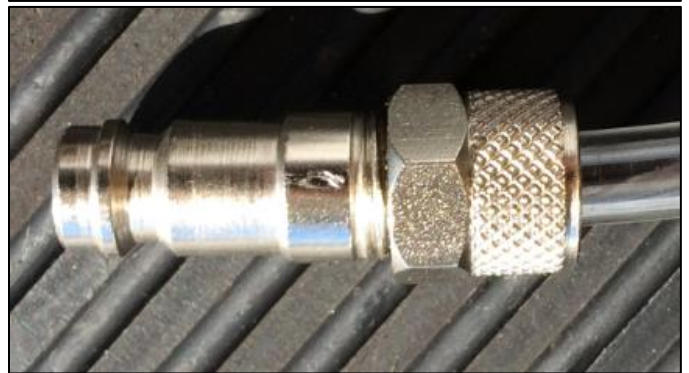
2b. Attach the compression fitting to the tubing on the new nozzle assembly.

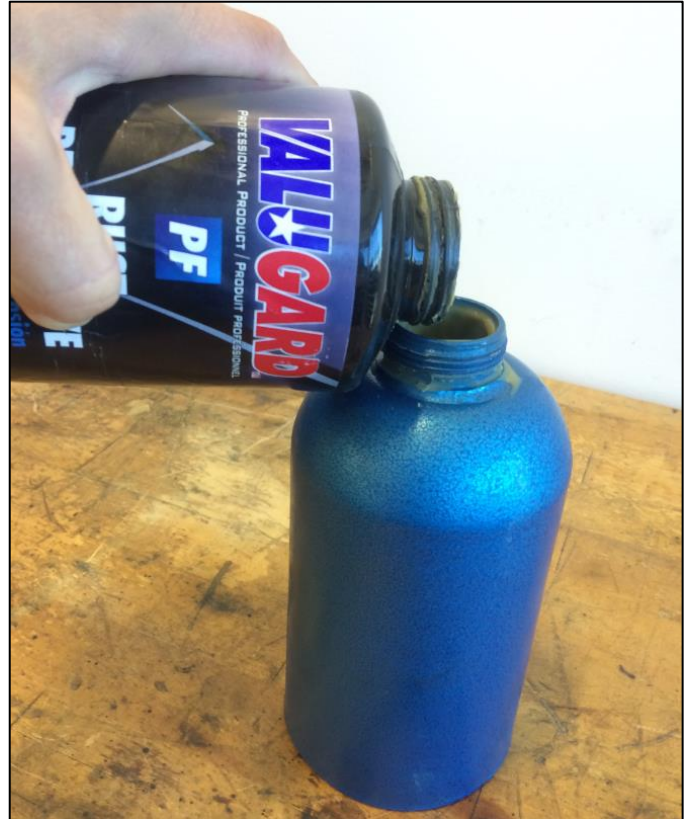
2c. Fill wax gun reservoir with cavity wax.

Prime the wax gun by spraying into a trash bag (or similar) until a light mist is visibly coming out of the nozzle.

Air supply pressure must be set to 70 psi.

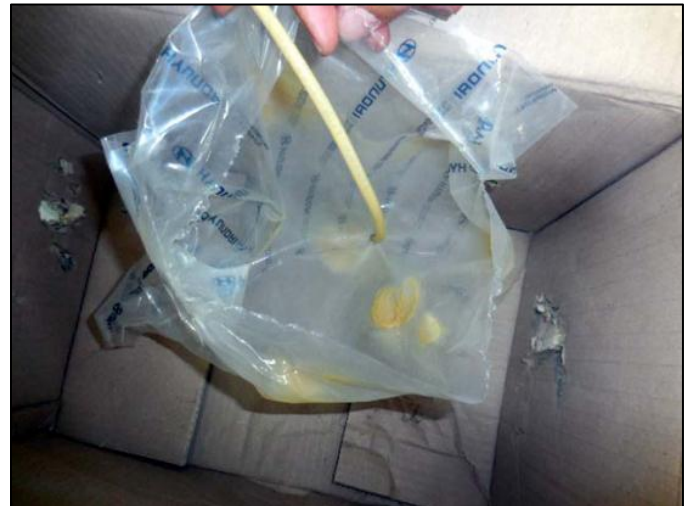
If volume of wax coming out of the nozzle slows significantly (so that a light mist is no longer visible), prime the gun again.

It may speed the priming process to block the nozzle with a rag while spraying the gun until the flow of wax increases.

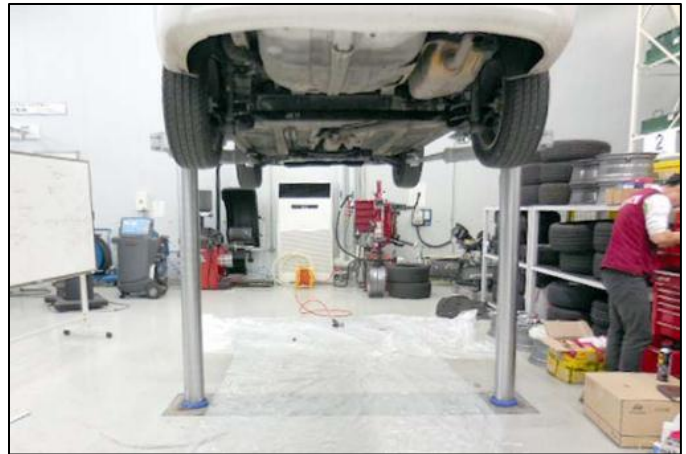
1. Lift the vehicle on a hoist.

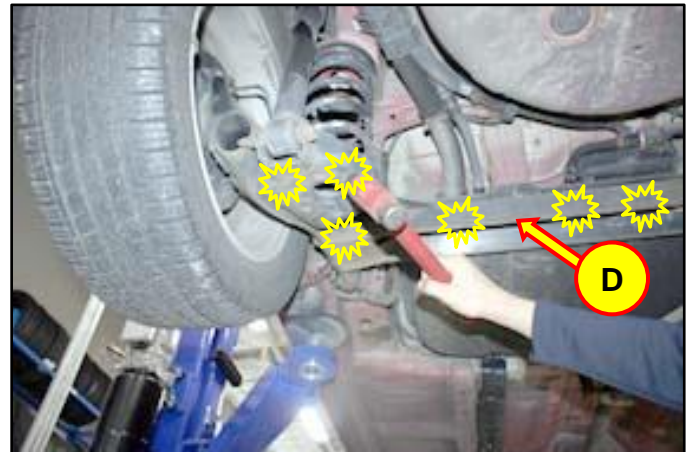
- Rear Beam Axle (D)

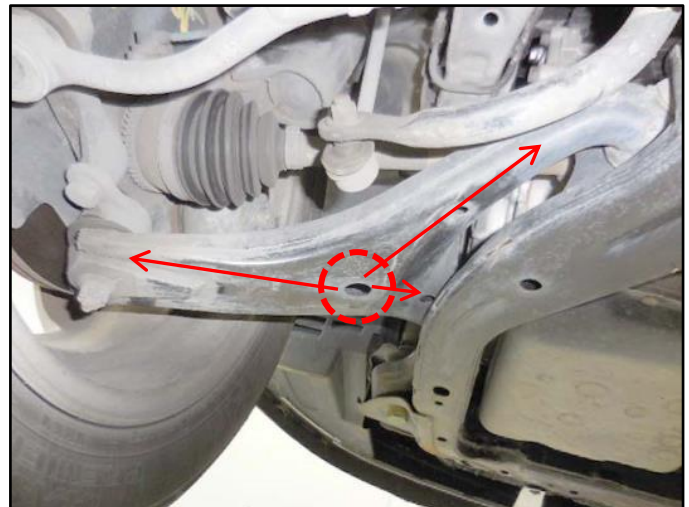
4. Remove the remaining debris by inserting an air nozzle into the locations shown, then blowing air in multiple directions.

- Left/Right Front Lower Control Arm

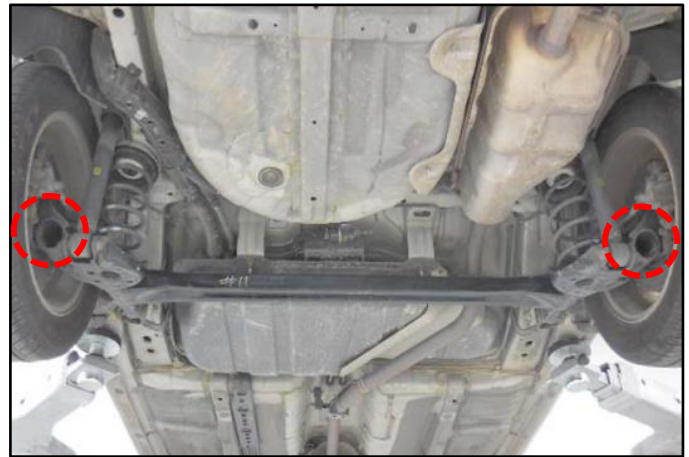
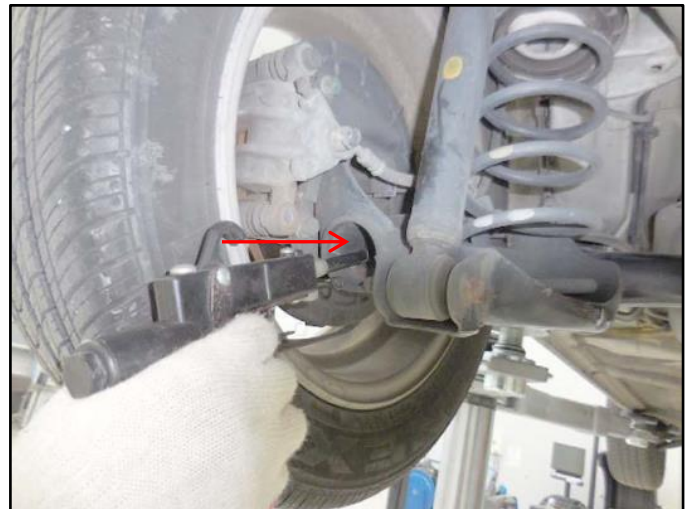
- Rear Beam Axle

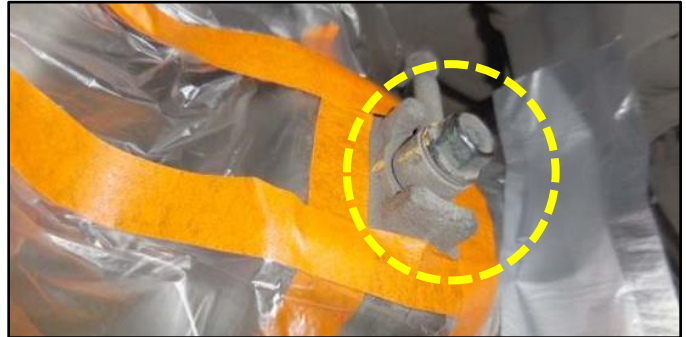
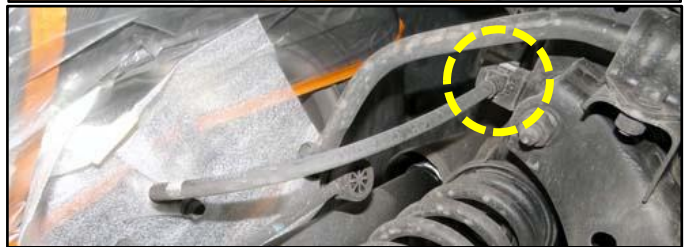
1. Clean the front and rear brake caliper banjo fittings surfaces and brake hose mounting brackets at all 4 calipers using a wire brush.

Then wrap the brake assemblies with plastic bags to protect them from overspray. Use tape to secure the plastic bags in place.

Leave the banjo fitting and brake hose bracket area exposed, as shown.

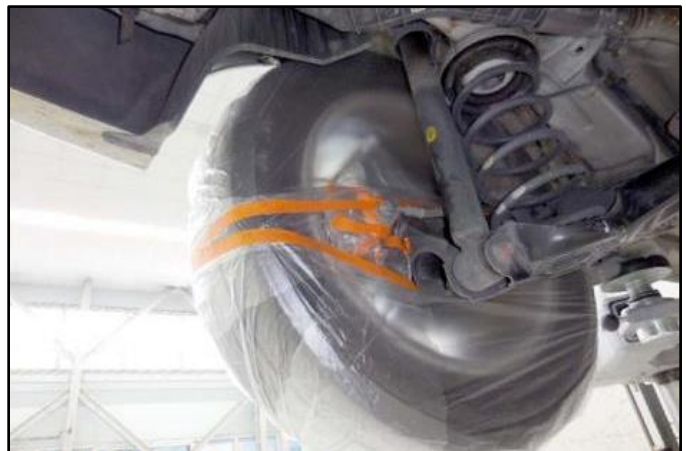
2. Wrap large plastic bags around the wheel/tire/brake assemblies to protect them from overspray. Use tape to secure the plastic bags in place.

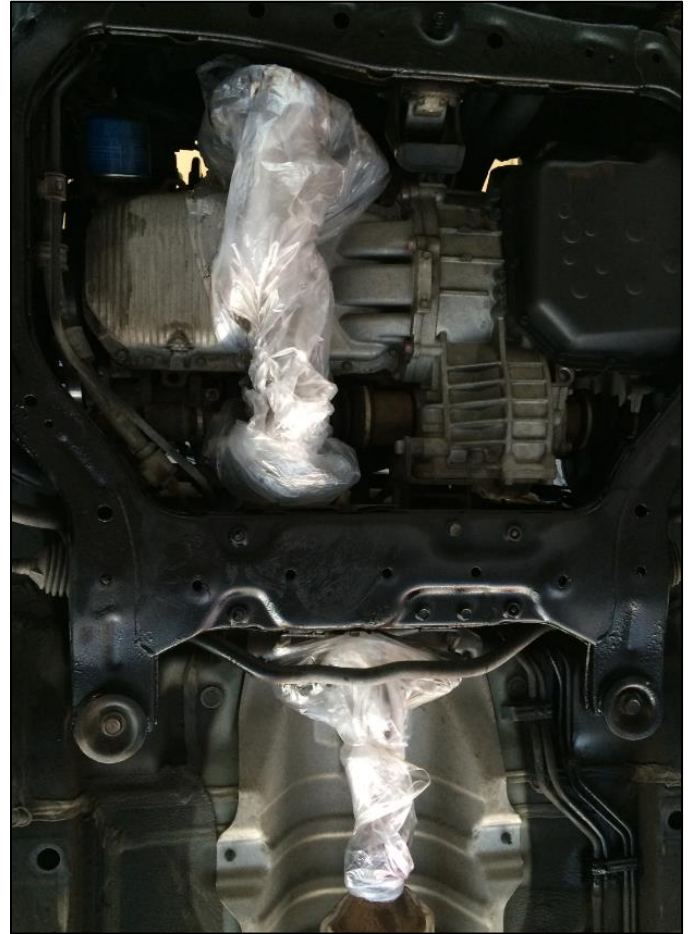
3. Wrap the exhaust areas adjacent to the Front Cross Member and Rear Beam Axle with plastic bags to protect them from overspray. Use tape to secure the plastic bags in place.

The exhaust must be sufficiently cooled before it is wrapped.

Front Cross Member

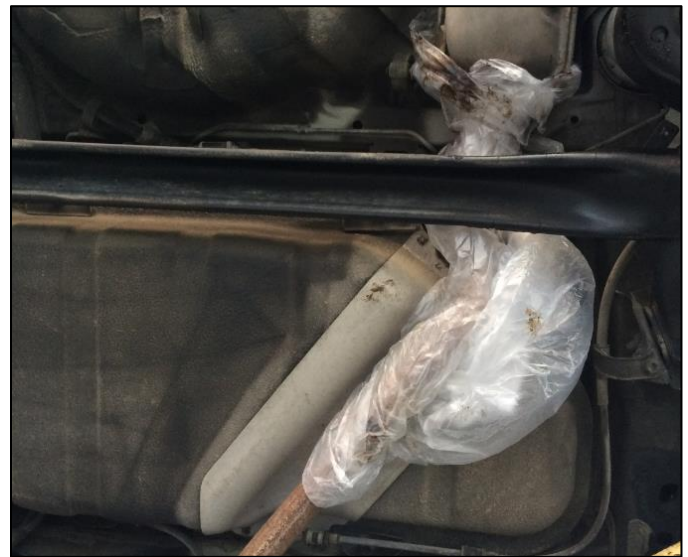
Rear Beam Axle

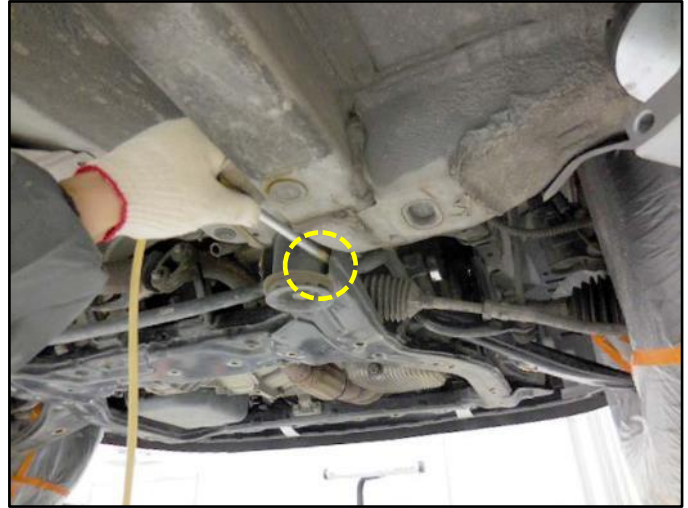
- Insert the nozzle through the opening in the rear of the Front Cross Member to spray the cavity wax.

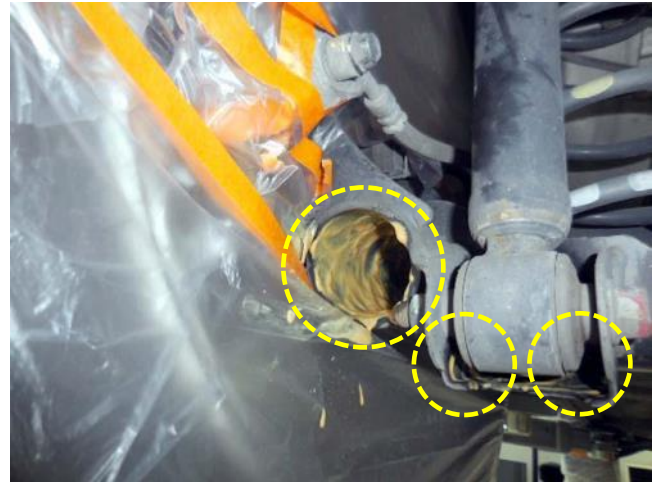
- 1c. - Inside the Rear Beam Axle

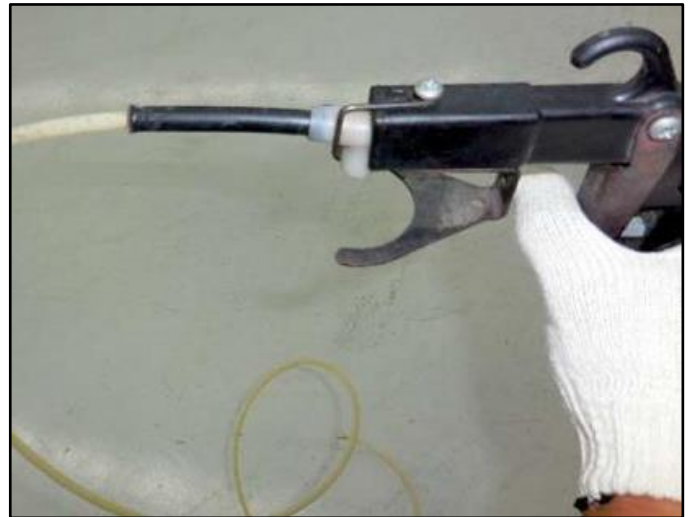
2. After applying the cavity wax, use an air nozzle to remove the remaining cavity wax in the nozzle.

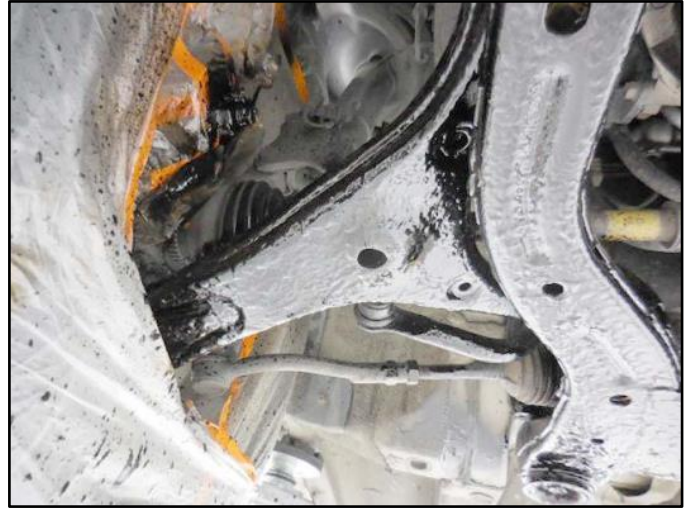
1c. - Left/Right Front Lower Arms

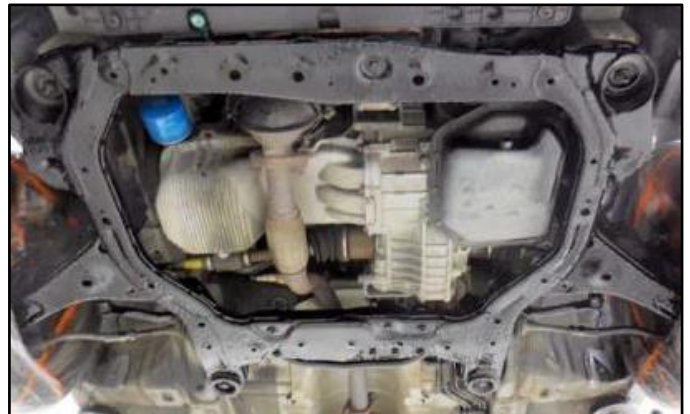
1d. - Front Cross Member
