September 22, 2017

05873 Version 2

## Product Update: MDX 9-Speed Transmission Warmer

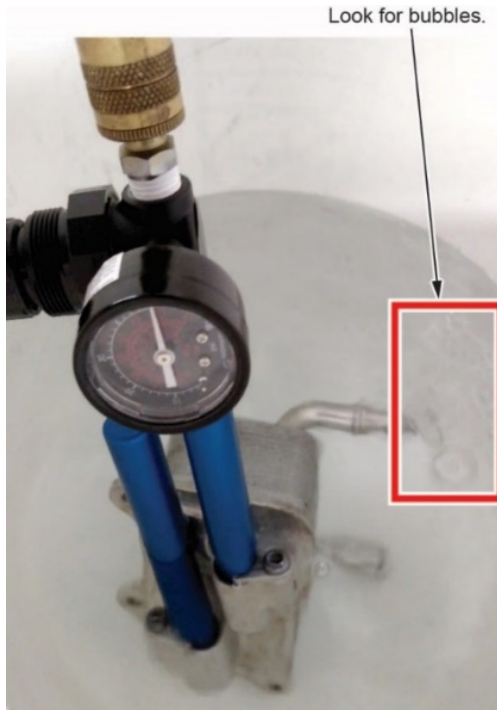
14. Check the transmission warmer for leaks by submerging the warmer completely under the water and watching for bubbles.

NOTE: Some bubbles are normal when the transmission warmer is first submerged and will come to a stop. If there is a leak, there will be a steady stream of bubbles coming from the transmission warmer.

- If there are no bubbles coming from the warmer, continue with the warmer replacement. Go to step 15.
- If there are bubbles, take photos (see Photos) and check to see if the vehicle also overheated by checking the client responses on the RO.
  - If the transmission warmer leaks, but the engine **did not overheat**, go to [REPAIR PROCEDURE B](#).
  - If the transmission warmer leaks, and the engine **overheated**, go to [REPAIR PROCEDURE C](#).

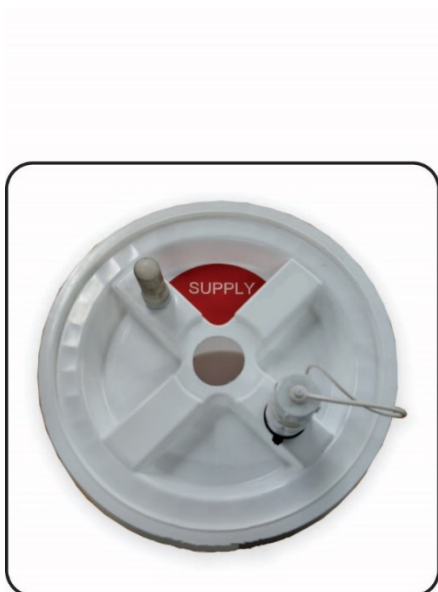
11. Remove the lid from the SUPPLY bucket, and install the large (1.5 in.) return hose with the T-fitting through the hole in the lid as shown.

ENGINE RETURN HOSE

T-FITTING

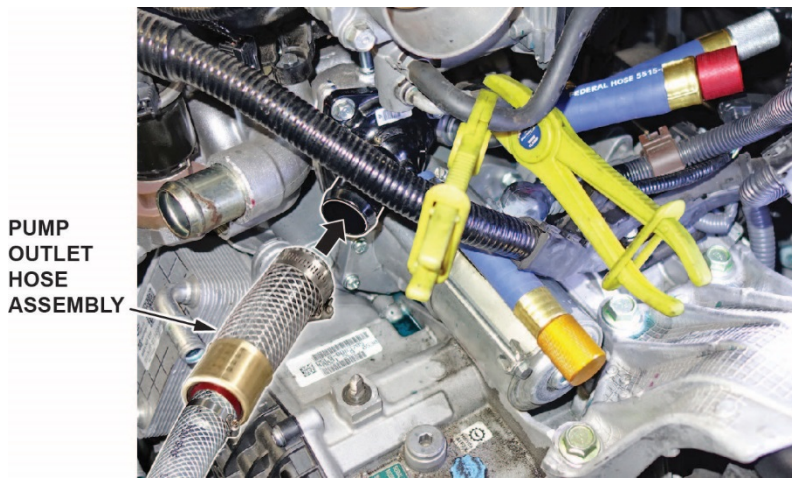
13. Install the pump outlet hose to the thermostat housing.
