Preliminary Information

PIC6284A Invalid Product Update Message During/After Navigation Map Update Outlined in Bulletin 16-NA-328

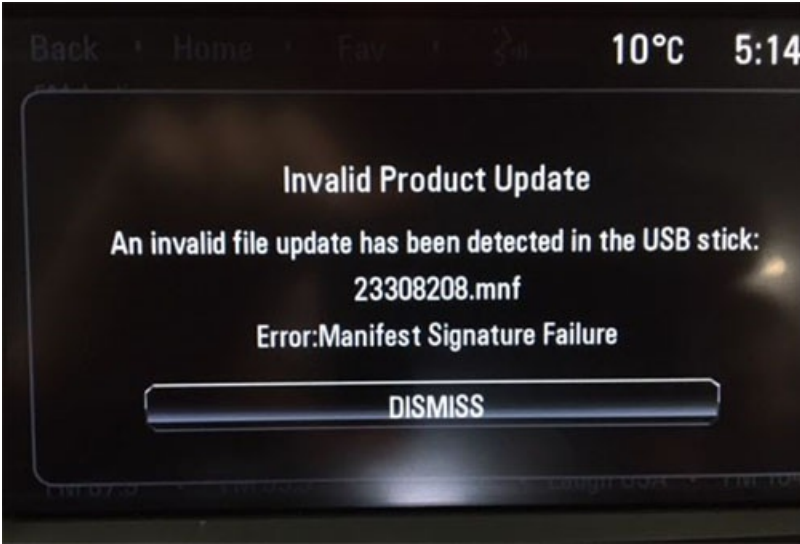
| Condition | <p>Some technicians may encounter an Invalid Product Update message during or after installation of the navigation map update outlined in bulletin 16-NA-328.</p> |
| Cause | <p>This may be a result of the USB concern described in the Invalid Product Update Section at the bottom of bulletin 16-NA-328.</p> <p>This may be a normal result of already having the latest map update installed as mentioned above step 1 and 7 of bulletin 16-NA-328.</p> |

If this concern is encountered follow the Invalid Product Update Section at the bottom of bulletin 16-NA-328, which explains how to insert the USB into a computer, eject it at least five times and re-evaluate for the concern. Also ensure that this is not a result of the normal concern outlined above step 1 and 7 of bulletin [16-NA-328](#) that occurs if the latest map update is already installed. If this does not alleviate the concern, please answer the following questions and contact GM Technical Assistance to document this and review next steps:
