Technical Service Bulletin

01 MIL on (P0491 and P0492 stored at same time)

01 17 03 2033001/11 February 23, 2017. Supersedes Technical Service Bulletin Group 01 number 17-01 dated February 13, 2017 for reasons listed below.

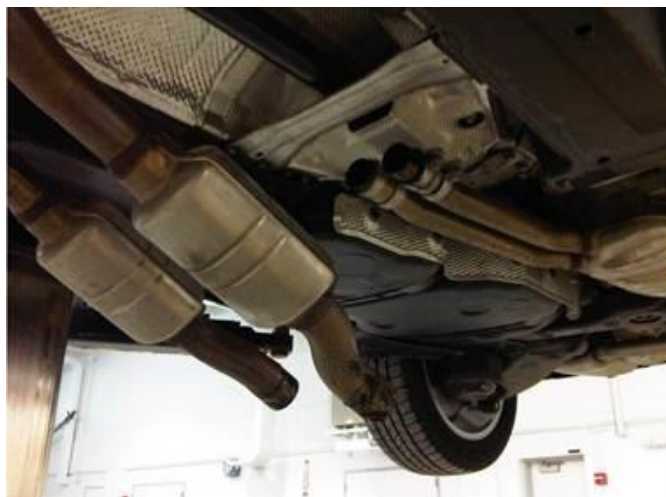
Figure 7. Lowered catalytic converter pipes.

1. Move the exhaust sliding bushings (that connect the catalytic converter and muffler) back, then lower the catalytic converter pipes (Figure 7).

For Q7, unbolt muffler from catalytic converter. Cover mufflers with plastic bag to prevent water from entering.

Cleaning water will drain out of the catalytic converter pipes during the cleaning process.

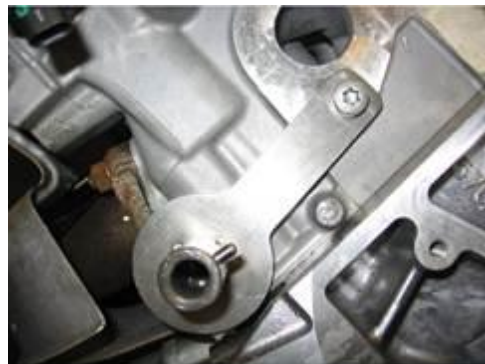
Figure 13. Engine adaptor on bank one.

2. To catch water, put a pan under the front of the engine and under the disconnected catalytic converter pipes.
3. Install engine adaptors on the appropriate banks (Figure 13 and Figure 14).

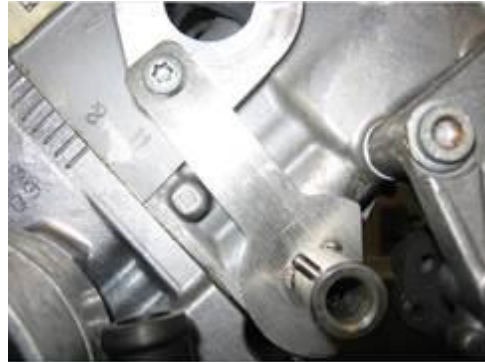
Figure 14. Engine adaptor on bank two.

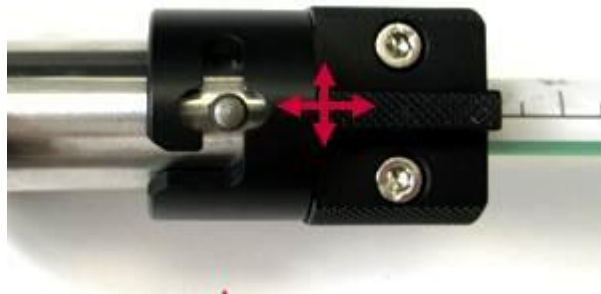
Figure 16. Locking position / transvers longitudinal movement and of the hose adaptor

- After adjusting the position of the hose adaptor, insert the special single port cleaning hose into the hose adaptor, and bring it back into locking position (Figure 16).

- While cleaning, make sure that the pressure washer is supplying pressure greater than 1800 psi.
- Based on the washer's pressure, clean the port based on the table below. While cleaning, continuously move the hose adaptor within the longitudinal and transvers slots (Figure 16).
