Technical Service Bulletin

23 MIL on, no start or rough running (DTCs P0087, P0088, P0191)

23 17 39 2040752/6 February 13, 2017. Supersedes Technical Service Bulletin Group 23 number 15-37 dated November 20, 2015 for reasons listed below.

Model(s)	Year	VIN Range	Vehicle-Specific Equipment
A3	2010 - 2012	All	TDI clean diesel
Q7	2009 - 2012	All	TDI clean diesel

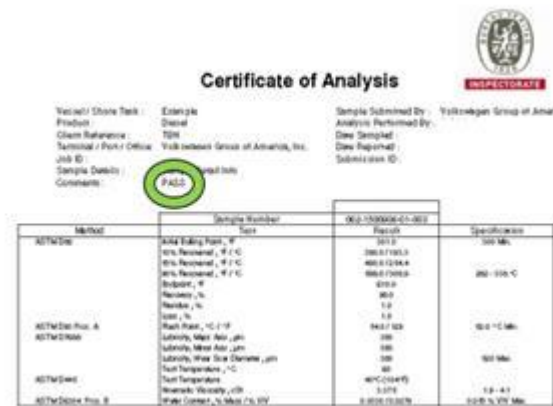
- Review the test results. The results will be marked "PASS" or "FAIL" in the comments section of the certificate of analysis (Figure 5 and Figure 6).

Figure 5. Example of a clean fuel sample analysis.

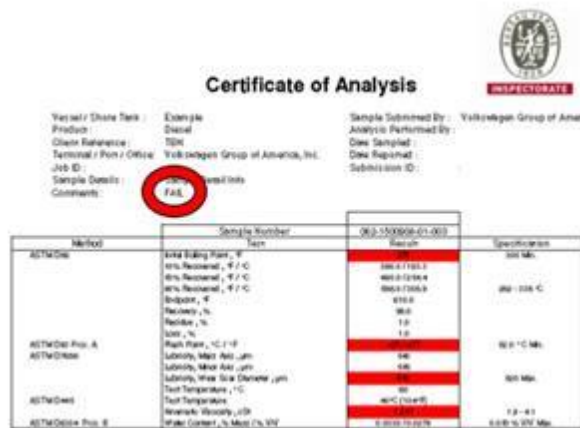
Figure 6. Example of a contaminated fuel sample analysis.
