| DOC # | PROCESS NAME | PAGE | REVISION | STATION | BY | DATE |
|---|--|---|---|---|---|---|
| <b>AR845</b> | Replacing Underhood 100A with 120A Circuit Breaker | 1 OF 1 | A | SER-E | C.WARD | 9/13/2017 |

**Complaint:** 100A Circuit Breaker Tripping Prematurely

**Correction:** Replace underhood 100A with 120A Circuit Breaker

**Vehicles Affected:** 2017 SOM/SOF Units with 100A Underhood Circuit Breakers with Aftermarket Electrical Equipment Installed.

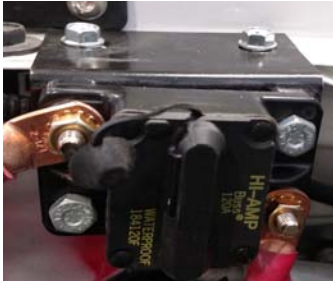
Step 5: Secure Bracket to Firewall with (2) 3/8" Self-Tapping Screws removed in step 2.

Step 6: Using 11mm Socket, re-secure Power Cables to 120A Circuit Breaker (50 in-lb max).
