GROUP ENG	MODEL 2016MY Optima (JFa) 2016-2017MY Sorento (UMa)
	NUMBER 159 (Rev 2, 09/08/2017)	DATE September 2016
<b>TECHNICAL SERVICE BULLETIN</b>		
SUBJECT: E-CVVT COVER AND MOTOR PLUG REPLACEMENT

This bulletin provides information about the replacement of the E-CVVT cover and motor plug on some 2016MY Optima (JFa), produced from August 29, 2015 to June 14, 2016, and 2016-2017MY Sorento (UMa) vehicles, produced from October 27, 2014 to June 14, 2016, which may exhibit a MIL ON with DTC P001000 and/or oil leakage in the E-CVVT motor plug of applicable vehicle models equipped with 2.4L GDI or 2.0 T-GDI engines. Follow the procedure outlined in this bulletin to replace the E-CVVT cover and motor plug to correct the concern.

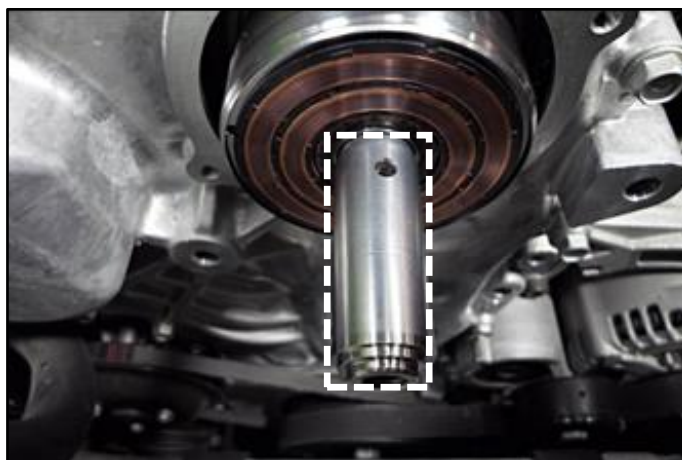
9. Apply oil to the oil seal lip of the new E-CVVT cover and install the SST "B" to the E-CVVT motor as shown.

When installing the cover, correctly insert the end of the SST to the motor shaft as shown below. Ensure that the SST hole faces towards the motor shaft.

Use caution not to fold the oil seal when installing the cover.

**SST INSERTED INCORRECTLY**

**SST INSERTED CORRECTLY**

E-CVVT removed from vehicle for demonstration only purposes.
