SERVICE BULLETIN

Classification: RS17-006b	Reference: NTB17-025b	Date: August 10, 2017
------------------------------	--------------------------	--------------------------

2013 – 2016 PATHFINDER OCCUPANT CLASSIFICATION SYSTEM RETROFIT

APPLIED VEHICLES: 2013 – 2016 Pathfinder (R52)
2014 – 2015 Pathfinder Hybrid (R52)

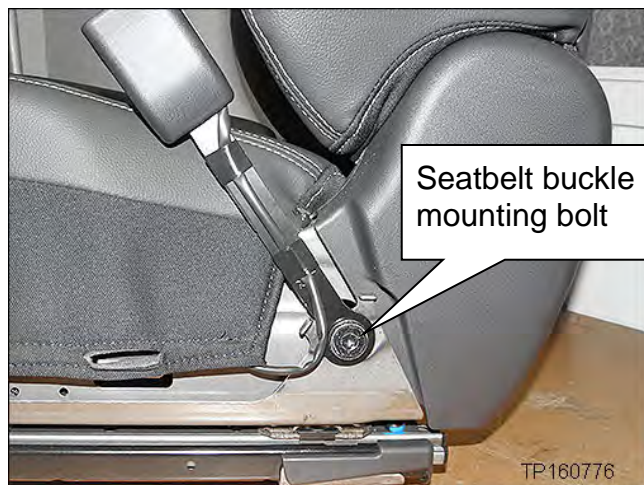
Figure 1

7. Remove the seatbelt buckle.

- Buckle is held on with one bolt.

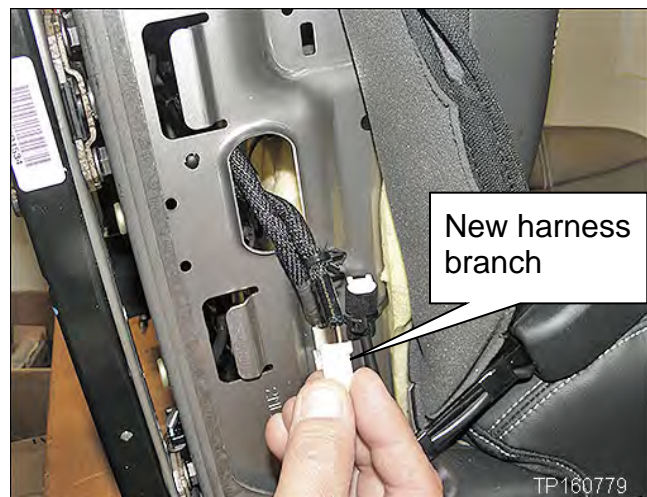
Figure 11

13. Route the new branch/connector of the OCS harness through the seat frame as shown.

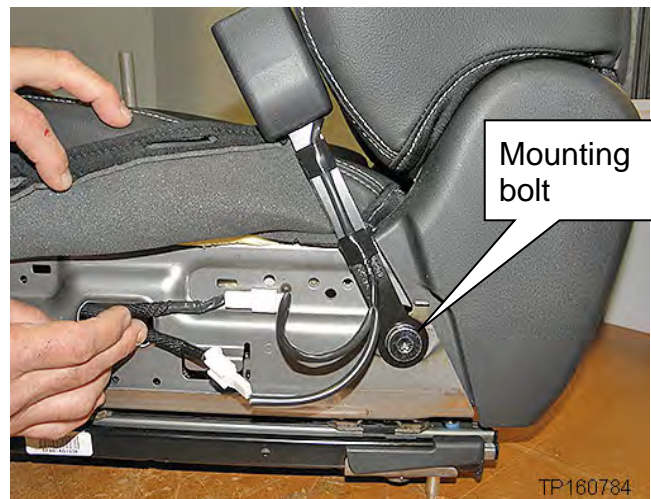
Figure 13

15. Install the new seatbelt buckle.

- Torque the mounting bolt to:
49 N·m (5.0 kg-m, **36 ft-lb**)
- Connect the 2 electrical connectors.

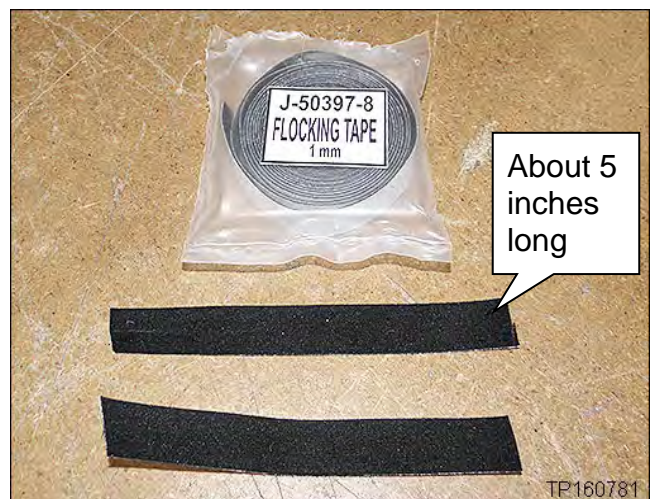
Figure 14

16. Cut 2 strips of flocking tape (J-50397-8); each strip about 5 inches long.

- Flocking tape is part of the squeak and rattle kit – J-50397.

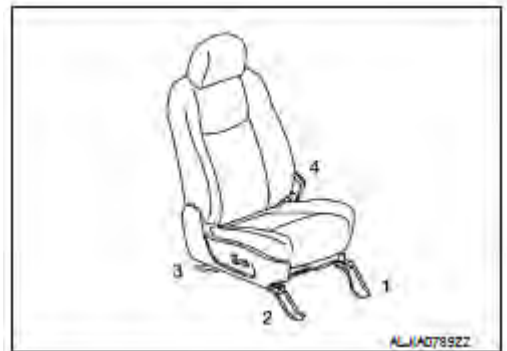
Figure 18

21. Reinstall the seat into the vehicle in reverse order of removal.

- Torque passenger seat mounting bolts to:
48 N•m (4.9 kg-m, **35 ft-lb**)
- Torque bolts in the order shown.

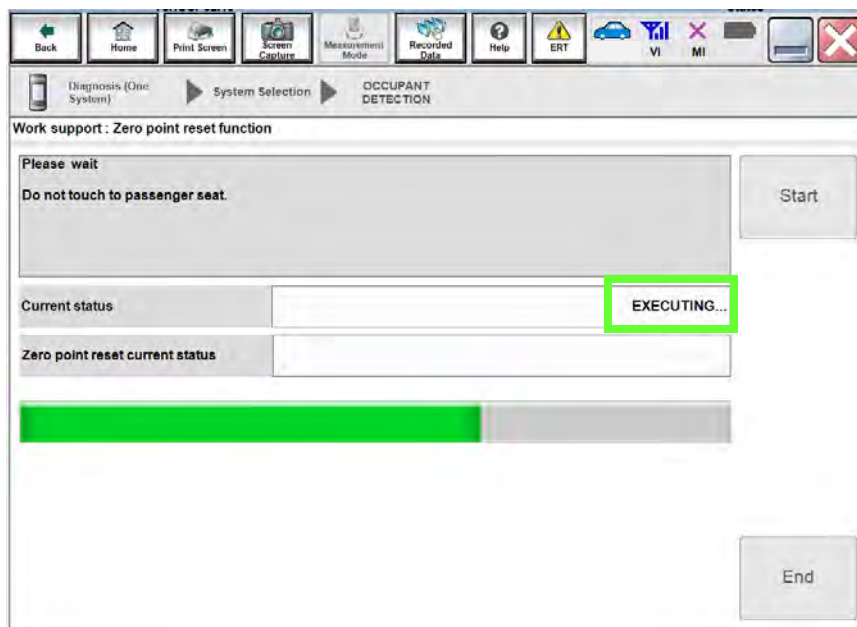
Figure 6A

12. Zero point reset will display “EXECUTING”.
