# SERVICE BULLETIN

Classification: RS17-014b	Reference: NTB17-059b	Date: August 25, 2017
------------------------------	--------------------------	--------------------------

## 2013 – 2016 SENTRA; OCCUPANT CLASSIFICATION SYSTEM RETROFIT

**APPLIED VEHICLES:** 2013 – 2016 Sentra (B17)

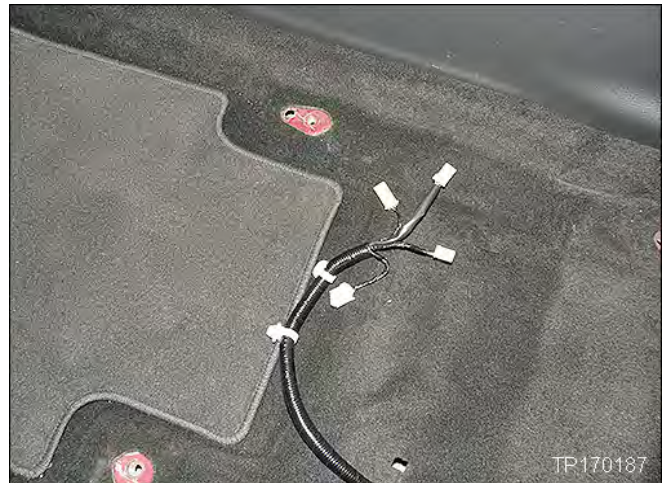
Figure 1

- With the seat removed you will have access to the connectors shown in Figure 1.
- These connectors were connected to the seat.

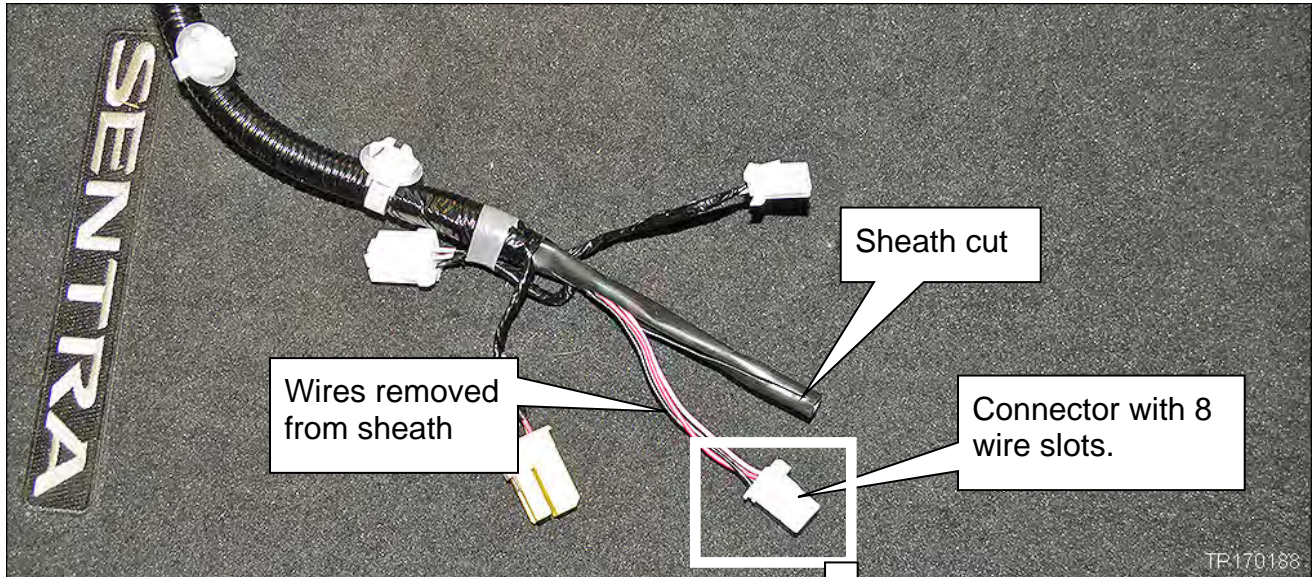
Figure 2

7. Carefully cut the sheath (harness cover) and remove wires as shown in Figure 2.
  - Inspect the wires to make sure there is no damage due to the cutting process.
8. Select the connector shown in Figure 2:
  - 8 wire slots, only 4 are occupied
  - The wire colors are:
    - Red (R)
    - Pink (P)
    - Black (B)
    - Gray (GY)

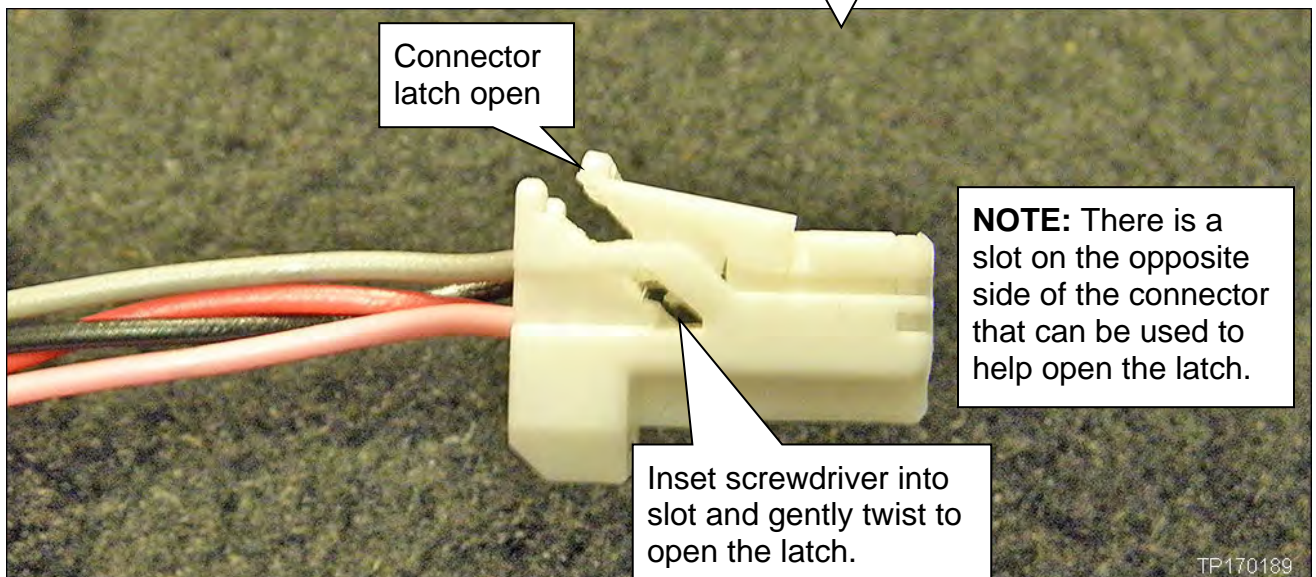
Figure 3

9. Use a small flat-blade screwdriver to open the connector latch (see Figure 3).

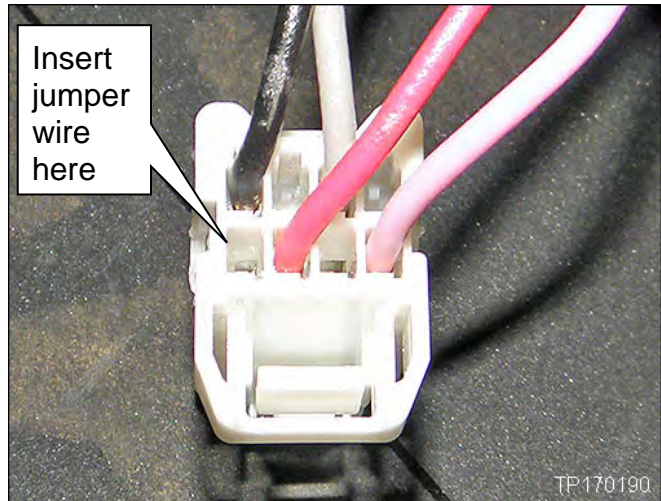
Figure 4

**NOTE:** In the next step, you will insert a jumper wire in the slot shown in Figure 4.

10. Insert the jumper wire as shown (see Figures 4 and 5).

- Jumper wire is listed in the Parts Information.
- Both ends of the jumper wire are the same, use either end.

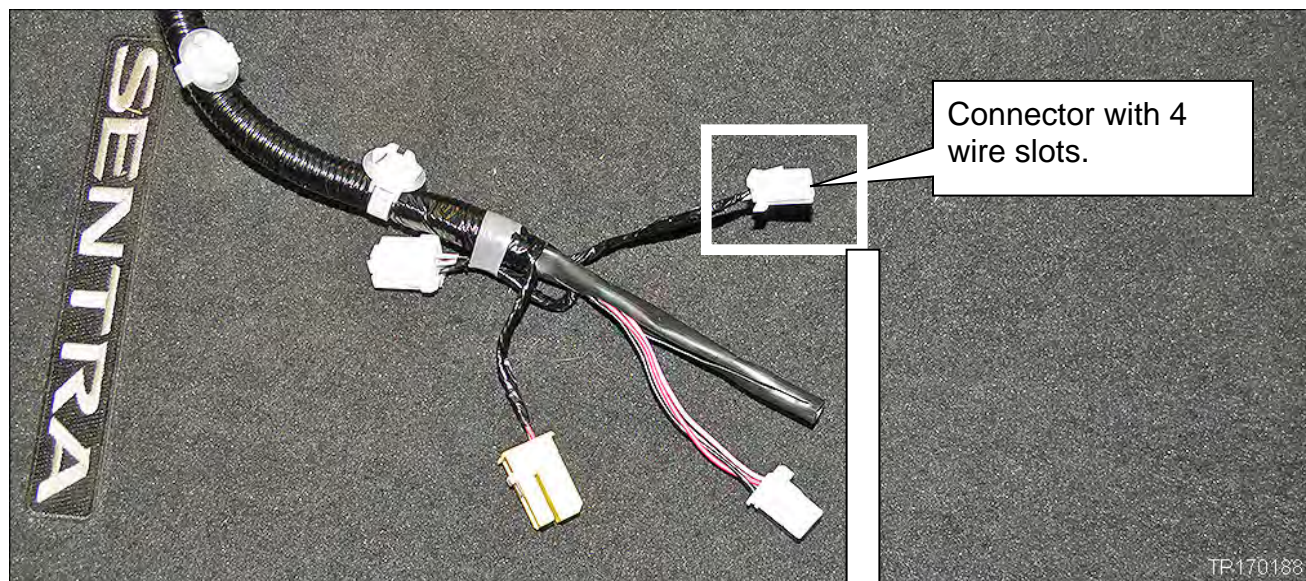
Figure 6

13. Select the connector shown in Figure 6:

- 4 wire slots, only 2 are occupied
- The wire colors are:
  - Light Green (LG)
  - Black (B)

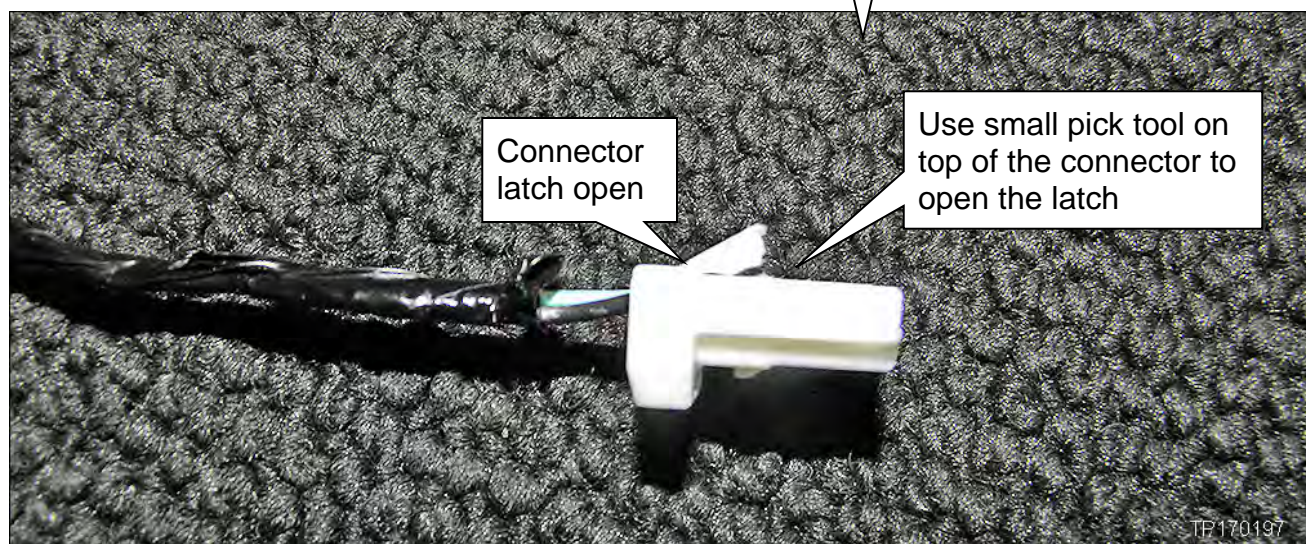
Figure 7

14. Use a small pick tool on top of the connector to open the connector latch (see Figure 7).

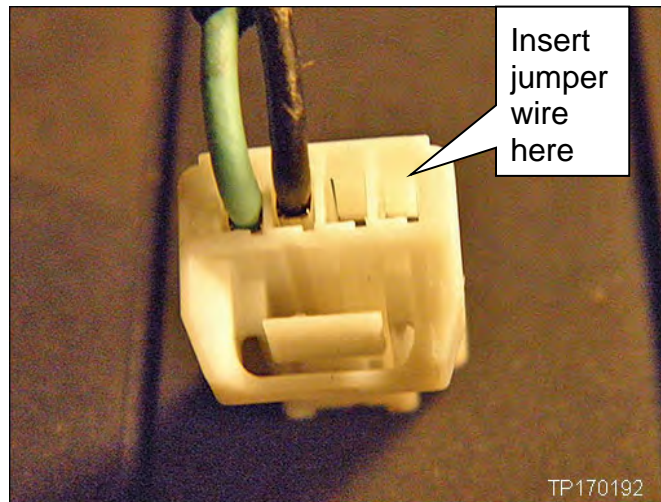
Figure 8

**NOTE:** In the next step, you will insert the other end of the jumper wire in the slot shown in Figure 8.

15. Insert the other end of the jumper wire as shown (see Figures 8 and 9).

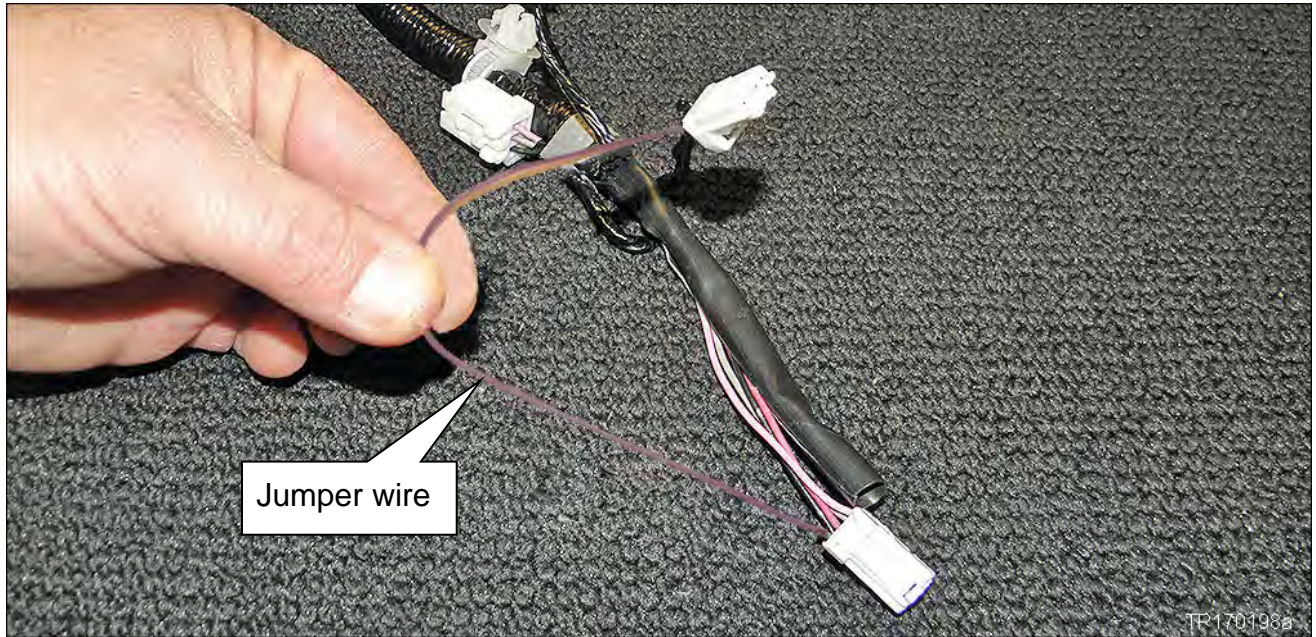
Figure 10

**NOTE:** The jumper wire is now connected as show in Figure 10.

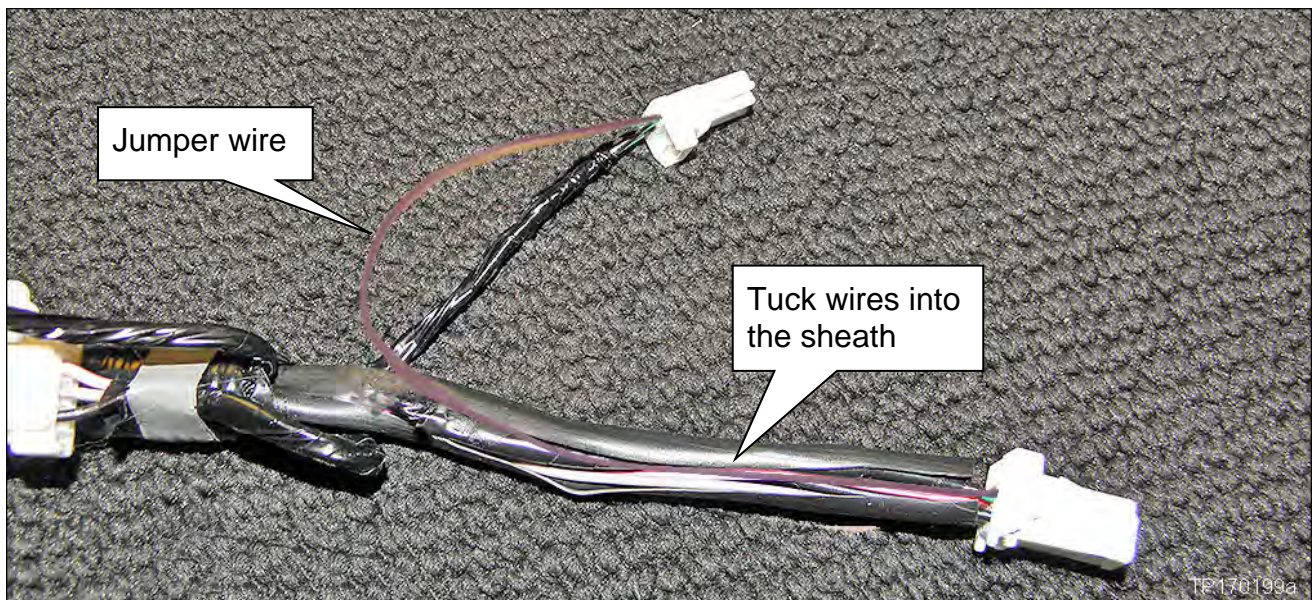
Figure 11

18. Tuck the jumper wire and other wires into the sheath.

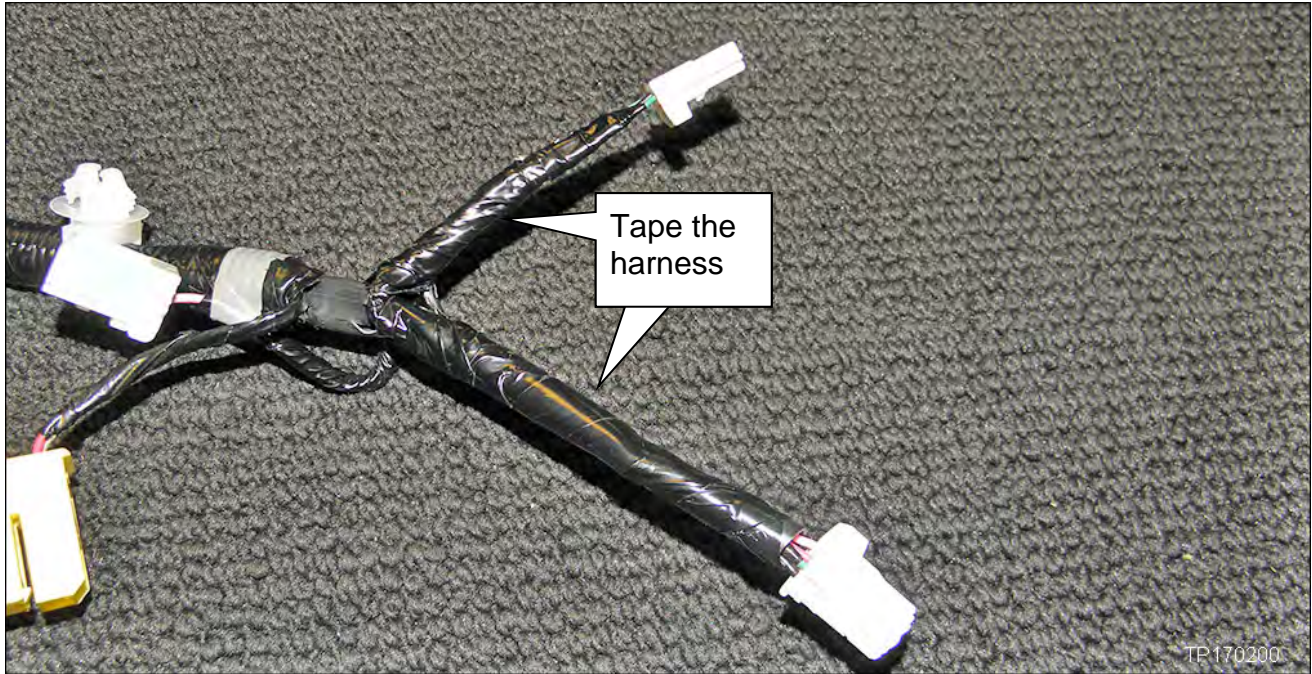
Figure 12

19. Tape the harness as shown in Figure 13.

- Refer to the Parts Information for electrical tape requirement.

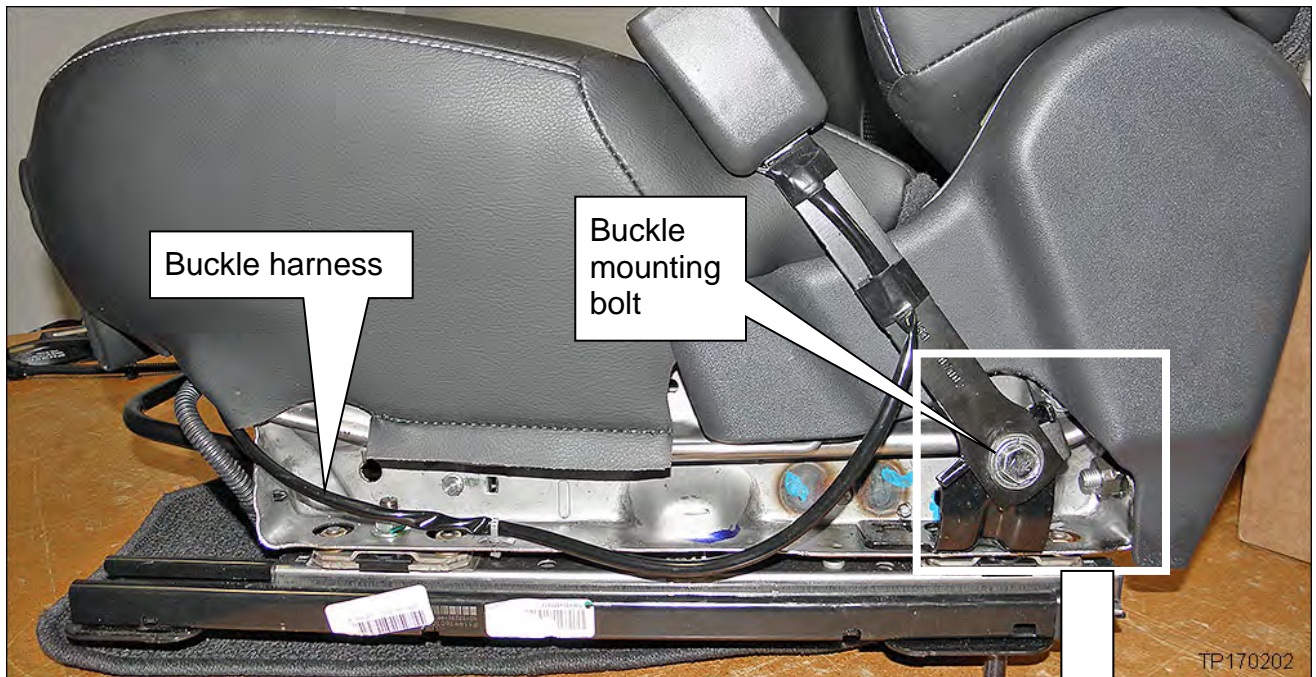
Figure 13

20. Remove the old seat belt buckle and install the **new** one (see Figure 13).

- New buckles are listed in the Parts Information.
- New buckles look the same as the old ones.
  - Harness connector of **new** buckle is 4 slots with 3 occupied.
  - Harness connector of old buckle is 4 slots with only 2 occupied.
- Buckle is held on with one bolt.
- Route and connect the harness of the new buckle the same as the old buckle.

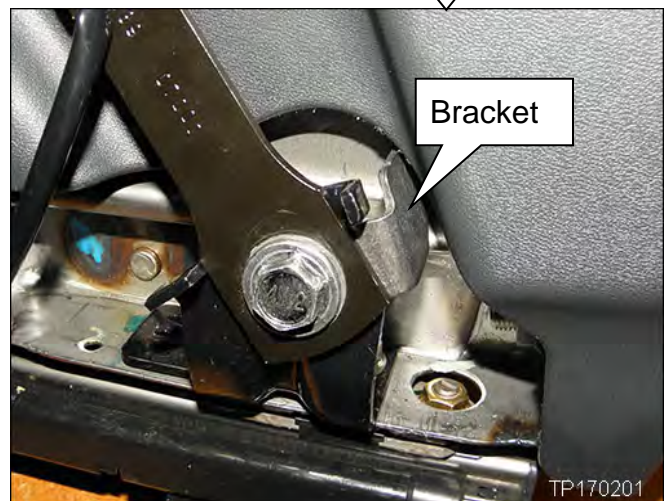
Figure 14

**IMPORTANT: Make sure this bracket is present.**

- This bracket is installed as part of campaign R1608 / NTB16-053.
- If the bracket is not installed, **it must be installed before continuing.**
- If needed, refer to NTB16-053 for bracket installation.

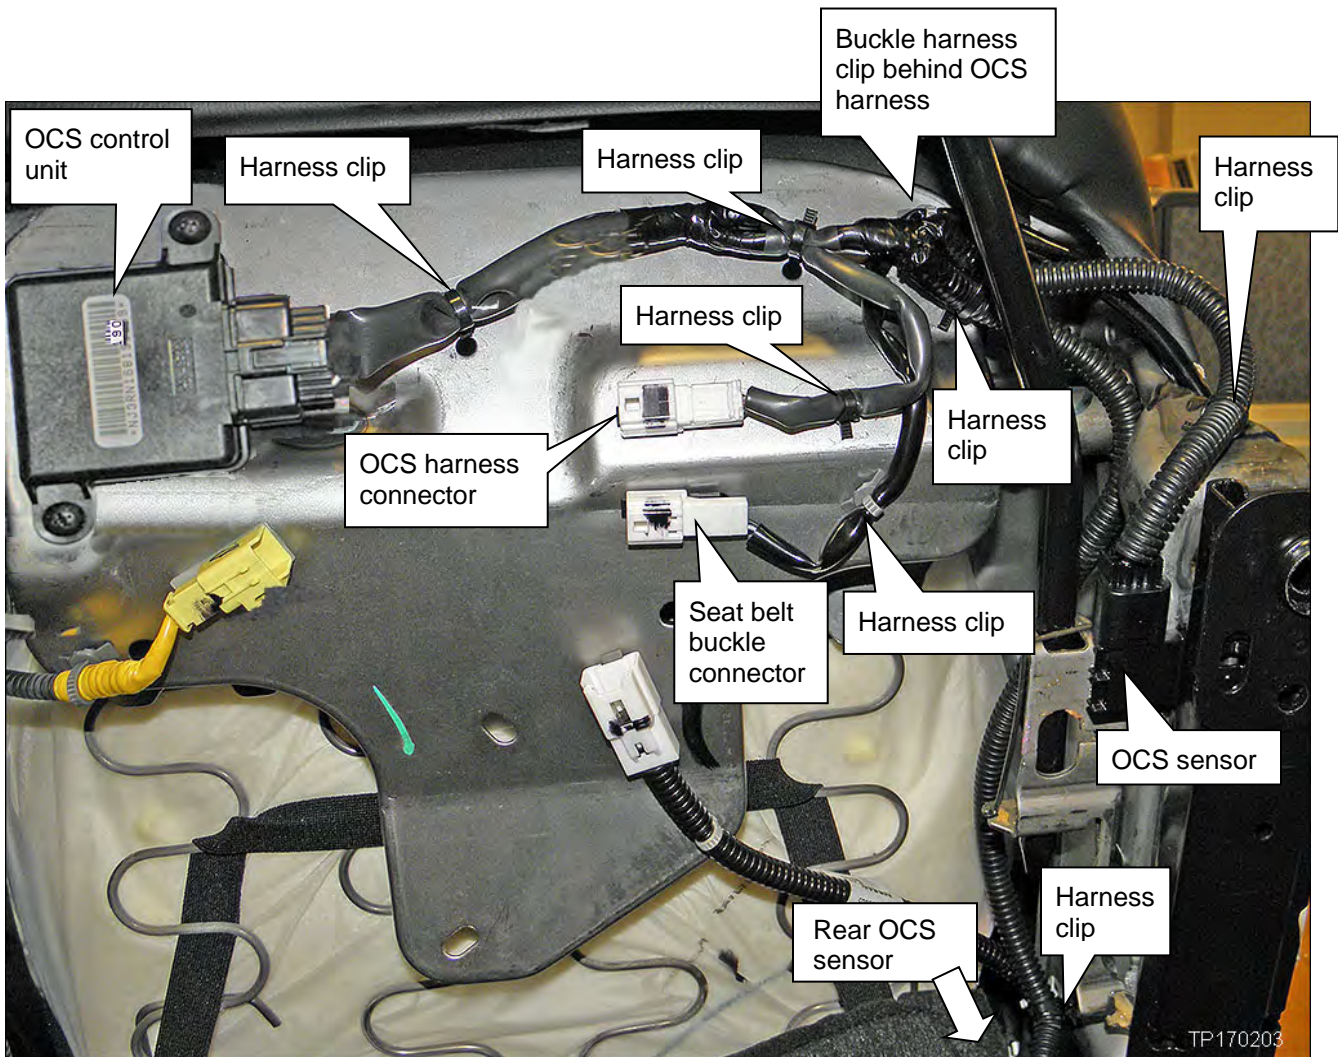
21. From under the seat, remove the old OCS harness and install the new one.

- The OCS harness consists of the wiring and connectors between the OCS sensors and the OCS control unit.
- The new OCS harness is listed in the Parts Information.

- a. Disconnect **one** OCS harness connector or mounting clip, then
  - b. Connect the new OCS harness connector or mounting clip before moving to the next one.
- Disconnecting/connecting one at a time will ensure that the new harness is connected **exactly** as the old one.
  - Refer to Figure 15 below and Figure 16 on the next page for exact harness mounting points.

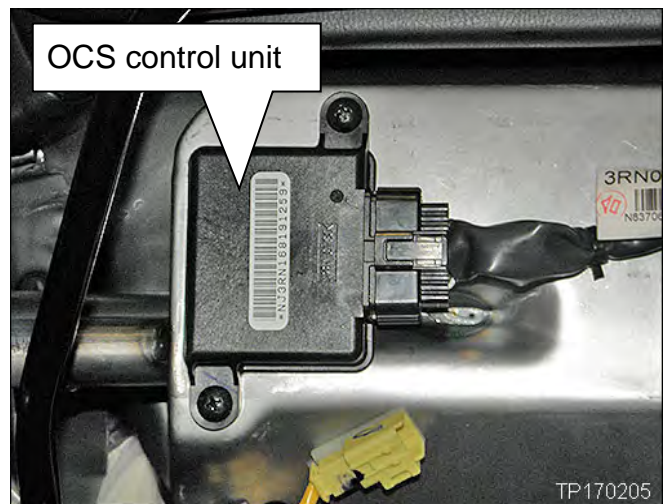
Figure 17

22. Replace the OCS control unit with the new one.

- The OCS control unit is held on with 2 screws.
- The OCS control unit is located under the front edge of the seat.
- New OCS control unit is listed in the Parts Information.

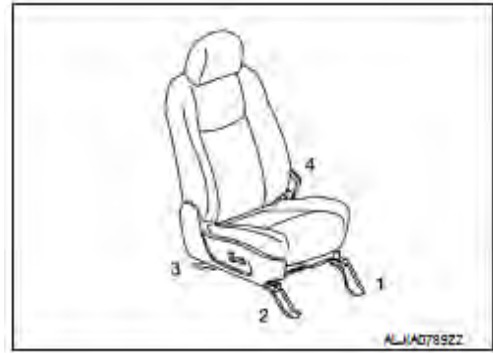
Figure 18

23. Reinstall the seat into the vehicle in reverse order of removal.

- Torque passenger seat mounting bolts to: 40 N•m (4.1 kg-m, **30 ft-lb**).
- Torque bolts in the order shown.

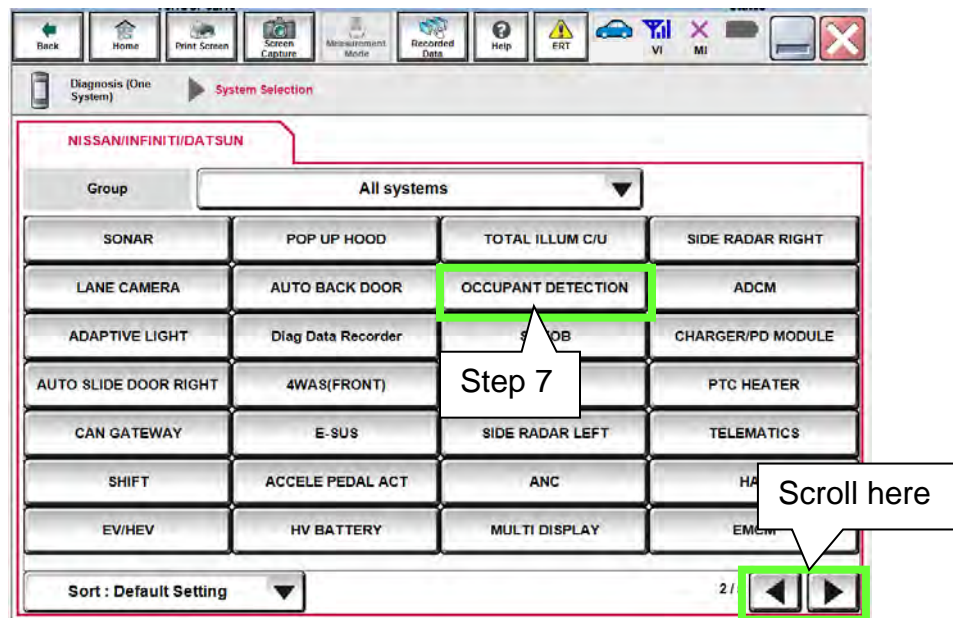
Figure 1A

1. Prepare the vehicle for OCS zero point reset as follows:
  - **Level the vehicle.**
  - **No objects on the passenger seat or in the storage bin.**
  - **No occupants in the vehicle – including the servicing technician.**
  - PC is outside of the vehicle on a suitable support.
    - Do not set the PC on the vehicle.
  - Do not touch the vehicle during the OCS zero point reset.
  - Minimize vibrations of the vehicle.
2. Connect the plus VI to the vehicle.
3. Open / start CONSULT-III plus (C-III plus).
4. Turn the ignition ON, with engine OFF (engine not running/not in ready mode).
5. Wait for the plus VI to be recognized.
  - The Serial No. will display when the plus VI is recognized.
6. Select **Diagnosis (One System)**.
7. Scroll C-III plus (All systems) and select **OCCUPANT DETECTION**.

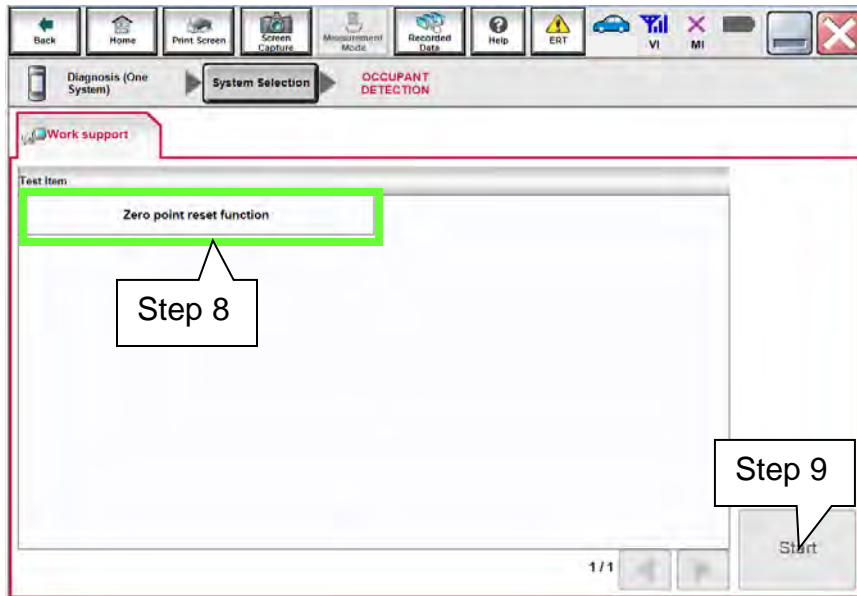
Figure 2A

8. Select **Zero point reset function**.

9. Select **Start**.

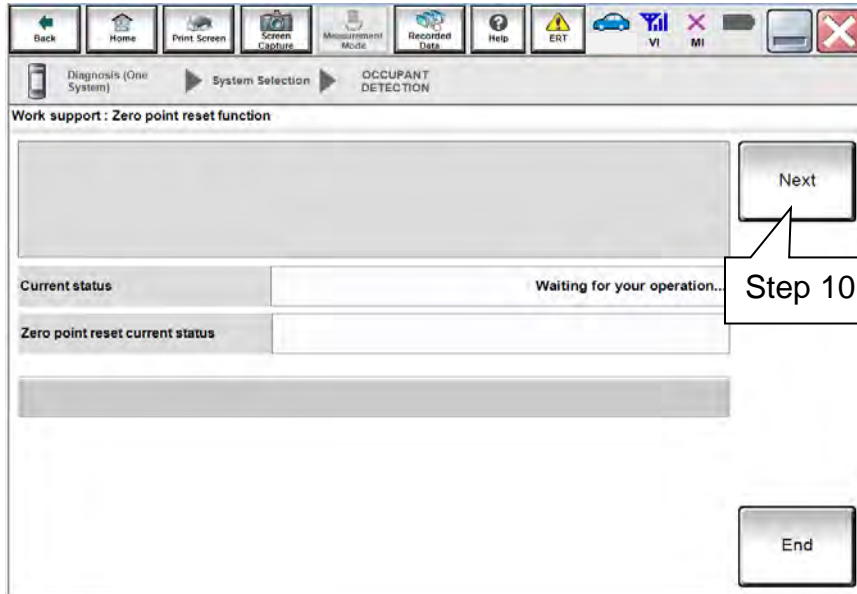
Figure 3A

10. Select **Next**.

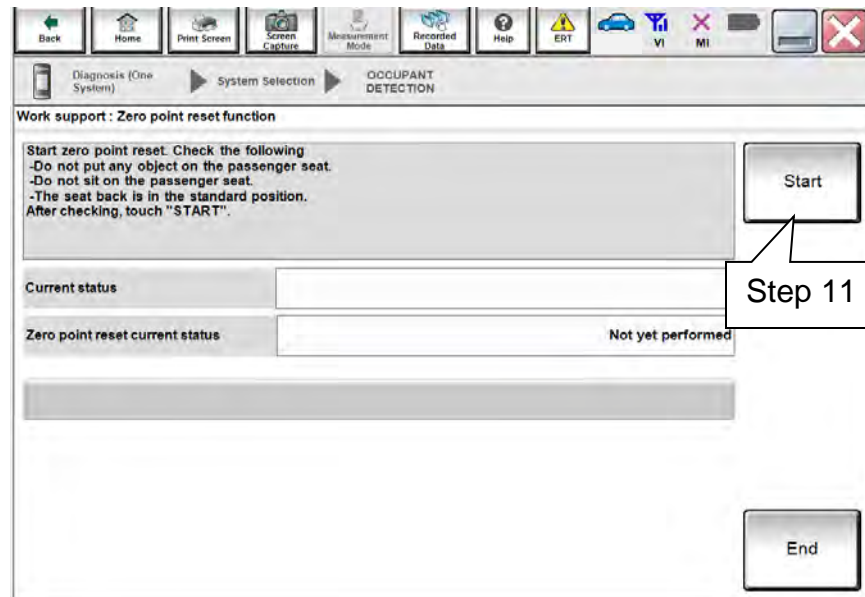
Figure 4A

11. Select **Start** and then proceed to step 12.

- After selecting **Start**, if Figure 5A is displayed:
  - a. Check the OCS control unit and confirm that harness connector is completely seated.
  - b. Turn the ignition OFF and then restart procedure from step 4 on page 15.

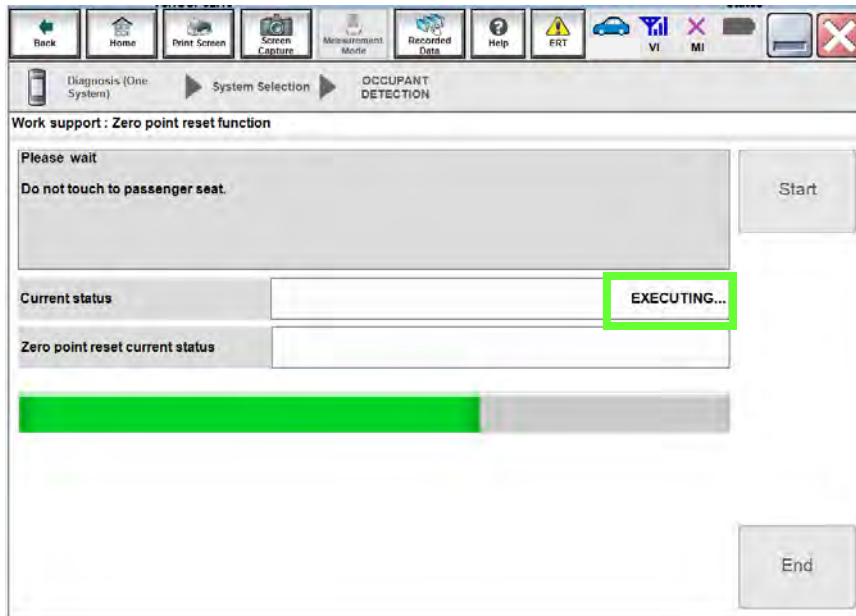
Figure 6A

12. Zero point reset will display “EXECUTING”.

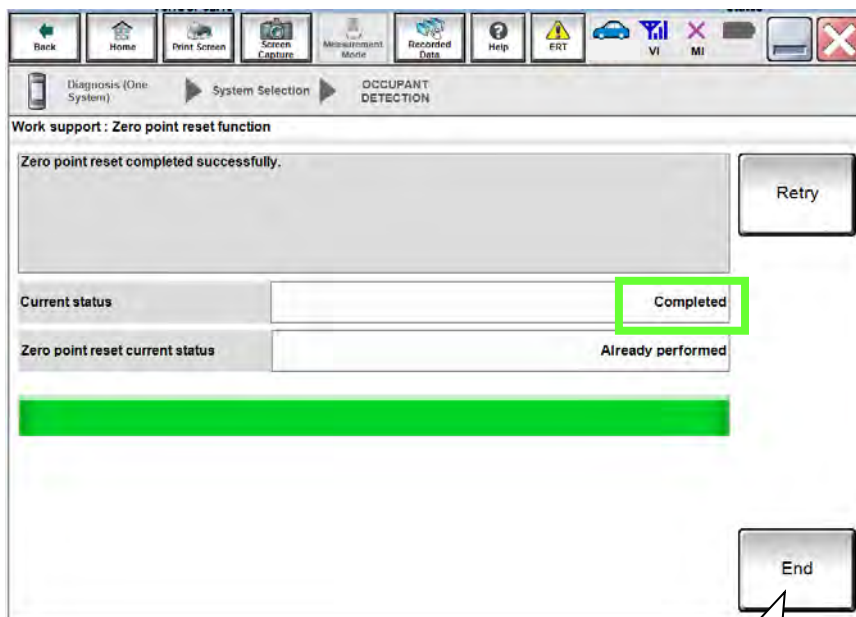
Figure 7A

13. When finished, "Completed" will display next to “Current status”.

- Select **End** and then proceed to step 14.
