Additional Coolant Pump Fault (POC4700) Causes MIL

Vehicle Type: **Cayenne PHEV (92A)**

Model Year: **2015 - 2017**

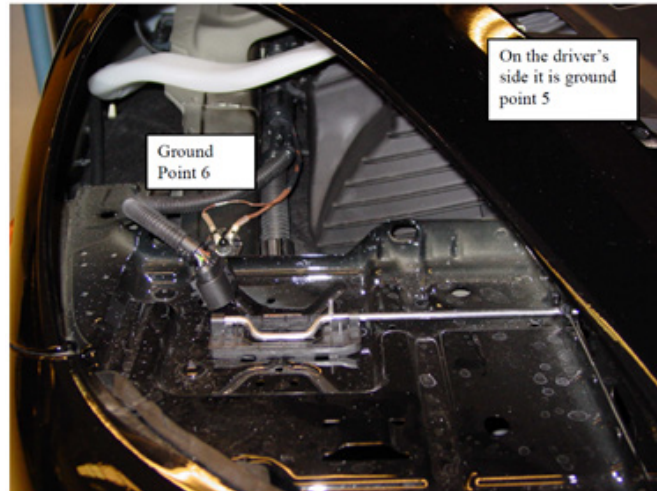
Figure 1 – Ground Pin 6B

Service Information: In many cases, technicians noted one or more of the following root causes:
a) Corrosion on Ground Pin 6B (See figures 1 and 2.)
b) Corrosion on the connector to the secondary low temperature coolant pump.
c) A bad ground or otherwise unsound wiring.

Looking into right front wheel well through the headlamp area (Driver side similar)

The service recommendation is to check the ground, connector, and wiring for corrosion and circuit continuity. Repair the ground, connector, or wiring as needed. Sometimes, the ground bolt is painted and not adequately conductive. In this case, clean the ground bolt and eyelet using a wire brush and sandpaper.
