Vehicle Does Not Move When in Third Gear

Vehicle Type: **718 Boxster/Cayman (982)**

Model Year: **2017, built before January 20, 2017**

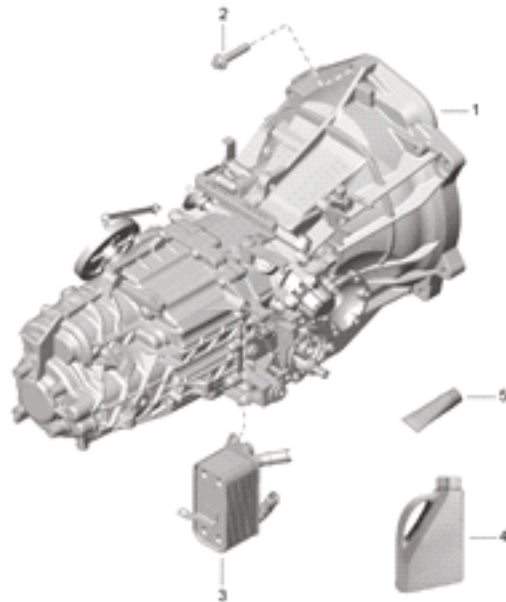
Customer Concern: The customer states there is no drive when the vehicle is in third gear.

Information: This was caused by poor welding of the fixed gear. The fastening process has been changed.

Resolution: Replace the transmission. Refer to WM343519 for the proper replacement procedure.
