TECHNICAL INSTRUCTIONS
FOR
LIMITED SERVICE CAMPAIGN H0L
PARKING BRAKE COVER INSTALLATION
CERTAIN 2018 C-HR

IV. BACKGROUND

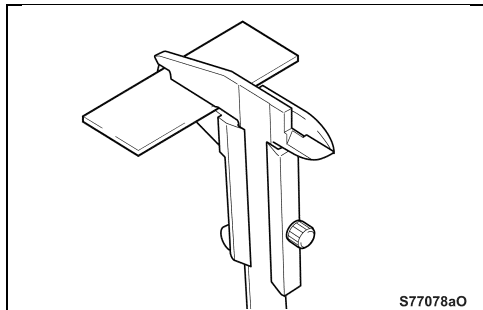
- Using a Vernier caliper, measure the thickness of the paper to ensure it meets the specification below.

**Specification: Approx: 0.7mm
(0.027in.)**

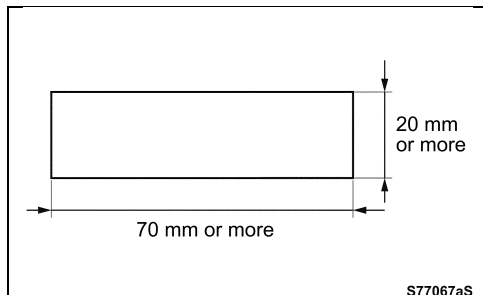
- Cut the paper to the size shown in the illustration

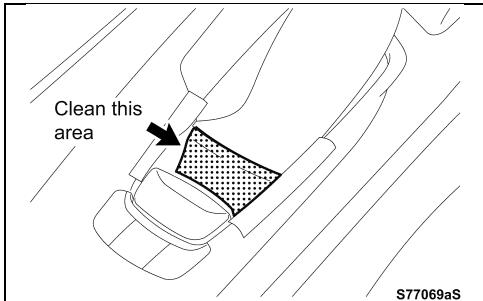
- c. Using the cloth that has been sprayed with parts cleaner, clean and degrease the upper surface of the upper console panel shown in the illustration.

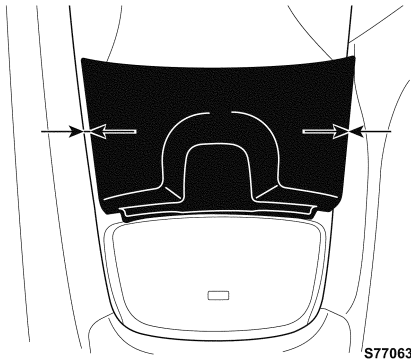
- a. Insert the spacer into the left-side gap between the electric parking brake switch and the upper console panel.

Be sure to use the spacer to ensure the gap is even on the right and left sides

- Be sure to use the spacer or the right and left side gaps between the parking brake cover and panel may become significantly uneven.
- Once permanently installed using double-sided tape, **DO NOT** reuse the parking brake cover, as it may accidentally detach due to reduced adhesive strength. Be sure to replace it with a **NEW** one.

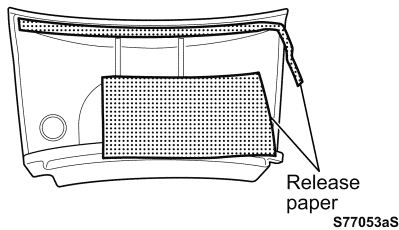
Upper console cover inner surface

- b. Remove the release paper from the double-sided tape on the **NEW** parking brake cover.

WHEN AMBIENT AIR TEMPERATURE IS 15°C (59°F) OR BELOW:
Slightly heat the tape on the parking brake cover and the mating surfaces of the upper console panel. The adhesive strength decreases when the temperature is 15°C (59°F) or below.

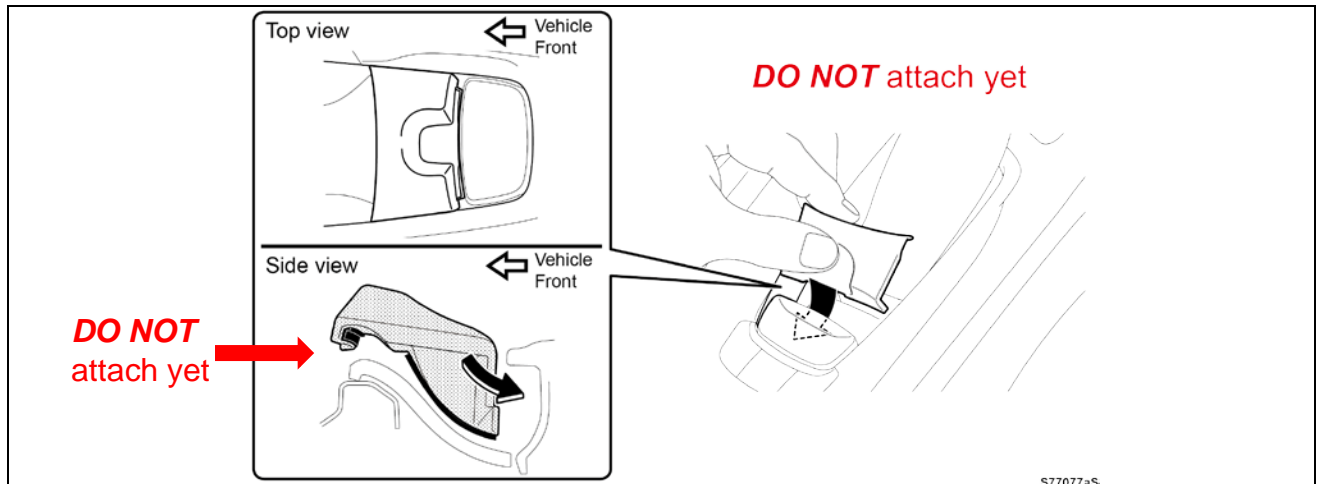
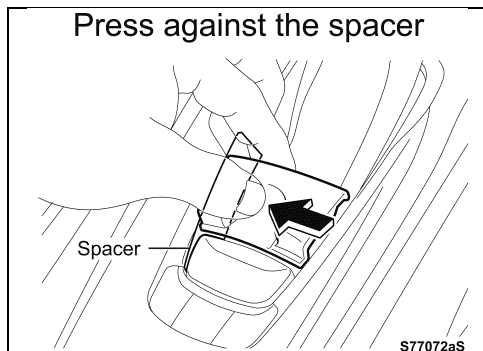
- c. Position the **NEW** parking brake cover in the space under the electric parking brake switch.

- **DO NOT** attach any part of the parking brake cover at this stage.
- **Be sure to first insert the parking brake cover as shown, or it will interfere with the parking brake switch.**

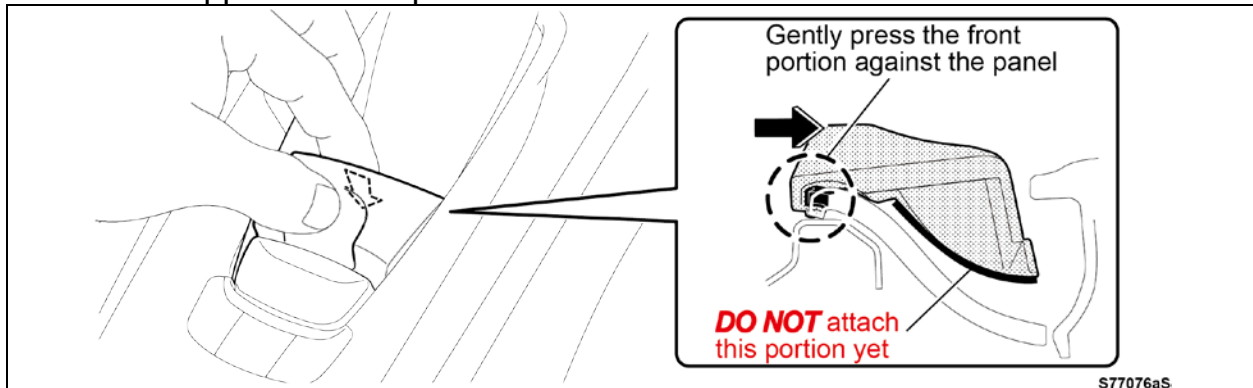
- d. Press the parking brake cover against the spacer

- e. While holding the parking brake cover against the spacer, gently press the front end against the panel as shown. Keep the rear portion lifted off the upper console panel.

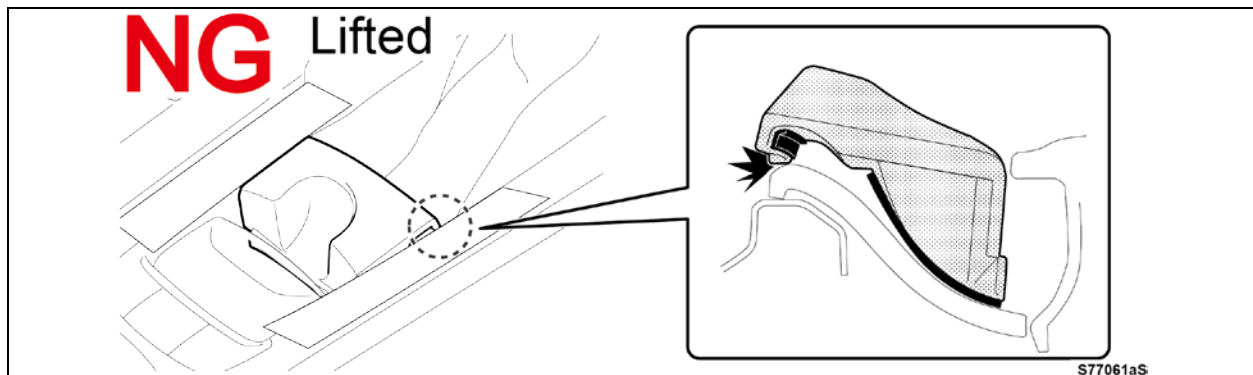
DO NOT attach the rear portion of the parking brake cover before the front portion, or the parking brake cover cannot be installed correctly.

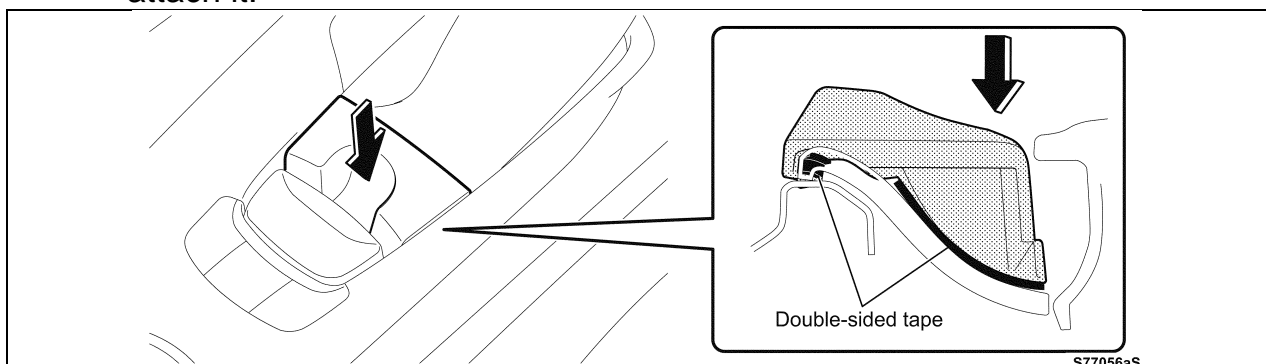
- f. Gently press down the rear portion of the parking brake cover to lightly attach it.

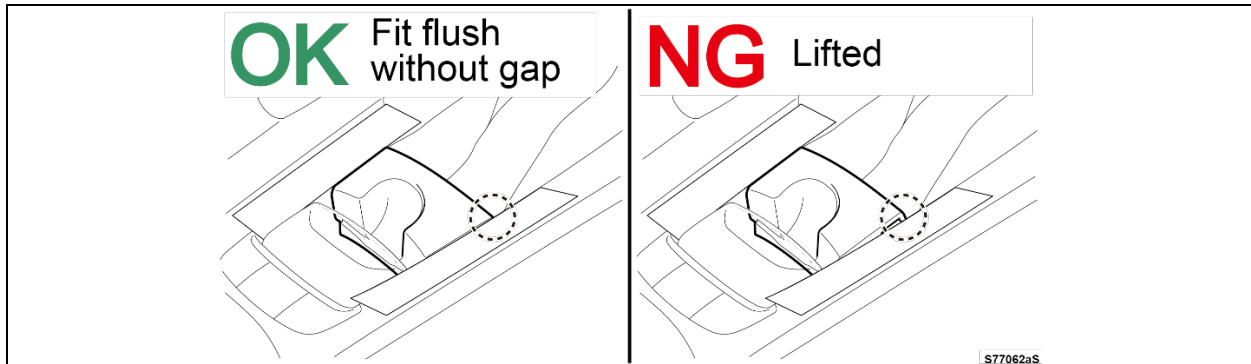
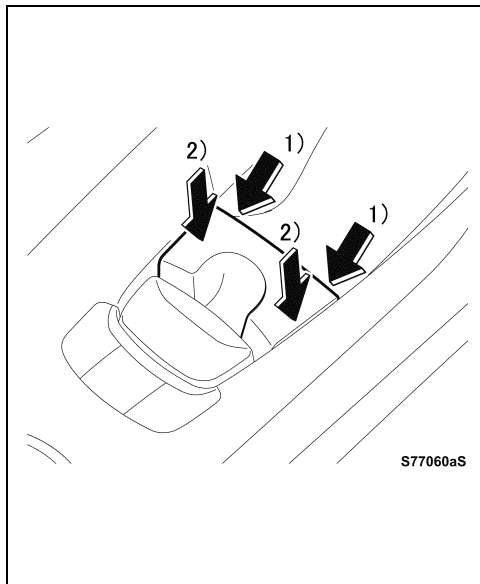
4. CHECK PARKING BRAKE COVER FOR PROPER INSTALLATION

- Check that the front end of the parking brake cover is flush with the upper console panel.
- If the front end is lifted, remove and reinstall the parking brake cover.

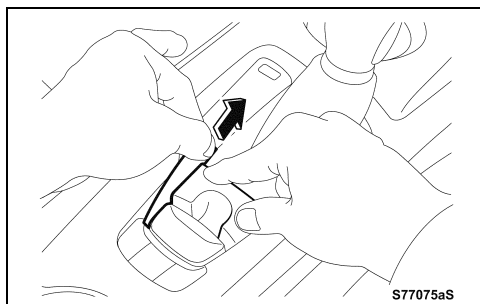
5. PERMANENTLY INSTALL PARKING BRAKE COVER

- Firmly press on the parking brake cover by hand
 - 1) Press the front end of the parking brake cover rearward
 - 2) Press the rear portion of the parking brake cover downward

The time the adhesive tape takes to build up to its full strength is approximately 10 hours.

DO NOT apply excessive force during this cure time.

- While pressing down on the parking brake cover to hold it in place, remove the spacer.
