SERVICE BULLETIN

Classification: FA17-005	Reference: NTB17-042	Date: April 17, 2017
-----------------------------	-------------------------	-------------------------

VERSA SEDAN, VERSA NOTE, AND MICRA SQUEAK IN FRONT SUSPENSION WHEN DRIVING OVER BUMPS

APPLIED VEHICLES: 2012 – 2016 Versa Sedan (N17)
2014 – 2016 Versa Note (E12)
2015 – 2016 Micra (K13)

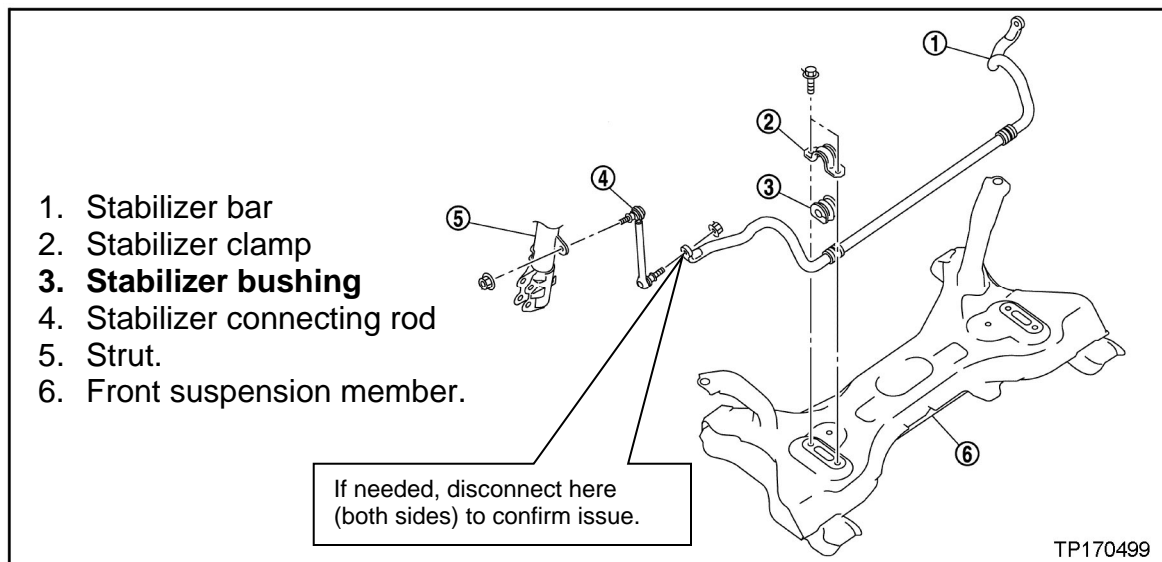
Figure 1

Squeak noise coming from the stabilizer bushings (see Figure 1) while driving over bumps at slow speeds,

NOTE: To confirm the squeak is coming from the stabilizer bushing, it may be necessary to:

- Disconnect the stabilizer connecting rod from the stabilizer bar – both sides (see Figure 1).
- Drive the vehicle slowly over bumps to confirm the squeak is eliminated.

Replace **both** stabilizer bushings.

- Refer to the Electronic Service Manual (ESM), section FSU-Front Suspension, for stabilizer bushing replacement.
- Stabilizer bushings are listed in the Parts Information.
