Limited Validity - Warning Message "Spoiler fault": Replacing spoiler (60/17)

Vehicle Type: **Panamera Turbo (971)**

Subject: **Rear spoiler**

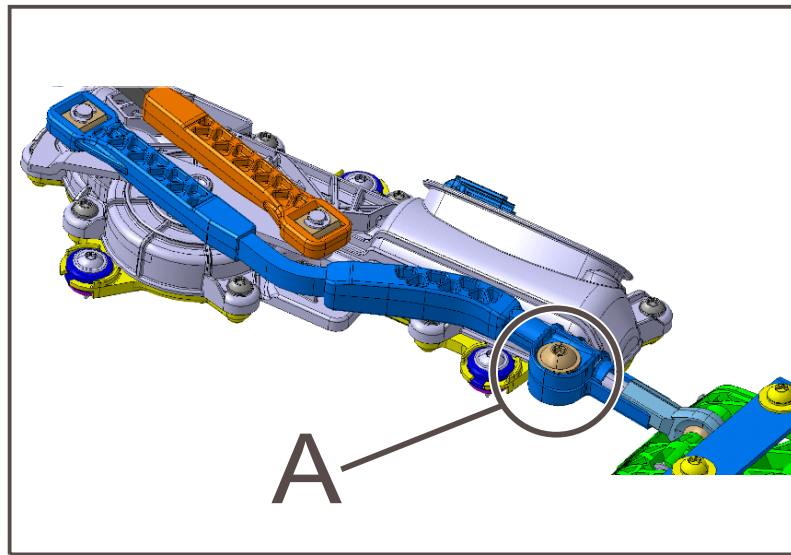
Spoiler with clamping screw

Information: **The clamping nut on the connecting link on the rear spoiler can become loose:**

- As a result, the **side spoiler flap can no longer be retracted,**
- a **warning message "Spoiler failure"**, "Spoiler fault" or "Spoiler control fault" appears in the instrument cluster and
- the **fault codes "EA6407" and "F00101"** are entered in the rear-end electronics control unit.

The new type differs from the previous type in that it has a clamping screw (see ⇒ *Spoiler with clamping screw*-**item A**-).

⇒ If there is **still a clamping nut** on the connecting link on the existing rear spoiler, **the rear spoiler must be replaced**.

⇒ **The faulty clamping sleeve/a loose clamping nut must not be replaced or repaired.**
