# Technical Bulletin

15 17 01 January 18, 2016 2045939 Supersedes Technical Bulletin V151603 dated November 23, 2016 to update procedure.

**MIL ON – DTC P0011 and or P0016 Stored in ECM Fault Memory – Engine May Run Rough At Idle**

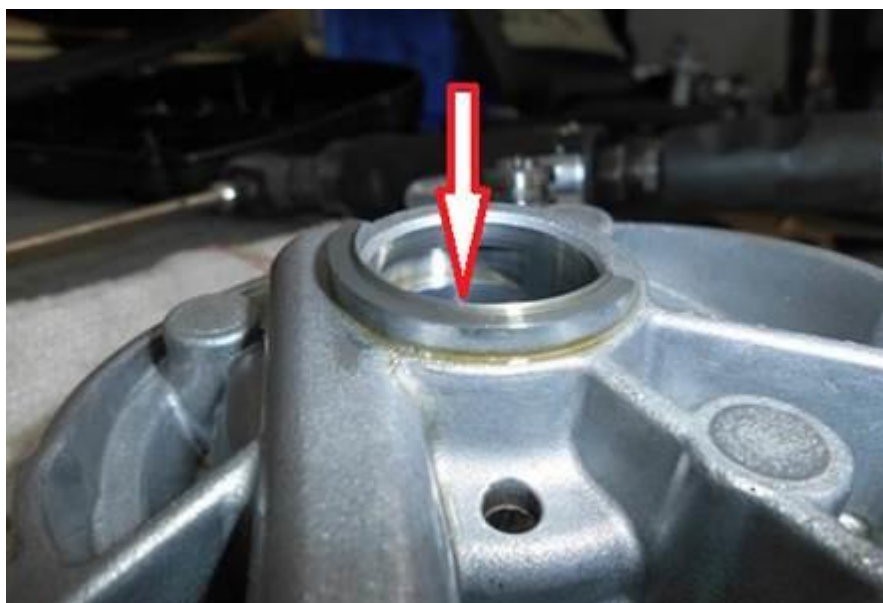
Wear of the camshaft bearing bridge can cause axial movement of the camshaft resulting in faults stored.

- Remove the camshaft bearing bridge according to the repair manual. Check the bearing bridge (camshaft side) for damage (groove in bearing surface or lip protruding from bearing surface as shown in figure 1).

Figure 1) example of worn camshaft bearing bridge

- If the bridge is damaged as indicated in (Figure 1), replace according to the repair manual.
- Change engine oil and oil filter.
