**NUMBER:** 23-042-17

Paint On Jeep Nameplate Is Peeling Off

This bulletin involves replacing the Jeep nameplate on the hood.

2017 (MP) Jeep Compass

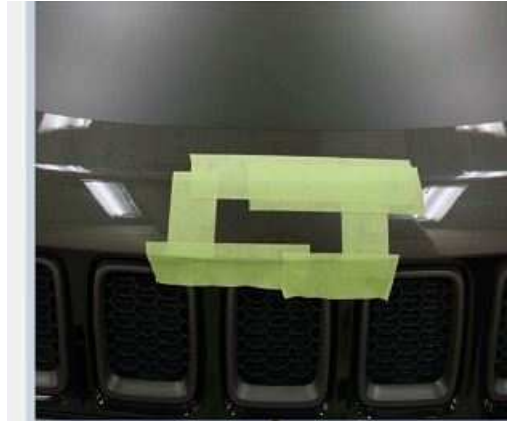
Fig. 1  
Marking Location

1. Apply a length of masking tape on the body parallel to the top edge of the nameplate as a guide if necessary (Fig. 1) .

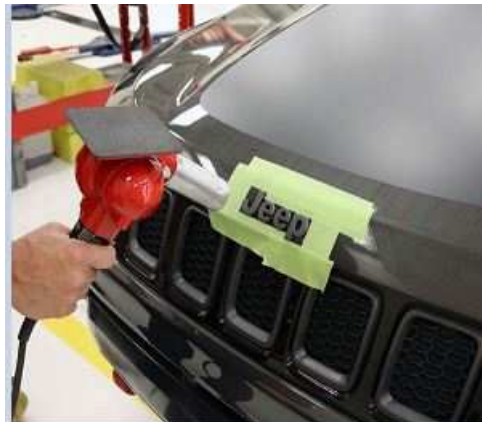
Fig. 2  
Heat Gun

2. If temperature is below 21° C (70° F), warm nameplate with a heat lamp or gun. Do not exceed 52° C (120° F) when heating nameplate for removal.

**NOTE:** The exterior nameplates are attached to the body with adhesive tape (Fig. 2) .

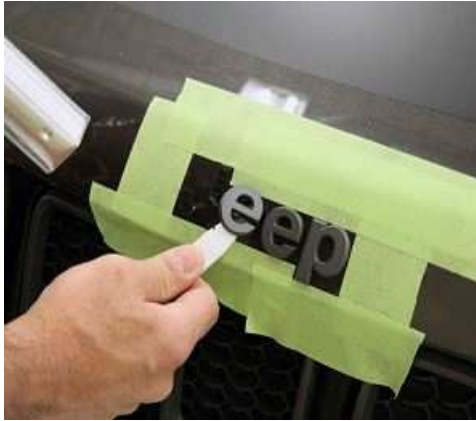
**Fig. 3**  
**Trim Stick**

- Using a trim stick or equivalent, carefully remove the nameplate or decal from the body panel, as necessary (Fig. 3) .

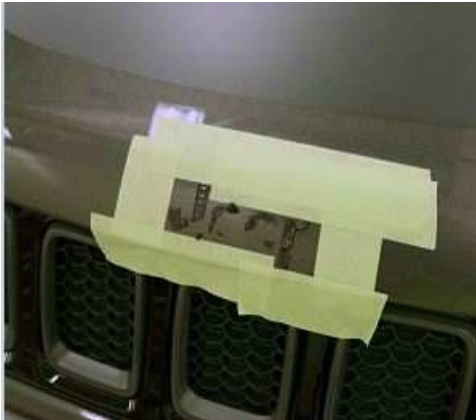
**Fig. 4**  
**Remove Adhesive**

- Thoroughly clean all residue from the nameplate attachment areas of the body (Fig. 4) .

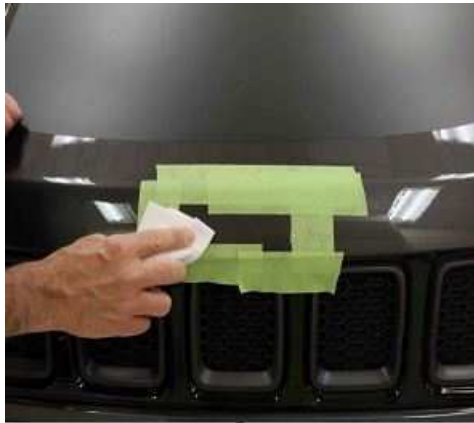
Fig. 5  
Cleaning The Area

5. Wipe the attachment areas with a clean, lint-free cloth, moistened with a 50% solution of water and alcohol. Wipe dry the areas immediately with a dry, lint-free cloth (Fig. 5) .

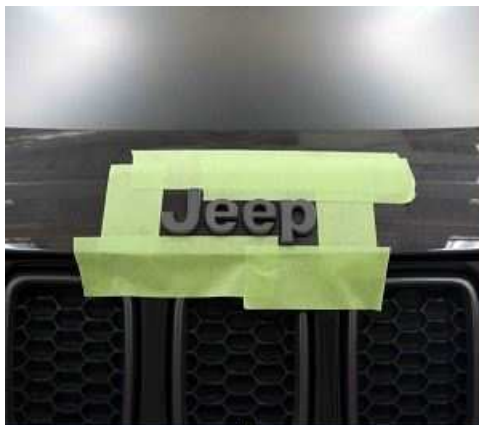
Fig. 6  
Apply Nameplate With Firm Pressure

6. Remove the protective covering from the back of the nameplate and position the nameplate onto the body using the previously installed guide tape .

**NOTE: To ensure proper nameplate or decal adhesion, apply consistent and uniform pressure of approximately 40 p.s.i. over the entire surface of each nameplate or decal. Remove the protective covering from the nameplate (Fig. 6) .**

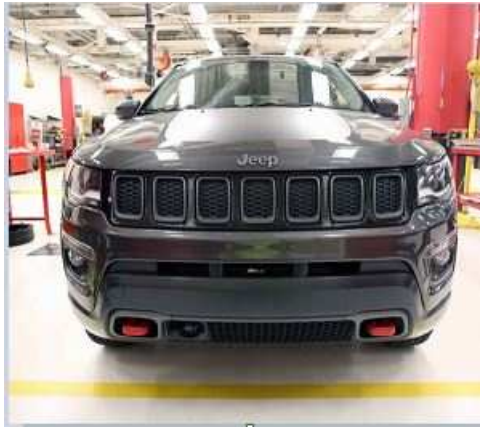
**Fig. 7**  
**Remove Protective Cover and Guide Tape**

7. Remove the guide tape (Fig. 7) .
