SERVICE BULLETIN

RS16-013a

2013 – 2016 ALTIMA AND 2015 – 2016 MURANO; OCCUPANT CLASSIFICATION SYSTEM RETROFIT

APPLIED VEHICLES: 2013 – 2016 Altima (L33)
2015 – 2016 Murano (Z52)
2016 Murano Hybrid (Z52)

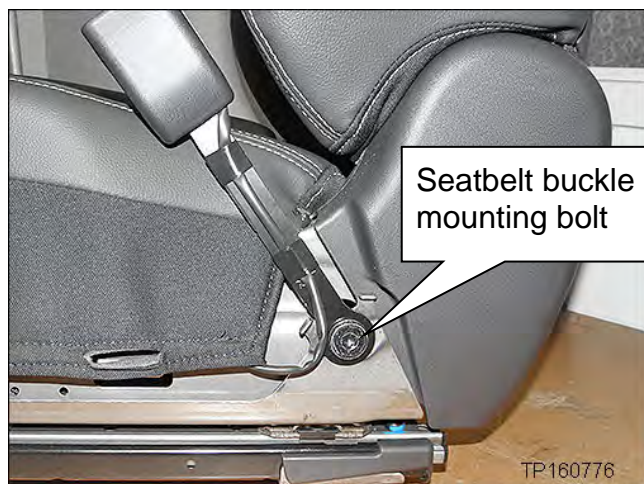
Figure 1

7. Remove the seatbelt buckle.

- Buckle is held on with one bolt.

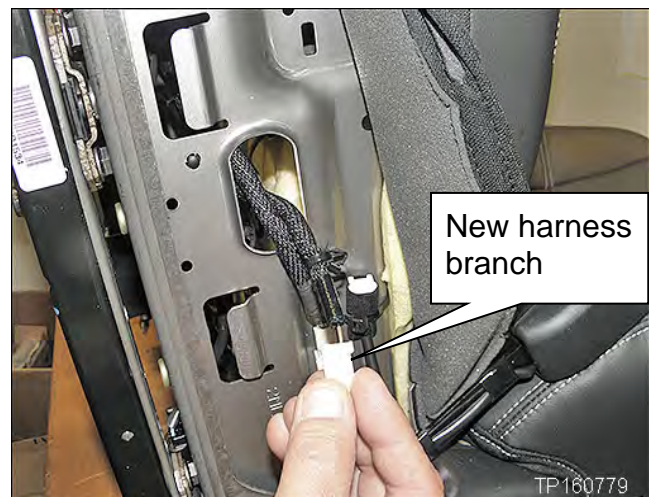
Figure 11

13. Route the new branch/connector of the OCS harness through the seat frame as shown.

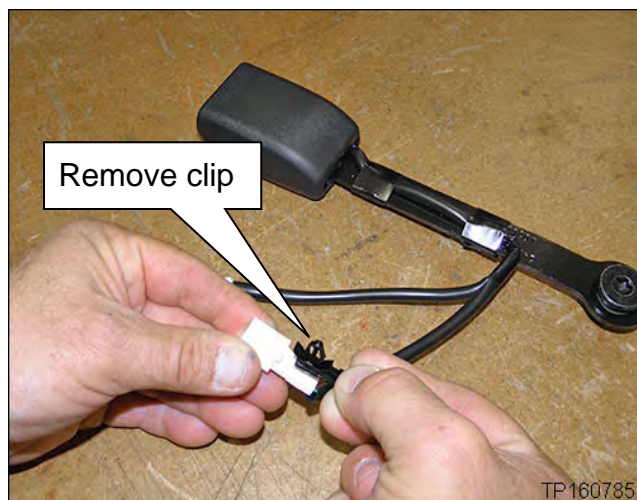
Figure 12

14. Remove the harness mounting clip from the new seatbelt buckle connector.

- This clip will not be used.

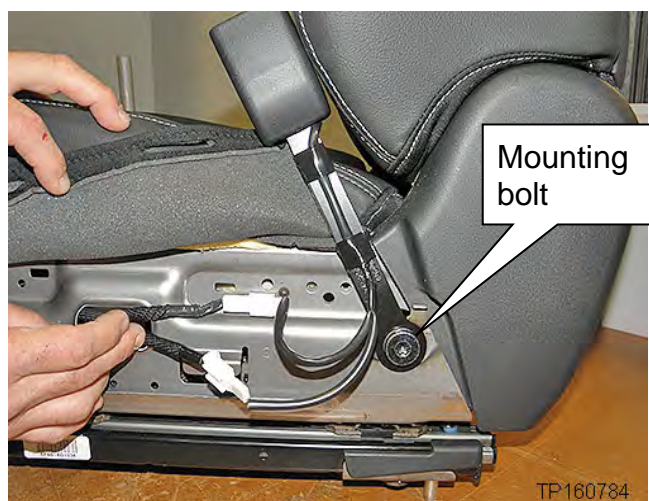
Figure 13

15. Install the new seatbelt buckle.

- Torque the mounting bolt to:
49 N·m (5.0 kg-m, 36 ft-lb)
- Connect the 2 electrical connectors.

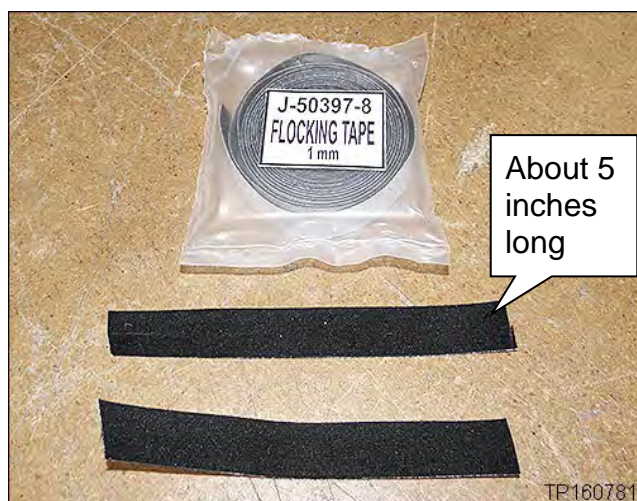
Figure 14

16. Cut 2 strips of flocking tape (J-50397-8); each strip about 5 inches long.

- Flocking tape is part of the squeak and rattle kit – J-50397.
