# Technical Bulletin

**92 17 01** March 13, 2017 **2026253** Supersedes Technical Bulletin V921502 dated July 22, 2015 to provide information on wiper blades inspection, windshield cleaning and proper warranty coding. This bulletin also includes additional model and model year applicability, and allows archiving of T.B. 2024878 (V921302).

**Windshield Wipers Do Not Clean Properly or are Noisy During Operation (U.S. Only)**

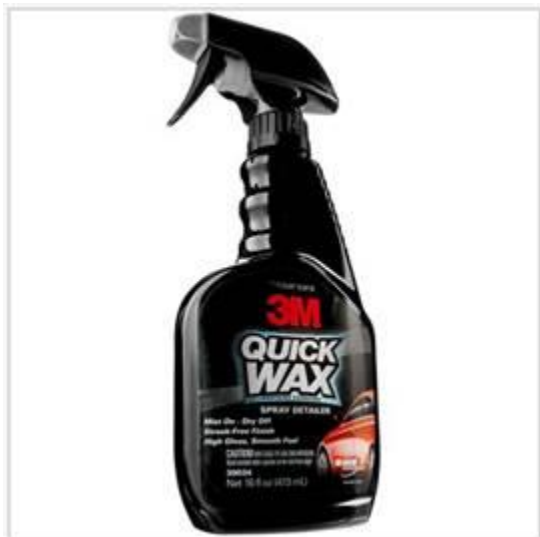
Steps for deep cleaning exterior glass surface using 3M™ Quick Wax and Perfect-It Clay.

With vehicle exterior (including all glass surfaces) washed and dried and the wiper arms placed in the service position, perform the following:

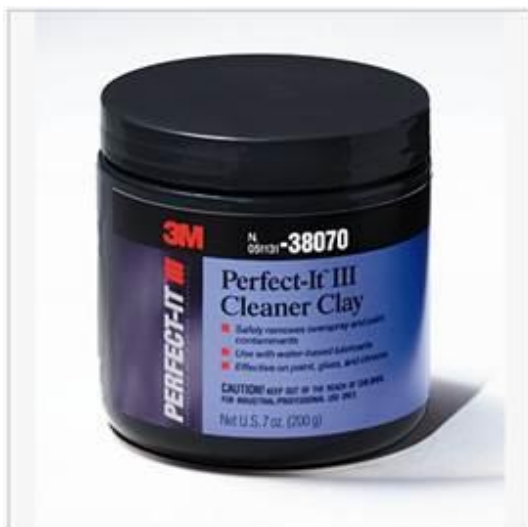
- Apply 3M™ Quick Wax Part No. 39034 to the windshield or rear glass.

Using 1/3 of a bar 3M™ Perfect-It™ III Cleaner Clay Part No. 38070:

- Flatten clay into a small palm size pancake.
- With clay flat between windshield and your hand, rub windshield (with light friction) using a vertical motion (up/down) across windshield.
