H TECHNICAL PROCEDURE

ULTIMAAX® Rear Suspension for Kenworth Vehicles

SUBJECT: Service Instructions

LIT NO: 17730-301

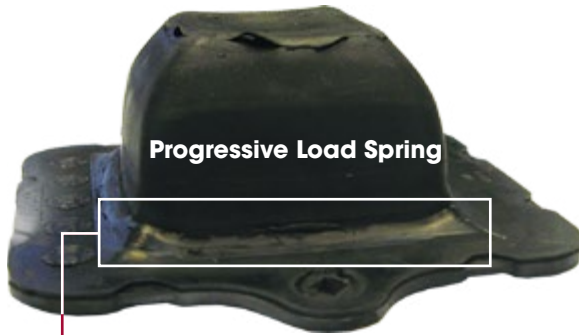
FIGURE 6-17

Polished Appearance — Creases formed by the folding of the rubber surface under load are acceptable.

- A bent or cracked mounting base requires PLS replacement.
- If any **cuts or splits** in the rubber of over 2" (50 mm) in length and an average depth of 1/2" (13 mm), the effected PLS requires replacement. A certain amount of gradual breakup of the rubber surface is normal. The most probable areas for potential cuts, splits, or wear are shown in Figure 6-16 as "//////".
- The **bonding separation depth** of the rubber from the PLS mounting base plate surface (see Figure 6-16) is more than a 1/2" (13 mm), the effected PLS requires replacement.
- Creases formed by folding of the rubber surface under load are acceptable. These appear as stripes on the surface, polished by wear or covered with tacky rubber, see Figure 6-17.

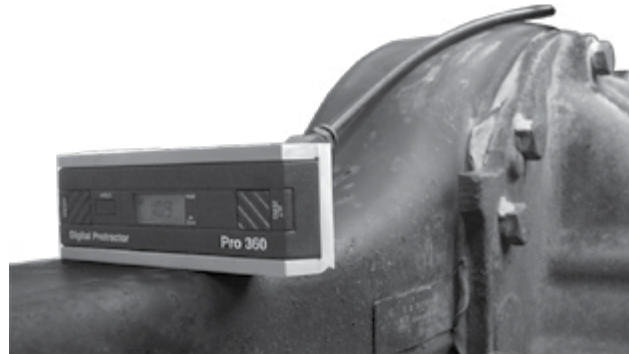
1. Loosen the longitudinal torque rod connection fasteners.
2. Place a digital protractor on the drive axle housing as shown in Figure 7-2.
3. Place a jack under the axle and raise or lower the axle to the correct pinion angle.
4. Add or remove shims at the bar pin connections on the longitudinal torque rod.

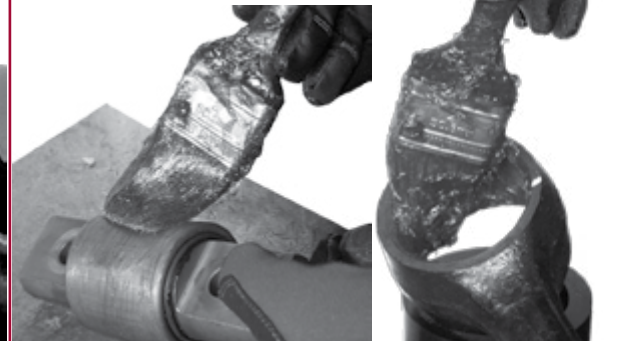
Apply NLGI #2-EP (Extreme Pressure) lubricant to the inner diameter of torque rod end hub and bushings

2. Lubricate the inner diameter of the torque rod end hubs and the outer metal of new bushings with NLGI #2 EP grease, see Figure 8-42.
