**November 14, 2017**

07641 Version 4

## High Pressure Fuel Pump Chirps

Supersedes 16-013, dated January 28, 2017, to revise the information highlighted in **yellow**.

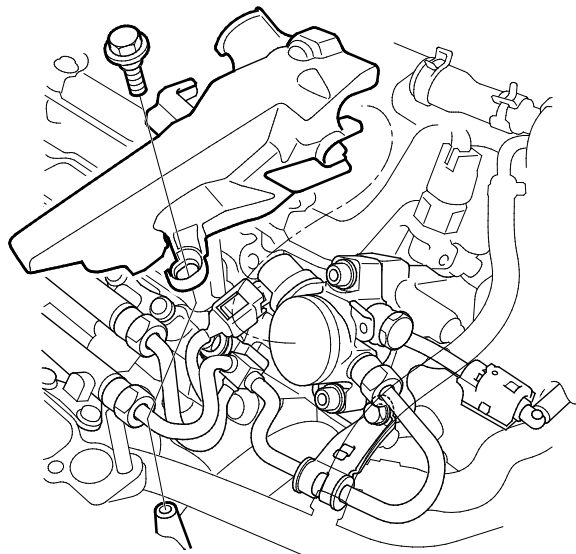
1. Relieve the fuel pressure. Due to the high pressure, see service information.
2. Set the No. 1 piston at top dead center (DTC). See service information.
3. Remove the intake manifold and intake manifold base. See service information.
4. Remove the high pressure fuel pump cover.

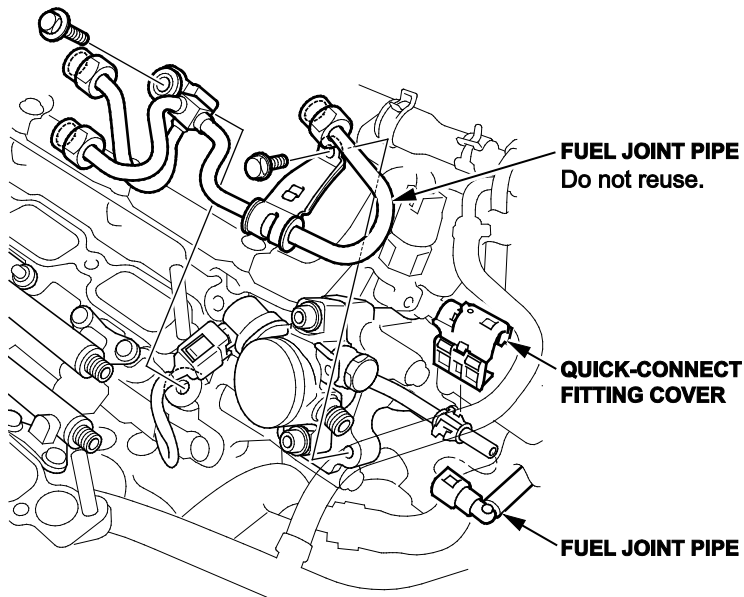
5. Remove the quick-connect fitting cover.

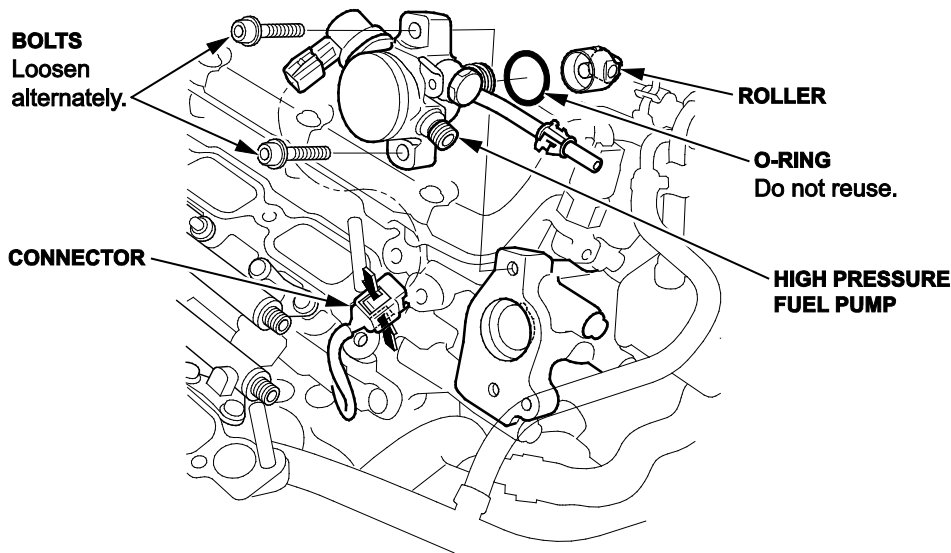
6. Disconnect the quick connect fitting.  
7. Remove the fuel joint pipe.  
8. Disconnect the high pressure fuel pump connector.

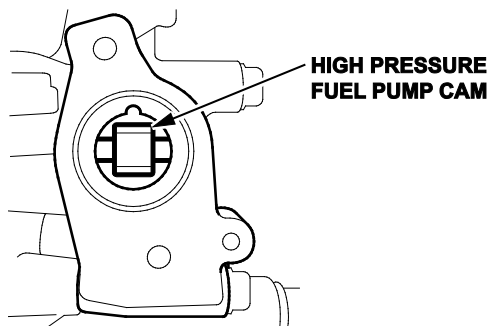
9. Remove the bolts by loosening them alternately, then remove the high pressure fuel pump and the roller.  
10. Rotate the crankshaft and check the high pressure fuel pump cam for pits, scores, and excessive wear. If needed, replace the rear camshaft.

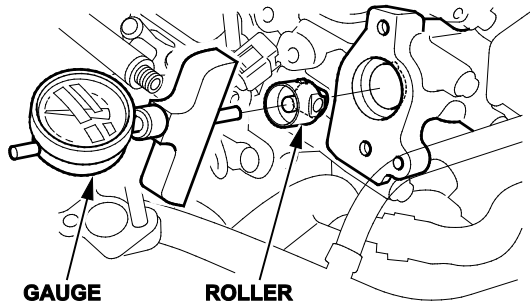
11. Set the No. 1 piston at top dead center (TDC).
12. Install the roller onto the high pressure fuel pump cam.

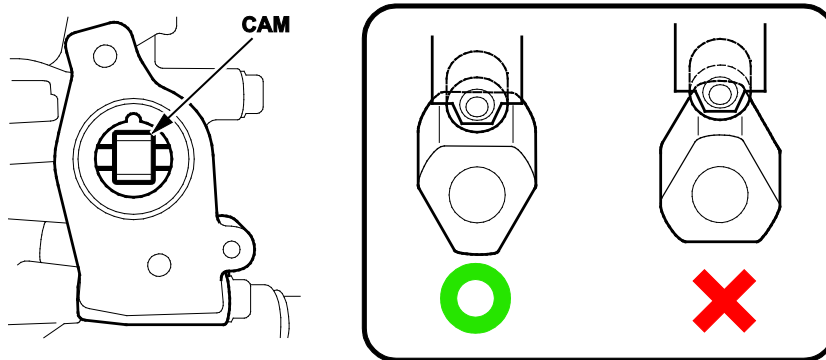
15. Set the No. 1 piston at top dead center (TDC).
16. Check the position of the cam that drives the high pressure fuel pump as shown.

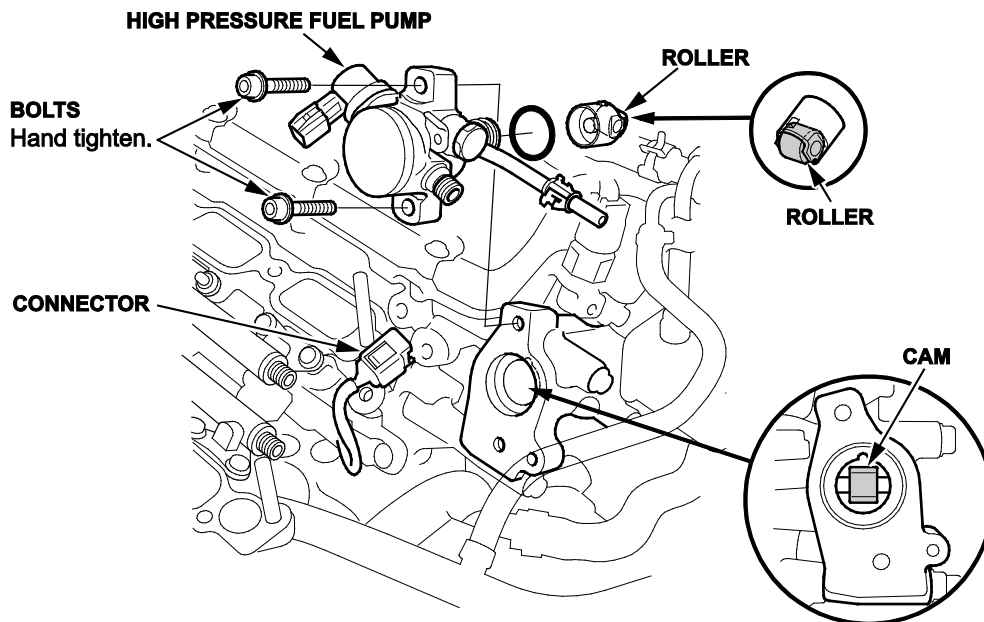
17. Coat the roller, O-ring, cam and around the bore of the lifter with clean engine oil.

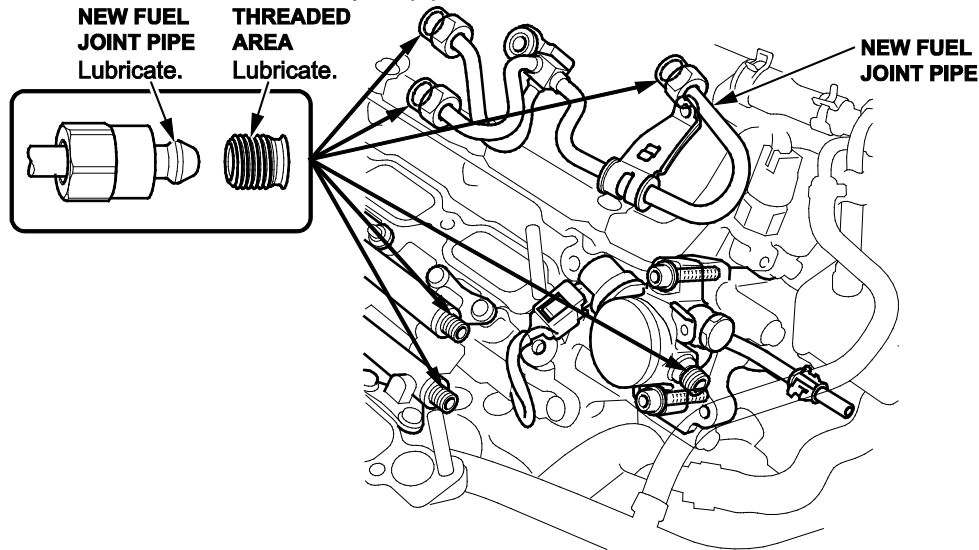
19. Lubricate the top of the new fuel joint pipe and the threaded area of the fuel rails and the high pressure fuel pump with polyethylene glycol included in the new fuel joint pipe kit.

NOTE: Do not reuse the fuel joint pipe.

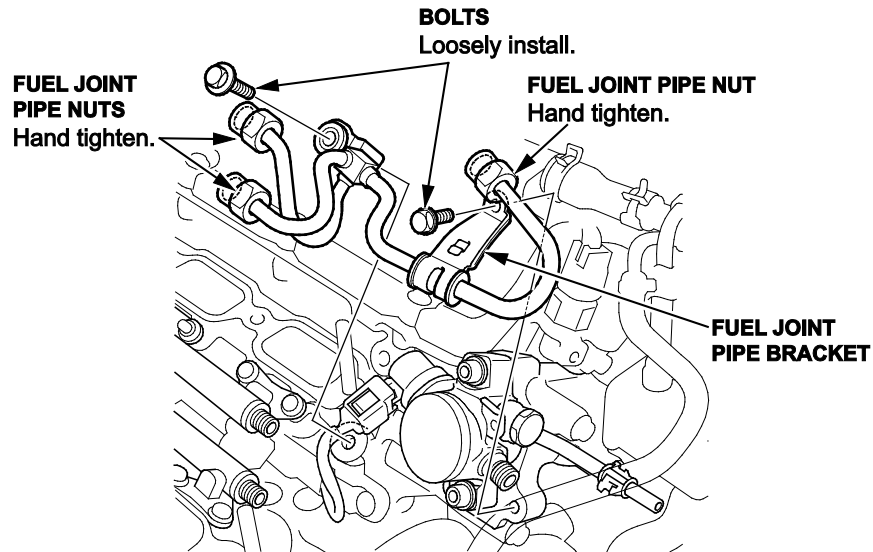
20. Tighten the fuel joint pipe nuts by hand until the end of the joint pipe is seated on the fuel rails and high pressure fuel pump.

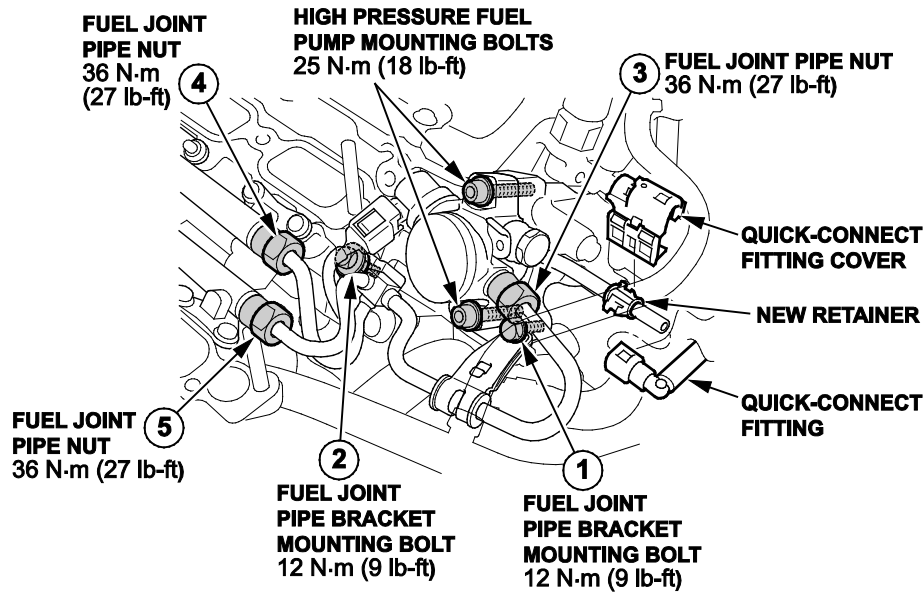
21. Set the fuel joint pipe bracket on the cylinder head and loosely install the bolts
22. Tighten the high pressure fuel pump mounting bolts to the specified torque.

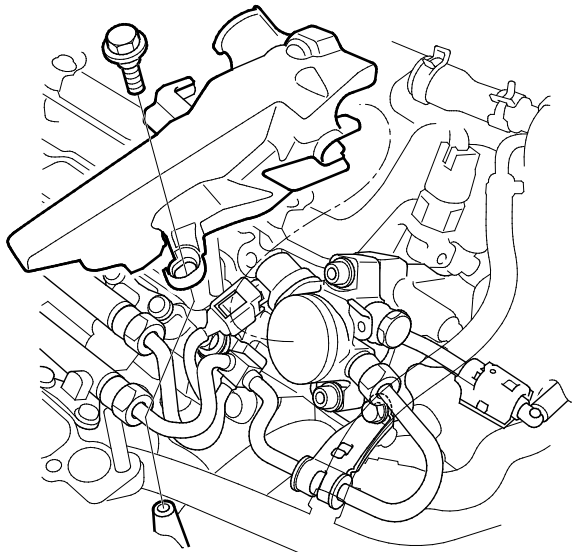
24. Connect the quick-connect fitting and install the quick-connect fitting cover.
25. Set the power mode to ON, but do not start the engine. After the fuel pump runs for about two seconds, the fuel line will be pressurized. Repeat this two or three times, then check for fuel leakage.
26. Install the high pressure fuel pump cover and torque it to **12 N-m (9 lb-ft)**.
