## **Field Phone Task Guidelines**

### **2018 Softail Jiffy stand**

**Specific components involved: Jiffy stand screws part number 4687**

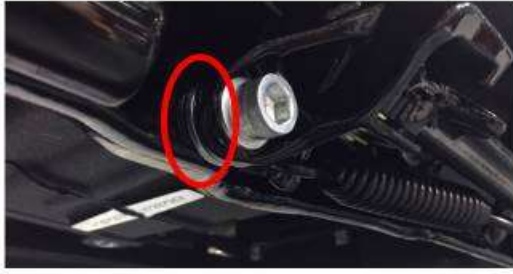
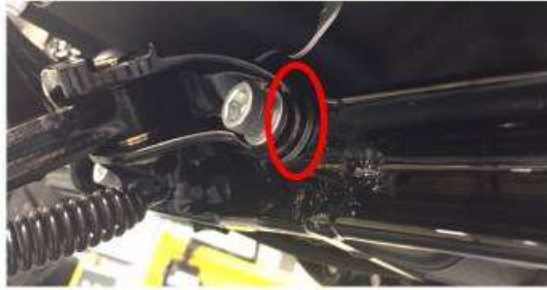
**Issue Description: a washer may have been incorrectly installed between jiffy stand bracket (Part No.50000137) and frame. During visual inspection, if the washer is present it must be removed.**

1. Inspect bike for washers installed between the jiffy leg bracket and the frame.  
(see photos)
  - A. If washers are not present, no further action required.
  - B. If washers are present
    1. Remove jiffy leg assembly
    2. Remove washers and discard
  3. Reinstall jiffy stand assembly as follows:
    - a. Apply Loctite 262 or equivalent to the two screws and install but don't tighten.
    - b. With the jiffy leg in the partially retracted position, pull the jiffy leg outboard away from the frame as much as possible while tightening the rear bolt to 40-45 ft-lbs.
    - c. Put jiffy leg in down position and tighten the front bolt to 40-45 ft-lbs.
2. Check jiffy stand for frame contact.
  - A. If there is contact, loosen the screws and go back to Step b above
    1. If retightening the screws does not prevent contact, replace the jiffy stand assembly by going back to Step 3 above.

- Visual inspection – determine if a washer has been installed between the jiffy stand bracket (Part No.50000137) and the frame. If a washer is present – it must be removed.
- Follow the installation instructions at the bottom of this page to verify that the sidestand does not contact the frame when retracted (after washer is removed).
- If no washer is present – no further action is required.
