# Authorized Field Change

AFC 17902

**Subject:** Spring Hanger Inspection and Replacement.

Model: DuraStar®, CE Bus, FBC Bus, FE Chassis, SFC Bus  
Start Date: 03/15/2017 End Date: 04/17/2017

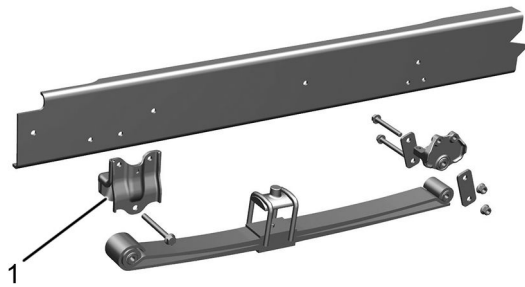
**Figure 1. Front Spring Hanger Bracket Location**

1. Spring hanger bracket
4. Locate front spring bracket (Figure 1, Item 1) on left-side of vehicle.

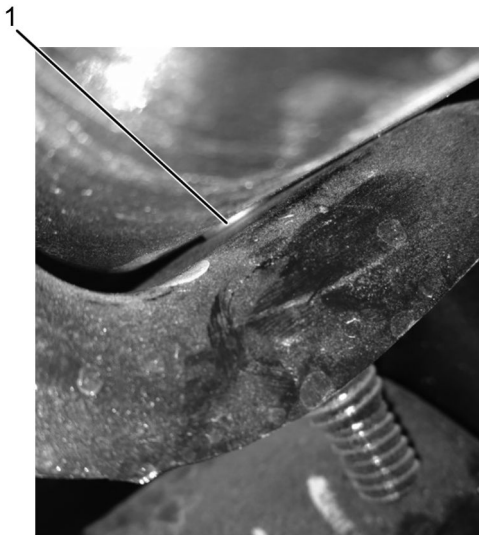
**Figure 2. Spring Hanger Bracket Gap**

Certain DuraStar, CE Bus, FBC Bus, FE Chassis, and SFC Bus models may have a gap between the Front Spring Bracket and the lower flange of the frame rails. This gap could cause a portion of the bracket to crack, which could result in noise from the front suspension system and shortened design life of the bracket.

1. Visible gap
5. Visually inspect between spring hanger bracket and bottom of frame for a visible gap (Figure 2, Item 1). If gap is present bracket should be replaced.

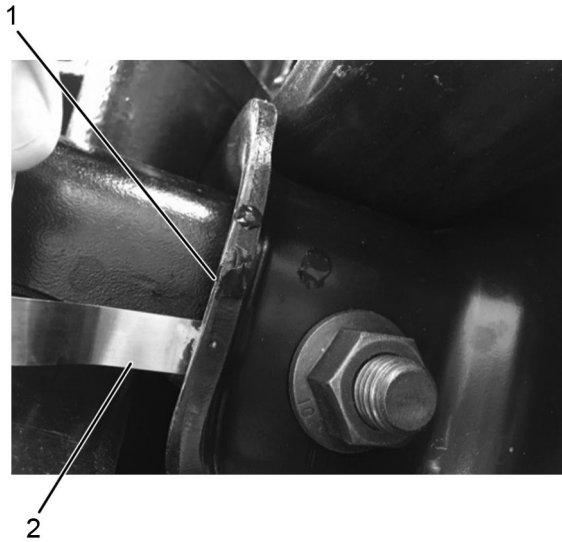
**Figure 3. Gap Inspection Location**

1. Flange rail / Bracket surface
2. Feeler gauge

**NOTE: Feeler gauge (0.001 inch thick) should not be able to slide between bracket and flange of rail within nut diameter. If any less then 3 out of 4 fail inspection, replace bracket.**

6. Use feeler gauge (0.001 inch thick) (Figure 3, Item 2) to verify contact between spring bracket and bottom flange of frame rail (Figure 3, Item 1) in any three out of four locations (Figure 4, Items 1, 2, 3, & 4) for both huck fasteners or bolts.
7. Locate spring bracket on right-side of vehicle and repeat steps 5 and 6.
8. If vehicle passes inspection proceed to step 9 of Inspection Procedure. If vehicle failed inspection, stop and perform Service Procedure.
9. Remove wheel chocks.

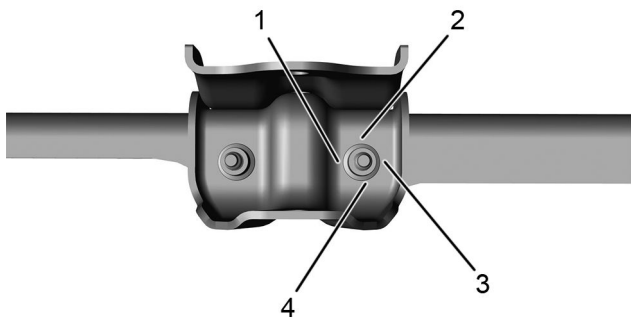
**Figure 4. Inspection Points**

1. Inspection point 1
2. Inspection point 2
3. Inspection point 3
4. Inspection point 4

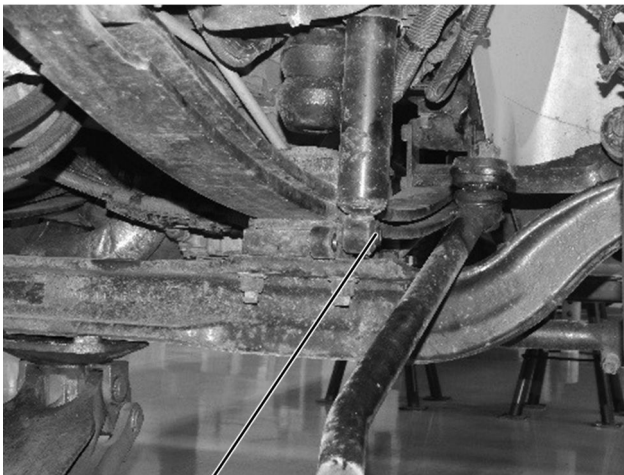
**Figure 5. Shock Bolt Location**

1. Lower shock bolt / Nut

3. Remove left-side front wheel. For vehicles requiring front right spring bracket replacement, remove front right-side wheel.
4. Remove left-side and right-side lower shock bolt and nut (Figure 5, Item 1) and allow shocks to hang.
5. If necessary, remove windshield washer reservoir and bracket.

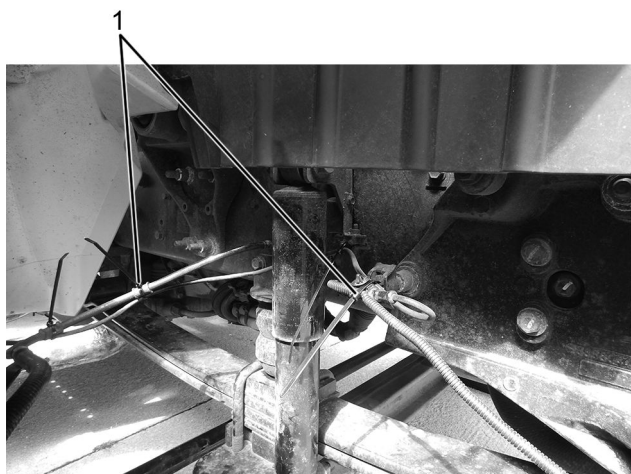
**Figure 6. ABS / Brake Hose Connection**

1. ABS / Brake hose connection
6. Remove brake hose from frame fitting on both sides and unclip ABS wire from hose (Figure 6, Item 1) to allow slack in cable.
7. Disconnect drag link from pitman arm.
8. If necessary, disconnect passenger-side radiator stay rod.

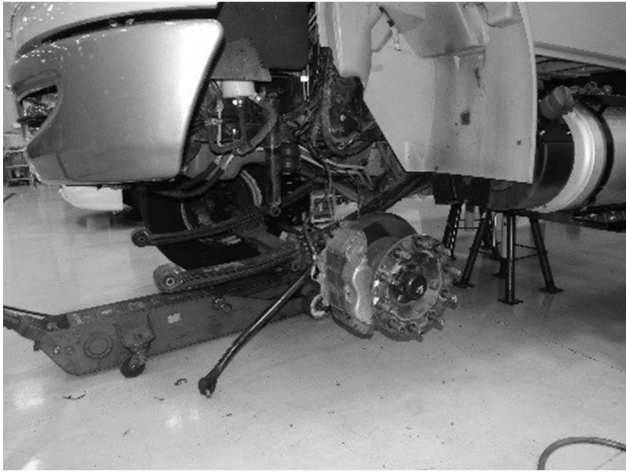
**Figure 7. Lowered Front Axle**

10. Lower jack and allow front springs to drop down from spring hangers until jack is lowered completely (Figure 7).

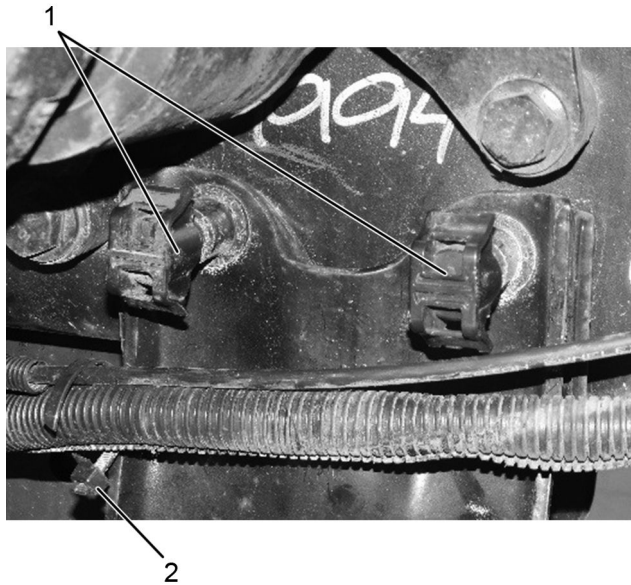
**Figure 8. Huck Fasteners and Tie Straps**

1. Huck fastener standoff (2)
2. Tie strap

11. Cut tie straps, remove standoffs from huck fasteners (Figure 8, Items 1 & 2).

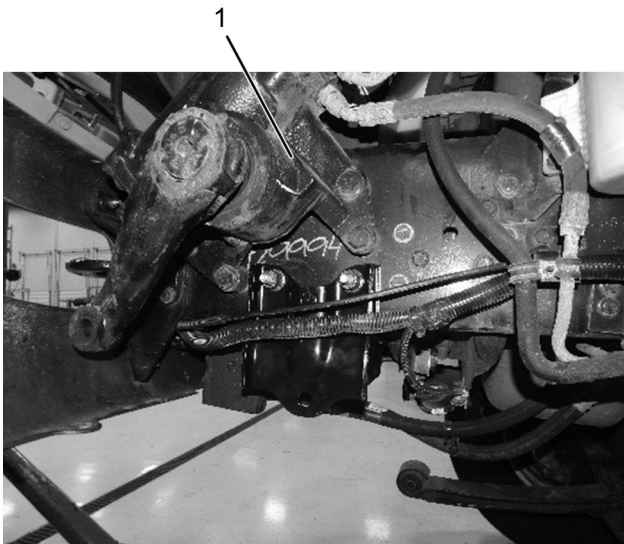
**Figure 9. Steering Gear**

1. Steering gear

**NOTE:** Some vehicles may require the steering gearing box to be repositioned to allow clearance for huck tool. Do Not disconnect steering gear hoses or the steering shaft to the steering gear.

12. If necessary, loosen steering gear box and position steering gear upward (Figure 9, Item 1).

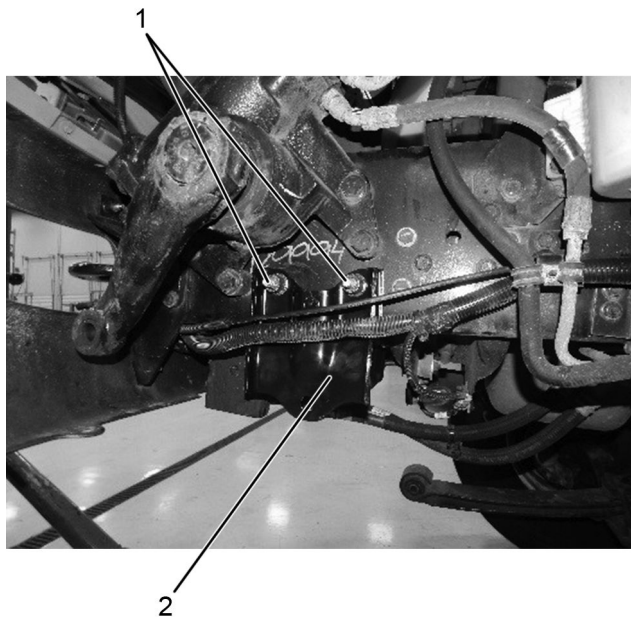
**Figure 10. New Spring Hanger**

1. Side huck fastener / Collar (2)
2. Spring bracket

15. Place new spring hanger (Figure 10, Item 2) in appropriate location and install new huck fasteners and collars (Figure 10, Item 1). CE buses; install bottom bolts (Figure 11, Item 1) and nuts.

16. Swage huck fasteners with huck tool starting with bottom first, then side fasteners. CE buses; tighten bottom bolts and nuts to 217 - 240 lb-ft (294 - 240 N•m), then swage side huck fasteners.

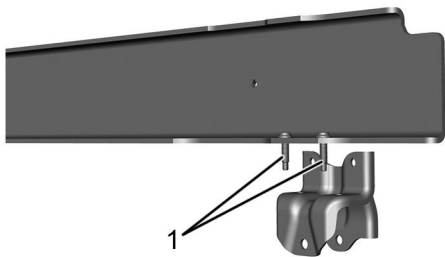
**Figure 11. Spring Bracket Bottom Hucks / Bolts**

1. Bottom huck / Bolt (2)

**NOTE:** The bottom huck fasteners or bolts must be tightened first.

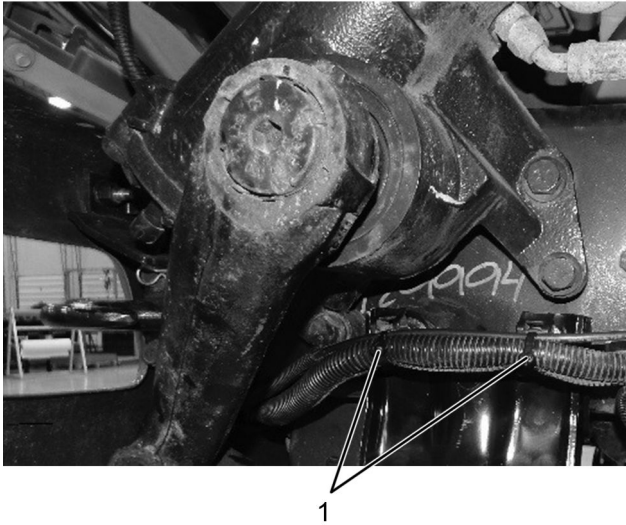
**Figure 12. Tie Straps**

1. Tie strap (2)

17. Reinstall standoffs for wiring on top of huck fasteners and install tie straps (Figure 12, Item 1) to secure harness.
18. If vehicle has steel stamped spring hanger bracket on right-side follow steps 11-17 on right-side.
19. If necessary, reposition steering gear box. Using torque wrench, tighten steering gear to 240 lb-ft (325 N•m).
20. Using floor jack lift front axle into position.

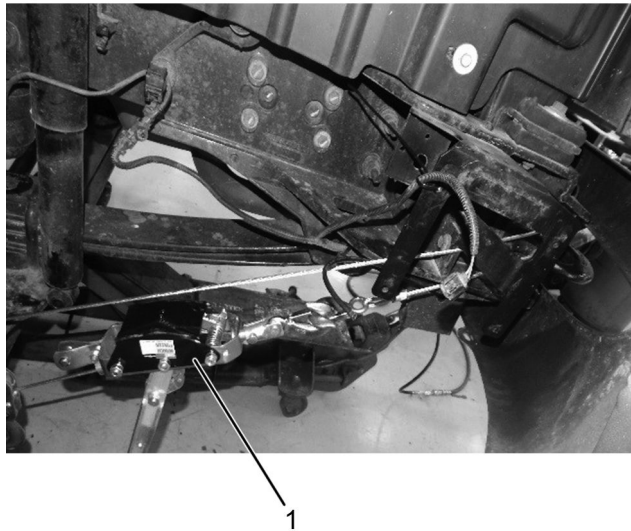
**Figure 13. Winch Puller**

1. Winch puller

21. Attach winch puller (Figure 13, Item 1) around right-side of axle and around the tow hook.

22. Use winch puller to move spring forward to align hole for spring bolt.

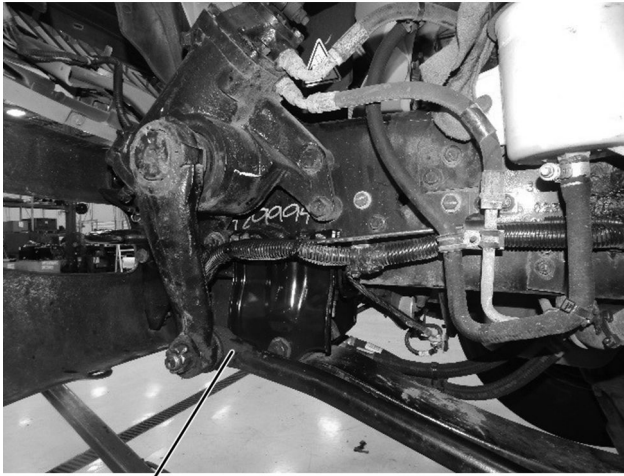
**Figure 14. Drag Link**

1. Drag link

28. Install drag link (Figure 14, Item 1). Using torque wrench, tighten nut to 163 - 230 lb-ft (221 - 312 N•m).
