| <b>Countries:</b> | CANADA, UNITED STATES | <b>Document ID:</b> | IK1900254 |

**Title:** Air Compressor Intake Hose Rubbing Zip Tie**Applies To:** CE Bus & DuraStar with Cummins ISB

This document will guide the user through steps to take when the Air Compressor Hose is rubbing against zip tie beneath the hose.

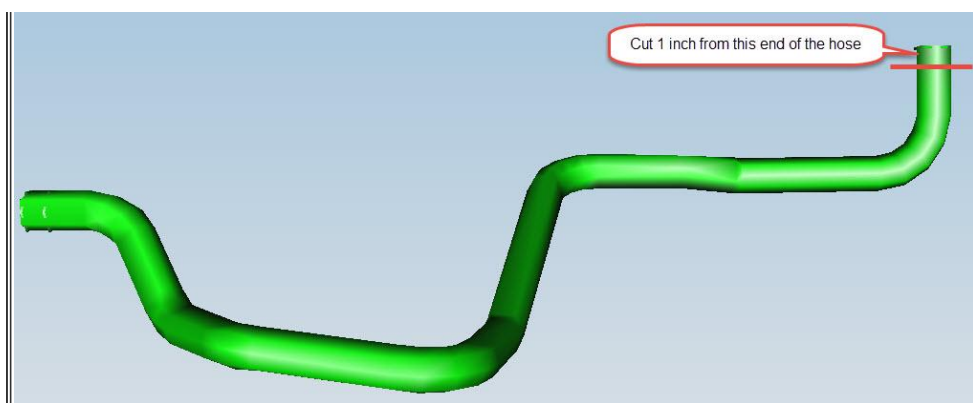
**Figure # 2**

Air Compressor Inlet Hose rubbing against zip tie.

Air Compressor Inlet Hose

2. Cut 1 inch off the compressor side of the hose (See figure 2), this will prevent the hose from making contact with the zip tie.
3. Reinstall hose.

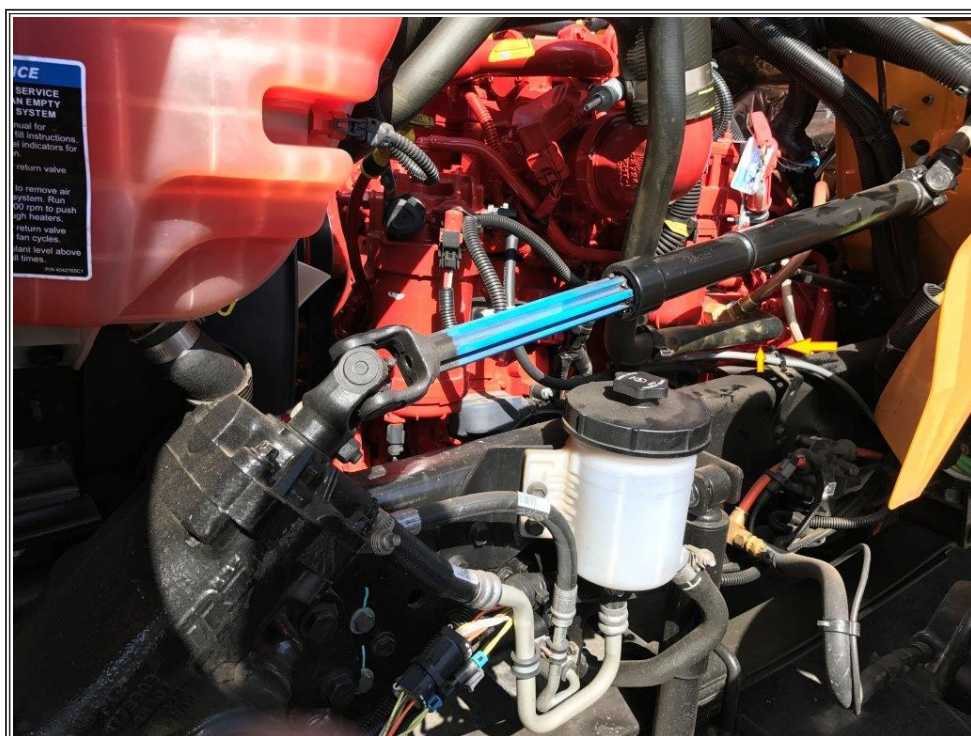
**Figure # 3**

Air Compressor Inlet Hose With 1" Removed From The End

| If replacement hose is unavailable cut hose at location of hole and install a double barbed brass fitting and hose clamps (obtain locally) to repair hose until 6132813C2 is available. Once complete follow repair steps below. |
