**Document ID:** IK2200138  
**Revision:** 0  
**Created:** 11/30/2017  
**Last Modified:** 11/30/2017  
**Author:** Brandon Akridge

**Title:** Replacing overhead lining screws with rivets

**Applies To:** Bus

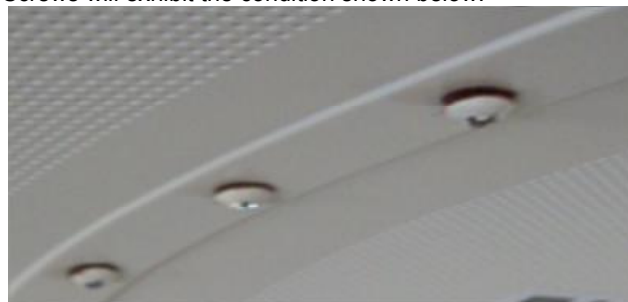
Overhead lining screws can begin to back out of lining if screw has been removed several times, initial pilot hole is too large, or screw was installed incorrectly. When this condition happens the recommendation is to replace the screw with a rivet.

Screws will exhibit the condition shown below.

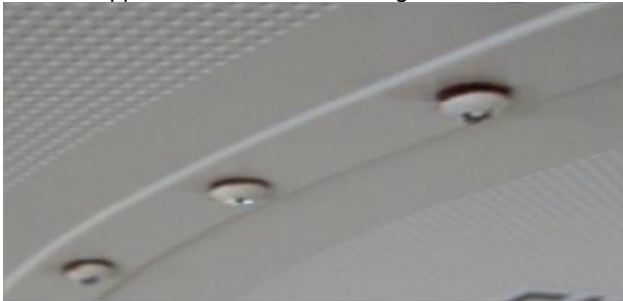
If screws appear to be loose or backing out as shown below, proceed to repair section.

1. Step 1 Remove loose screw

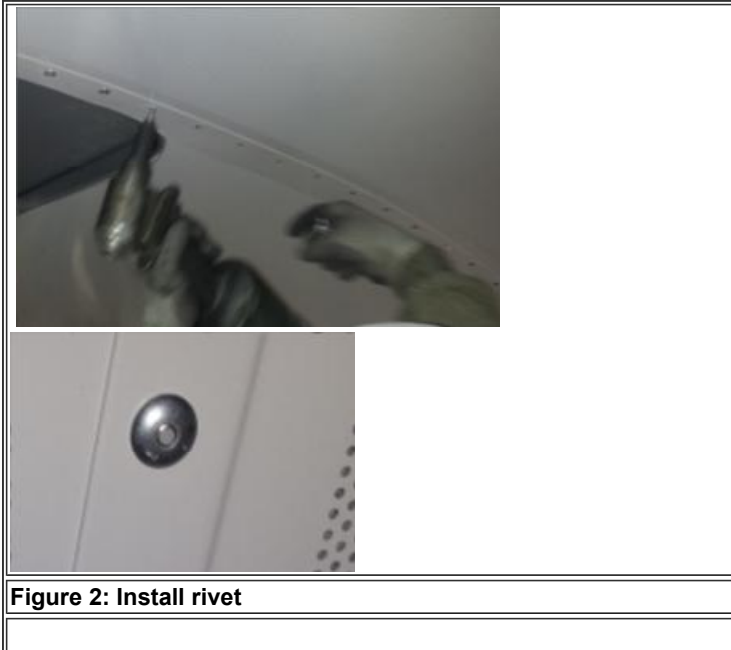
**Figure 1: Drill hole for rivet**

1. Step 1 Drill hole with a 17/64 drill bit, be sure to keep drill perpendicular as shown in Figure 1

2. Step 2 Install 1/4" mag pop rivet into hole as shown in Figure 2
3. Step 3 Paint newly installed rivet same color as interior
