# Emissions Recall

## Code: 23U3

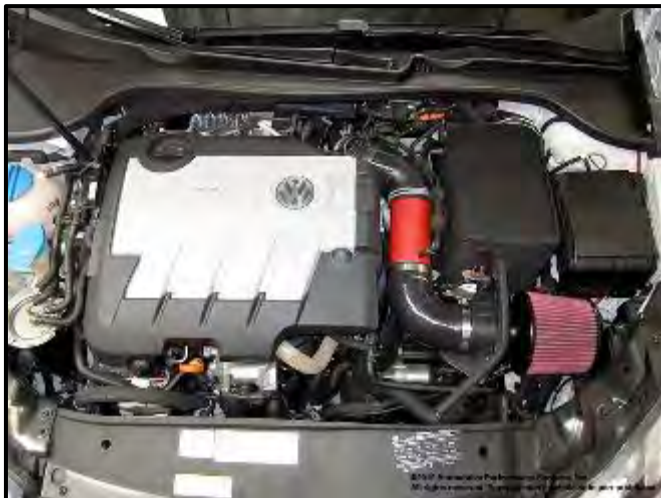
- Perform a visual inspection of the intake, exhaust, and emissions systems.
  - o If the visual inspection of the intake, exhaust, or emissions equipment reveals damage or concerns, **STOP**, create a VTA ticket and contact the Volkswagen Technicians Helpline.
  - o If the visual inspection of the intake, exhaust, or emissions equipment reveals no damage or concerns, continue the work procedure.

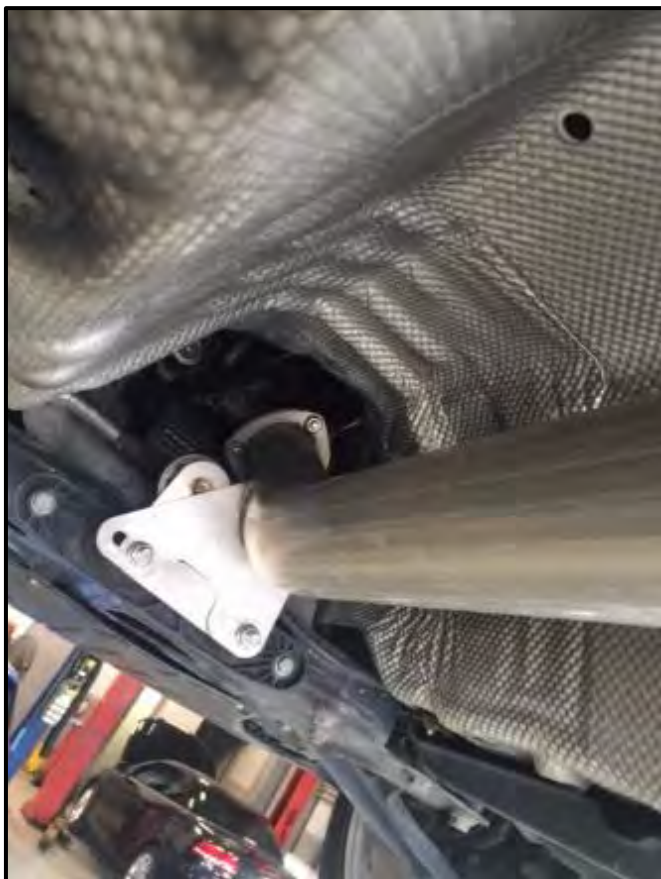
- Check for vehicle modifications from original equipment.
  - o If vehicle modifications from original equipment related to emissions components are found, **STOP**, create a VTA ticket and contact the Volkswagen Technicians Helpline.
  - o If vehicle modifications from original equipment related to emissions components are not found, continue the work procedure.

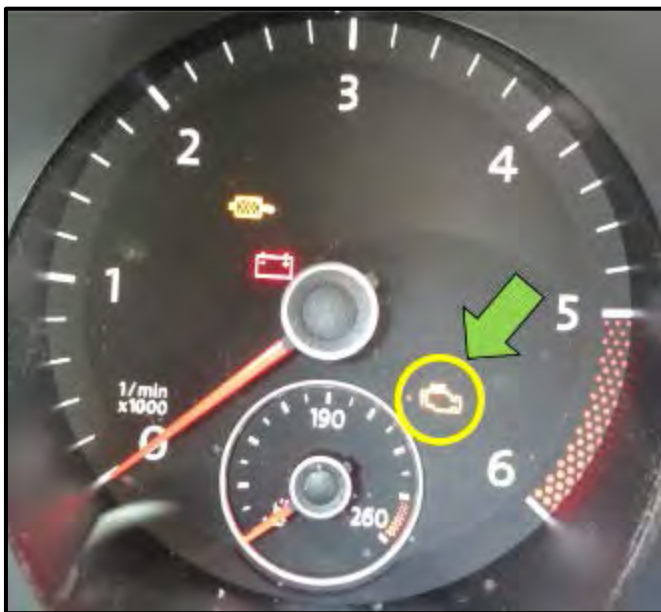
- Check for illumination of the MIL <arrow>.
  - o If MIL is illuminated, **STOP**, create a VTA ticket and contact the Volkswagen Technicians Helpline.
  - o If MIL is not illuminated, continue the work procedure.

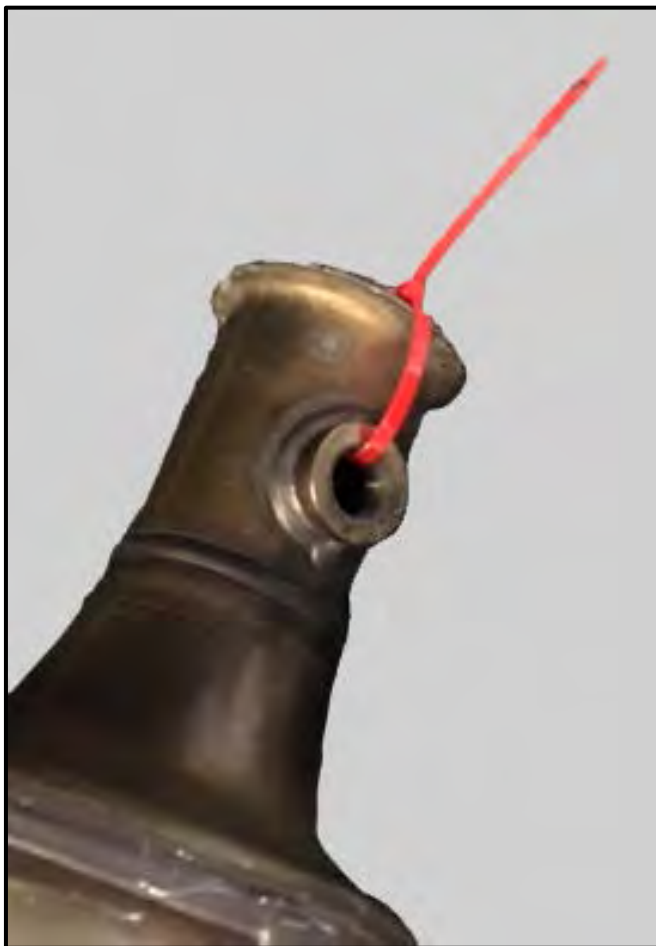
- Install the **RED** validation strap to the NOx catalytic converter <as shown> to confirm that the proper part is being returned for core.

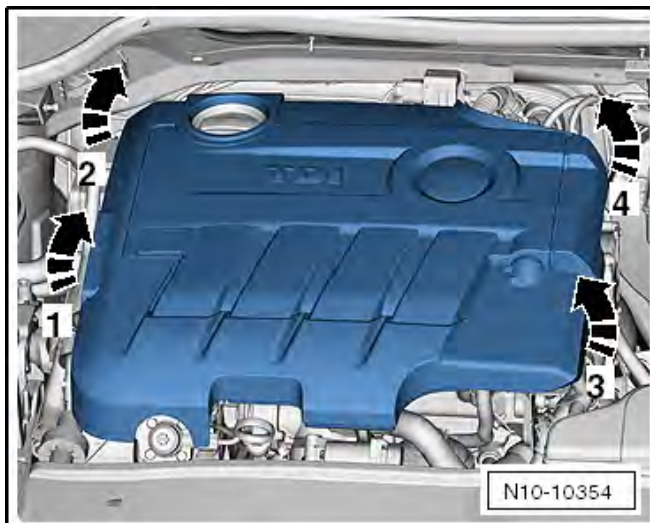
- Pull engine cover up out of fastening elements near <arrows> in order shown. To do this, grip as far as possible beneath engine cover.

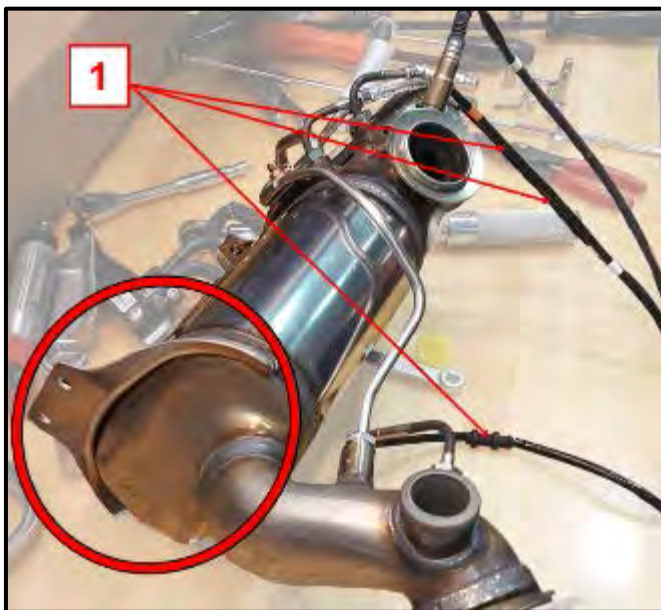
When “bench-installing” the exhaust gas temperature sensors to the DPF, the edge of the lower bracket <circle> can damage the sensor wires <1> if they are allowed to get underneath the bracket while positioning the DPF. Pay special attention to the sensor wiring to prevent damage to these sensors.

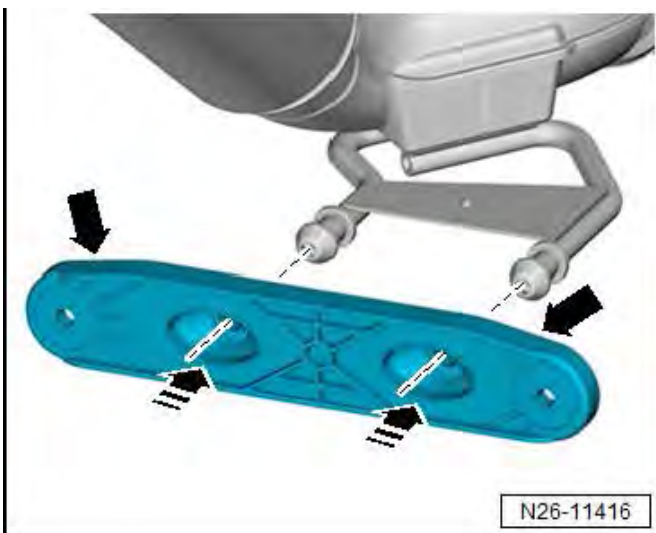
- Press bracket in <direction of arrow> onto pins of particulate filter. The bracket edge which tapers towards the ends <arrows> must face upwards.

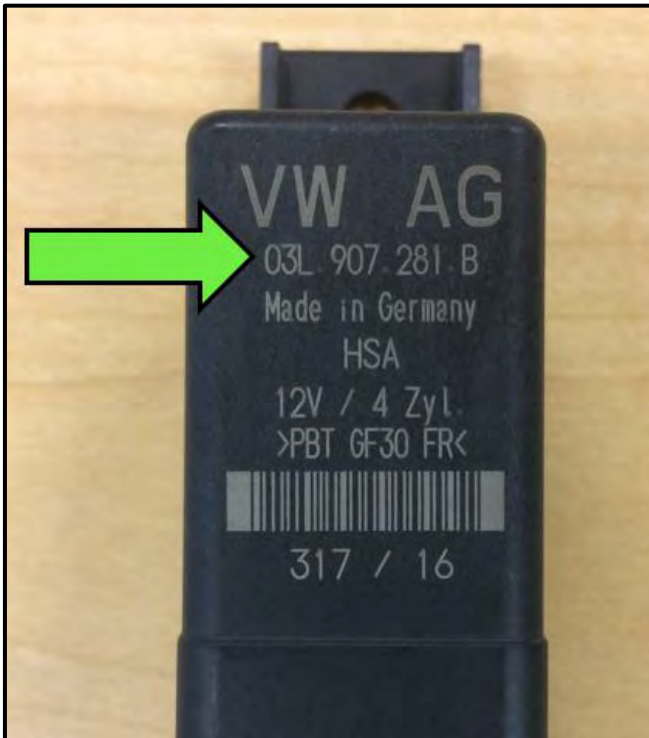
- Inspect, and if required, replace the glow plug control module based upon the part number.
  - o If part number “**03L 907 281 B**” <arrow> **is present**, continue the work procedure and reinstall the glow plug control module.
  - o If part number “**03L 907 281 B**” <arrow> **is not present**, you are required to replace the glow plug control module with part number **03L 907 281 B**.
    - If the glow plug control module requires replacement, disconnect electrical connector, remove screw with bracket and reinstall onto new glow plug control module with part number **03L 907 281 B**.

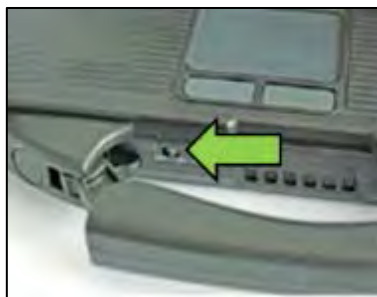
**VAS 6150 & VAS 6150A**  
(Front panel behind handle)

- Performing a software update using a Bluetooth connection increases the risk of losing connection during the update, which could result in damage to the control module. It also greatly increases the time required to perform the update. Requests for additional time or parts will be denied if the GFF log shows the update was performed using Bluetooth.
- ✓ **The Bluetooth function of the scan tool is physically switched off <see pictures below>.**

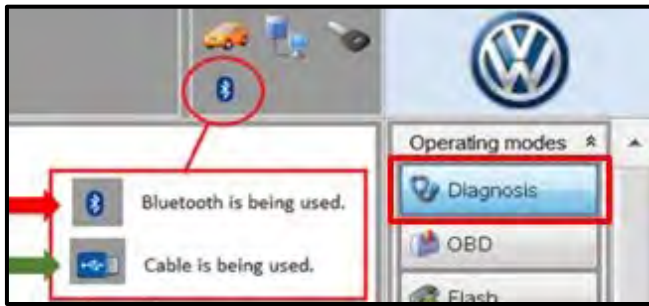
- Confirm that scan tool is communicating with the diagnostic head by USB <Green Arrow>.
  - If the Bluetooth symbol is shown <Red Arrow> then disconnect the diagnostic head from the vehicle and reconnect the USB cable to the diagnostic head and then reattach to the vehicle.
- Upon ODIS startup, verify the “Diagnosis” operating mode is selected <as shown>.

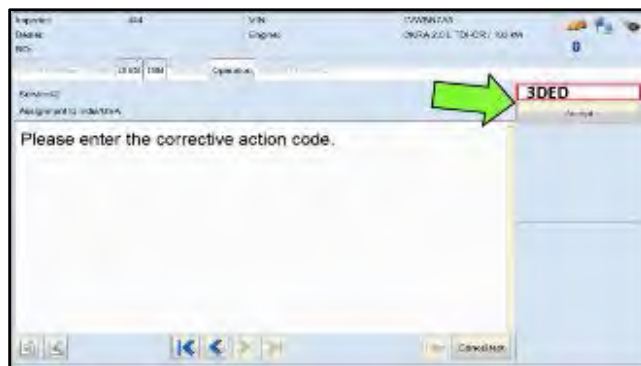
- **DO NOT SELECT** the normal test plan for “Adapting Software”.
- **ONLY SELECT** the test plan “**Adapt software, diesel, exhaust EA189 action 23XX**” to perform this repair.
- Select “Complete/Continue” <arrow> after the control module adaptation, action 23XX note appears.

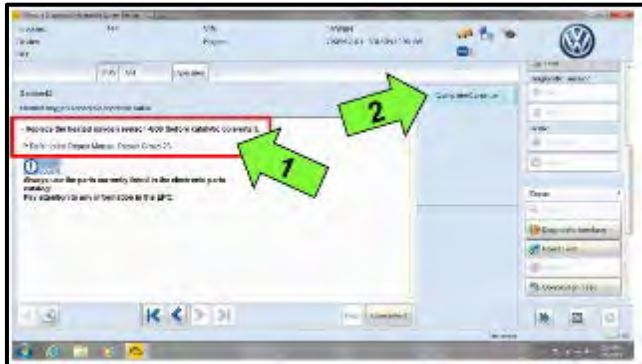
- You may receive the message “**Replace the heated oxygen sensor -G39- (before catalytic converter), Refer to the Repair Manual, Repair Group 23**” <arrow 1>:
  - o If Campaign 24CV has **NOT** been completed, **STOP** and perform that action at this time. When complete, return to the beginning of **Section F** to restart the flash process.
  - o If Campaign 24CV has been completed, select “Complete/Continue” <arrow 2> to bypass this operation and **proceed to the next step**.
