Service Update

17096 Engine Stall During Aggressive Driving

Reference Number: N162069020

Models: 2016-2017 Cadillac CTS-V
Equipped with 6.2L V8 Engine (RPO LT4)

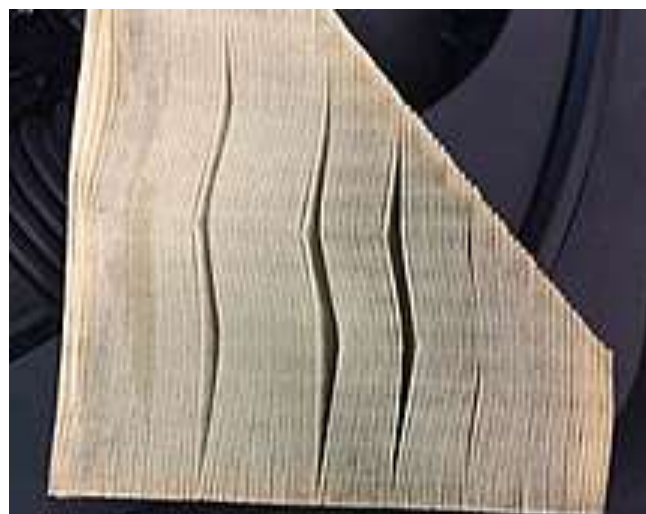
4733221

Use the following steps to inspect the air cleaner filter element for the installation of glue beads. If the glue beads are present replace only the air cleaner filter element. If the glue beads are missing, the air cleaner outlet duct may have collapsed, replace both the air cleaner filter element and the air cleaner outlet duct.

Glue Beads Missing

- If the glue **beads are installed**, install a new air cleaner filter element only.
- If the **glue beads are missing** install a new air cleaner filter element and a new air cleaner outlet duct assembly. Refer to *Air Cleaner Outlet Duct Replacement* in SI.
