Service Bulletin

Bulletin No.: 17-NA-233

Subject: Malfunction Indicator Lamp (MIL) Illuminated - DTC P0446 Set

Brand:	Model:	Model Year:		VIN:		Engine:	Transmission:
		from	to	from	to		
Chevrolet	Cruze	2016	2017			LE2

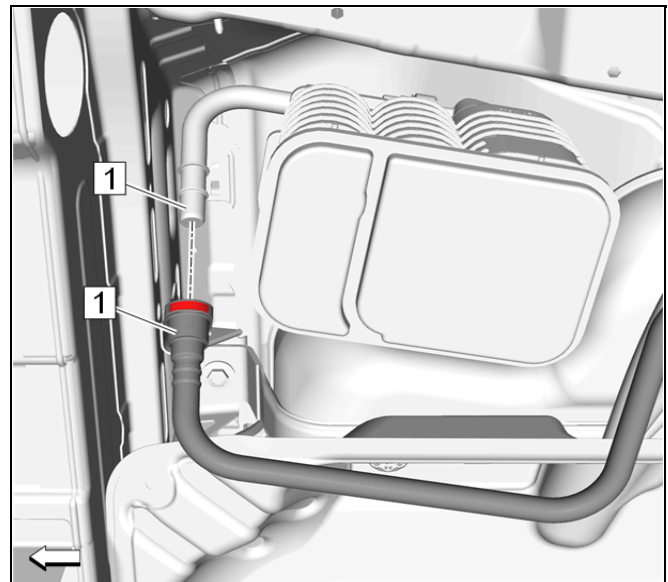
4743901

3. Using care, disconnect the evaporative emission canister filter pipe (2) from the evaporative emission canister (1). Refer to *Plastic Collar Quick Connect Fitting Service* in SI.

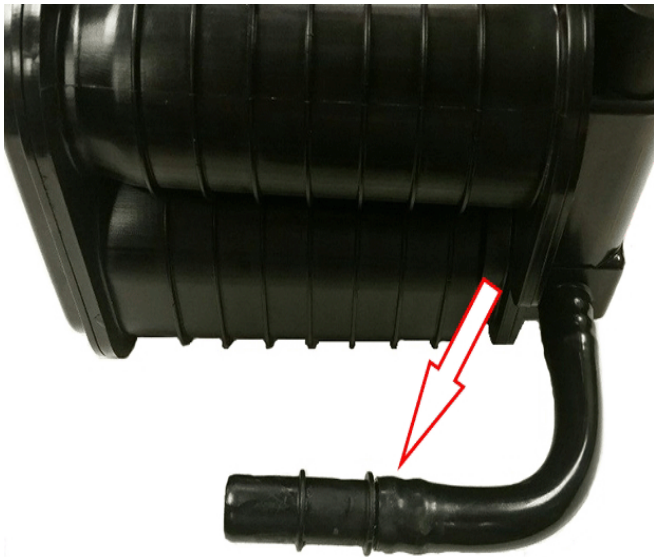
4799118

Note: The boot must be positioned onto the pipe up to the pipe nozzle crimp location so that it can seal the filter pipe nozzle and connector.

4. Install the boot (2) onto the filter pipe (1).
 - Validate the boot has not rolled on itself when installed.
 - Allow time for water to drain or melt, if frozen, from the pipe.
5. Connect the evaporative emission canister filter pipe to the evaporative emission canister. Refer to *Plastic Collar Quick Connect Service* in SI.

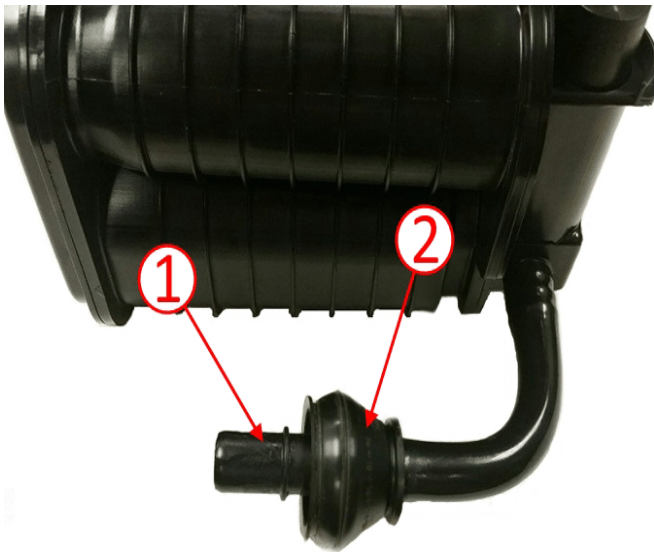
4799141

6. Using care, position the boot (2) around the pipes connector (1) so that it forms a seal.
7. Lower the vehicle.
8. Connect the negative battery cable.
