GROUP <b>Service Campaign</b>	MODEL <b>2015-2017MY K900 (KH)</b>
	NUMBER <b>SC156</b>	DATE <b>November 2017</b>
<b>VOLUNTARY SERVICE CAMPAIGN</b>		
SUBJECT: SEAT BELT ANCHOR PRETENSIONER COVER WARNING LABEL APPLICATION (SC156)

# SEAT BELT ANCHOR PRETENSIONER COVER WARNING LABEL APPLICATION (SC156)

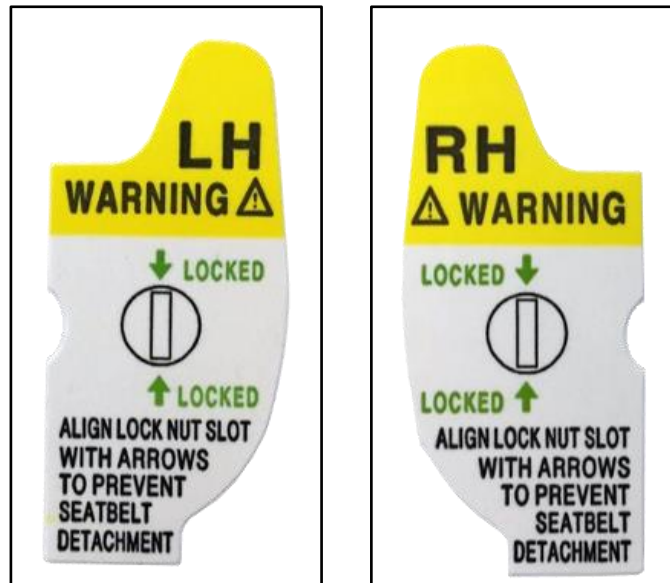
This bulletin provides information for applying a warning label to the front right and left side seatbelt anchor pretensioner covers on all 2015-2017MY K900 (KH) vehicles produced from December 18, 2013 through May 18, 2017. The warning label shows the proper position of the lock nut slot. During a collision repair or other repair involving either of these components, the service procedure listed on the label must be followed. If this procedure is not followed, there is a chance that the connection would not be fully locked. Before conducting the procedure, verify that the vehicle is included in the list of affected VINs.

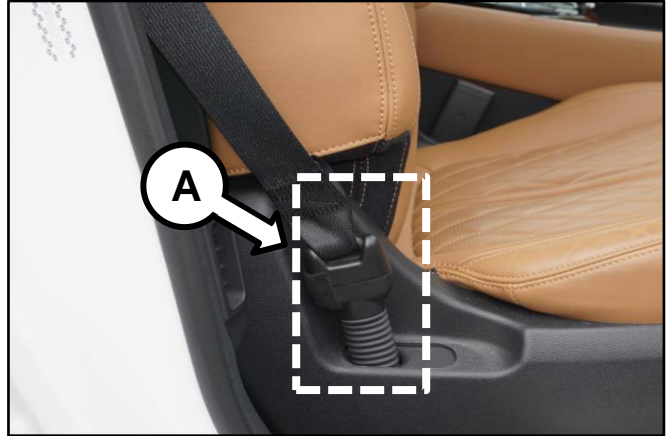
1. Locate the front LH/RH Seat Belt Pretensioners (A).

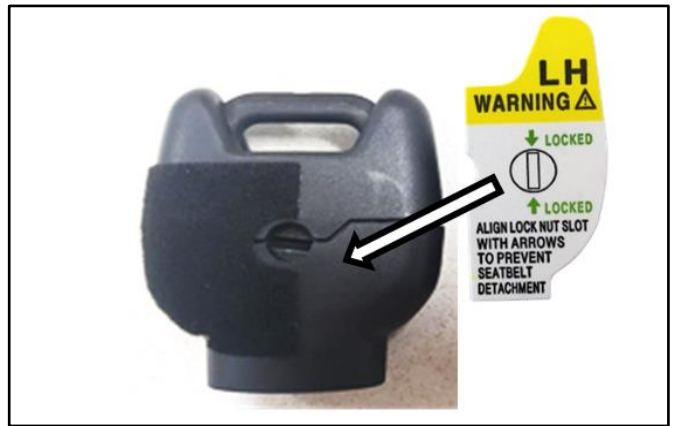
2. Apply the LH warning label to the LH pretensioner surface. Do not apply the sticker over any felt covered surface.

**NOTE: Be sure the surface of the pretensioner is clean before applying the warning label.**

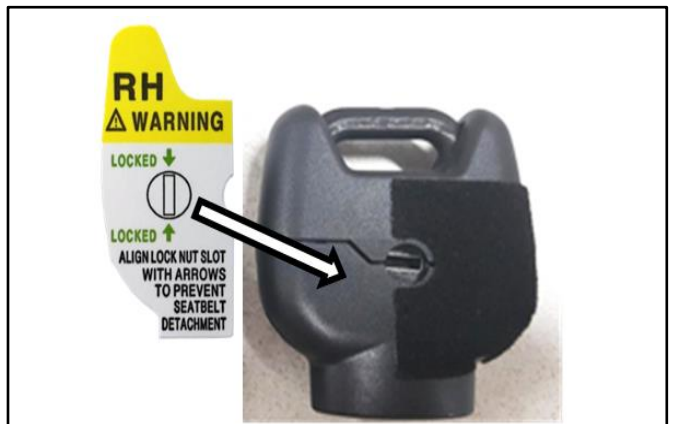
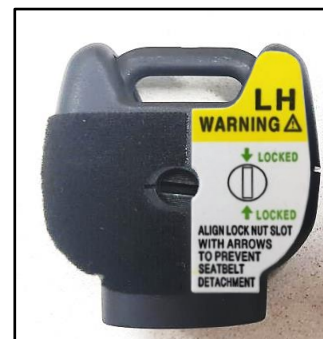
Sample Applied Label

3. Repeat step 2 for the RH pretensioner warning label.
