MODEL: Karma Revero

TITLE: Pilot-Proximity Cable Harness Overlay

Service Campaign

CC-17-90-12

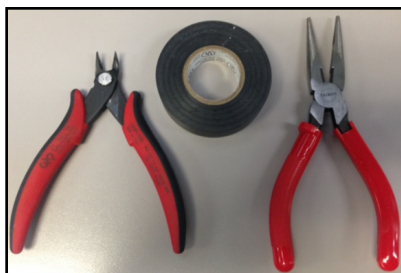
fig. 1a

- wire snips
- needle nose pliers
- highest quality electrical tape
- cable ties (fig. 1a,b)
- standard type automotive connector pick

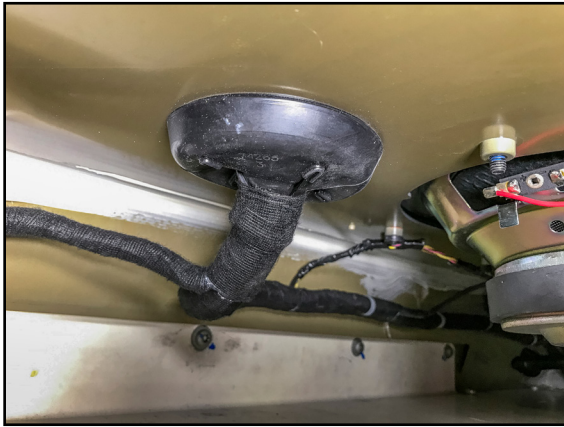
fig. 5a

2. Route the cable overlay as described above, a hole will need to be made in the grommet, towards the center away from the molded arrow (indicated in fig.5b). This is the pass through section from the package tray to the trunk area (fig. 5a).

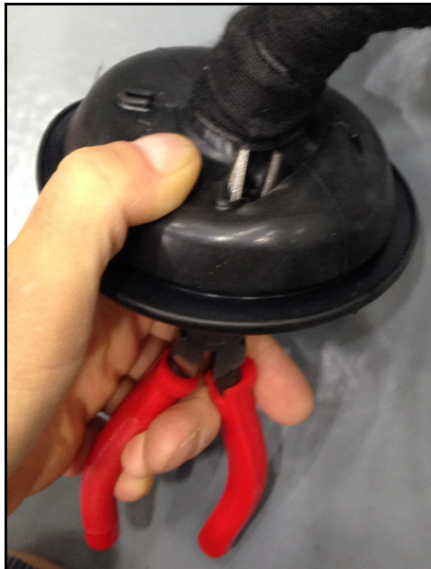
fig. 5c

Spread the hole with pliers (fig. 5c) to allow space to pass the cable assembly through (fig. 5d). This is shown from bench photos for clarity, this procedure can be done in the vehicle.

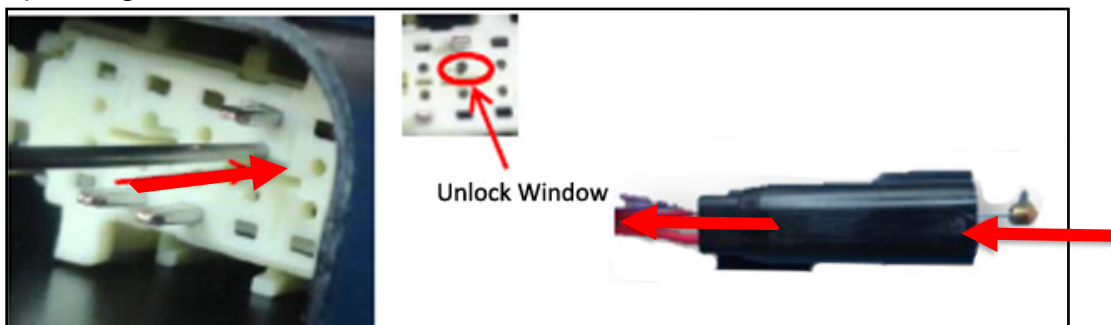
fig. 8e

5. Using the Round Pick, Insert to the corresponding position to unlock the terminal (11,12,13) as shown (fig 8e).

Pull the corresponding cable from the back of the connector to remove it from the connector
