GROUP	NUMBER	
<b>Body Interior</b>	17-BD-003	
DATE	MODEL(S)  Genesis (DH)	
DECEMBER, 2017

**Description:** This bulletin describes the procedure to replace the front seat cushion tilt pipe housing. If wobble, and/or noise occurs from the front seat track assembly, it is recommended to replace the front seat cushion tilt pipe housings with new ones instead of replacing the front seat track assembly.

Applicable Vehicles: 2015MY and 2016MY Hyundai Genesis

#### FRONT SEAT TILT PIPE HOUSING REPLACEMENT

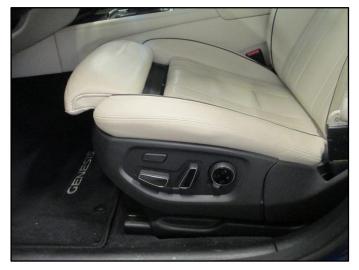
1. Adjust seat to highest position and extend cushion extender to furthest position.

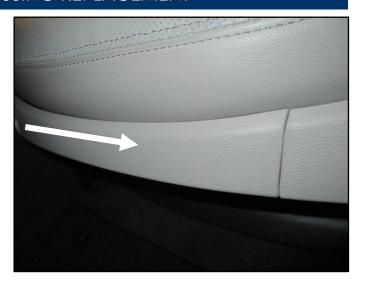
4. Remove front cover shield.

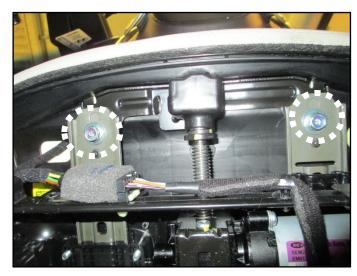
5. Remove 2 X 10MM bolts under cushion extender.

Tightening torque: 4.9 ~ 5.9 N-m (0.5 ~ 0.6 kgf.m, 3.6 ~ 4.3 lb-ft)

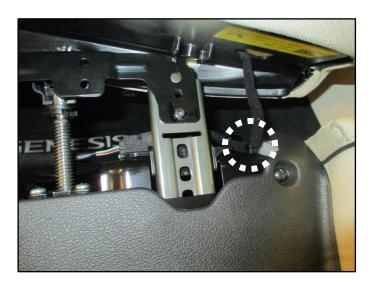
6. Detach harness from seat assembly.

Remove cushion extender and place aside.

Do not cut tab.

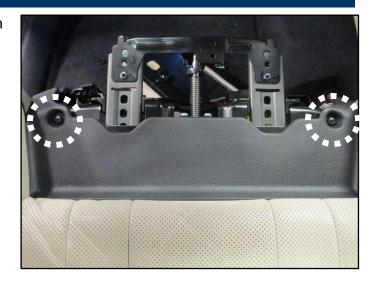
7. Remove extender cover screws and detach cover.

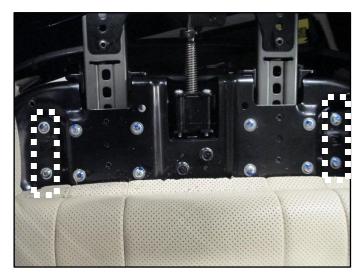
8. Remove pipe housing screws.

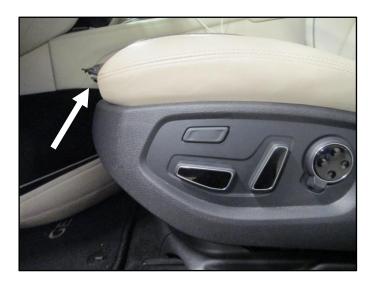
9. Lift cushion to remove tilt pipe housing.

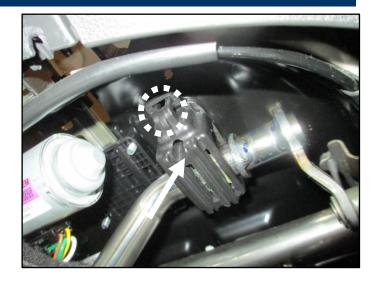
10. Detach and replace both tilt pipe housings; one on each side.

Ensure housing is fully locked in placed.

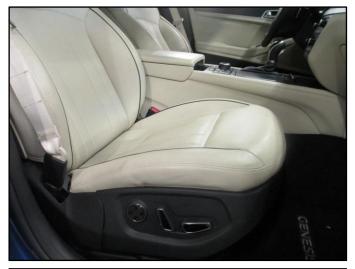
1. Adjust seat to highest position and middle position of track.

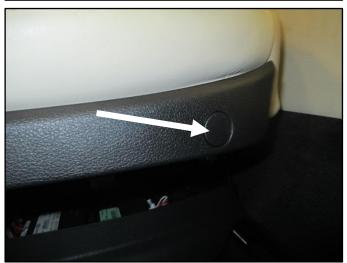
3. Remove plastic cap and remove front shield cover screw underneath plastic cap.

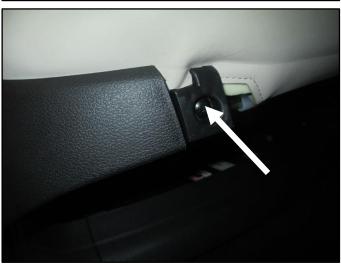
5. Remove side shield cover screw.

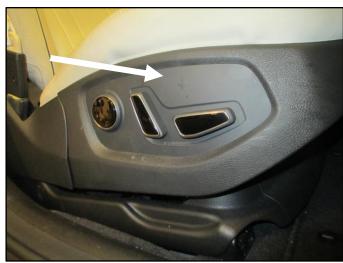
6. Remove side shield cover.

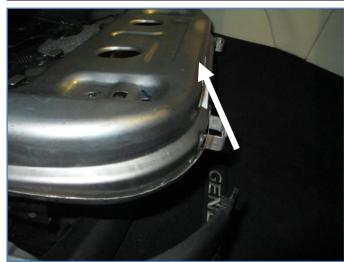
9. Lift seat cushion panel to remove tilt pipe housing.

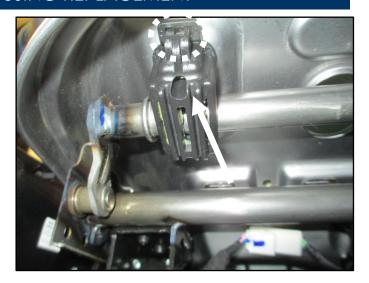
10. Detach and replace both tilt pipe housing components; one on each side.

Ensure housing is fully locked in placed.
