GROUP	NUMBER
BODY ELECTRICAL	17-BE-018
DATE	MODEL(S)
DECEMBER, 2017	AZERA (HG)

15MY-16MY AZERA (HG) AVN 4.0 TEMPERATURE DISPLAY DEFECT

Description: This bulletin describes the procedure to determine if the vehicle's head unit needs to be replaced as a result of the temperature not displaying correctly on the screen.

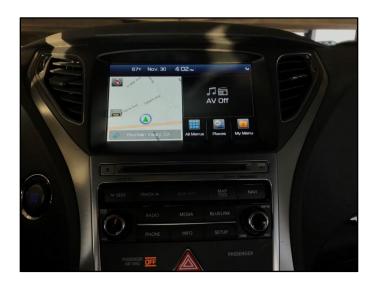
SYMPTOM(S) Temperature doesn't display correctly when over 100°F

Replace the Head Unit or Perform a map update.

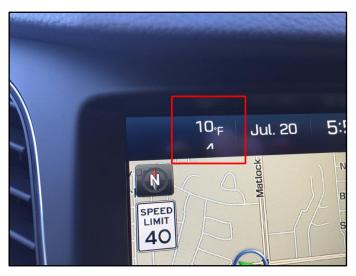
Temperature doesn't display correctly when over 100°F

This can be confirmed by checking the HU software version. If the HU software version is below <u>ST.HG.USA.E469.150810</u>, then the vehicle is affected.
