MODEL: Karma Revero**DATE:** December 2017**TITLE:** Back Lite Seal Lubricant Application**First Release****PRIORITY:** On Complaint**APPLICABILITY:** MY17 and MY18 Revero**MARKET REGION:** North America**PURPOSE:** Remedy for a trunk squeak on opening

Technical Service Bulletin

TB-17-76-34

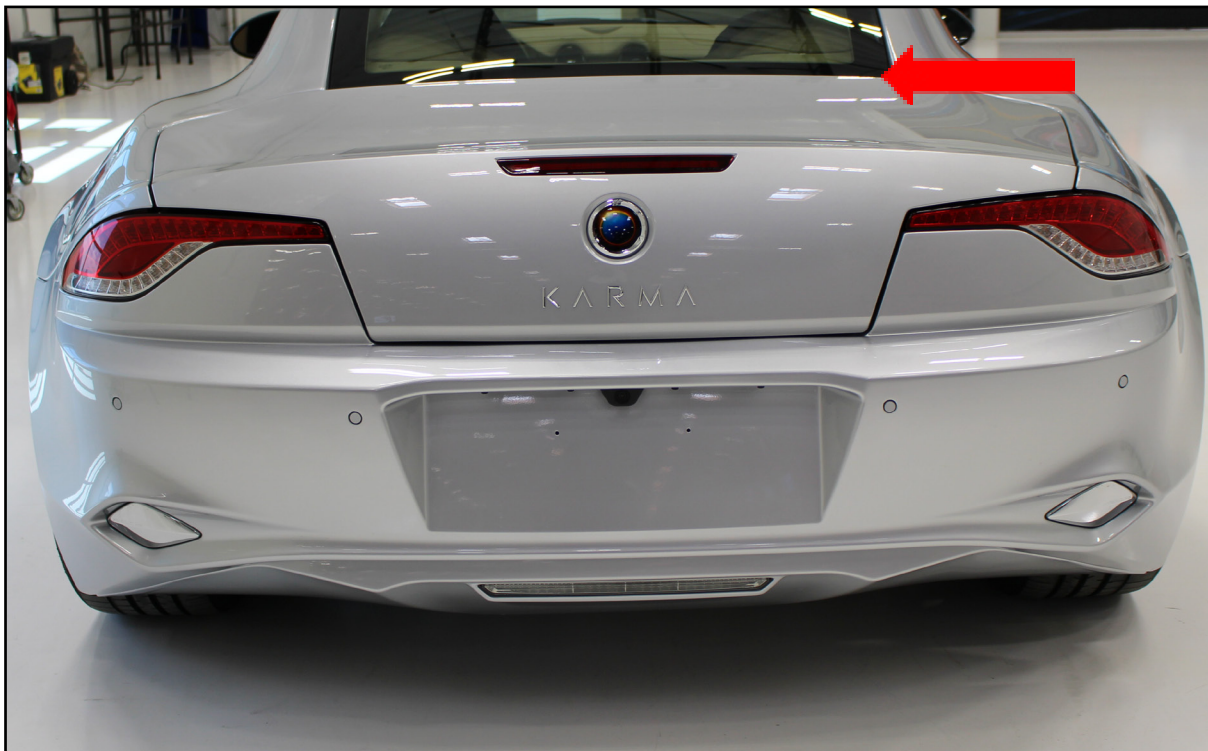
fig 1

If the trunk lid exhibits a loud squeak on opening, an application of lubricant along the backlite seal is found to remedy this. (Use Nextzett, Gummi Pflege Stift)

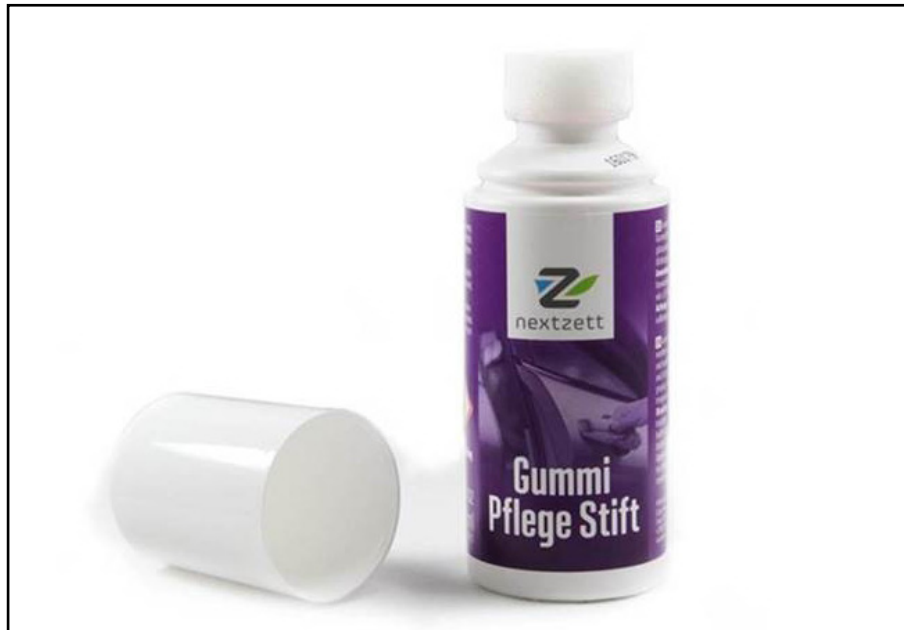
fig 2a

Apply the Gummi Pflege Rubber Care lubricant to the seal lip along the entire length (fig 2a)
 Apply to both surfaces of the seal as shown in (fig 2b and 2c).

Ensure squeak is gone or minimized before returning to the customer.
