Bulletin Type.....: Safety Recall

Bulletin No.....: TS-S123 (Rev01)

**Bulletin Name.....: Tag Axle Air Bellow Protection
Cover**

Vehicle Model.....: TS45

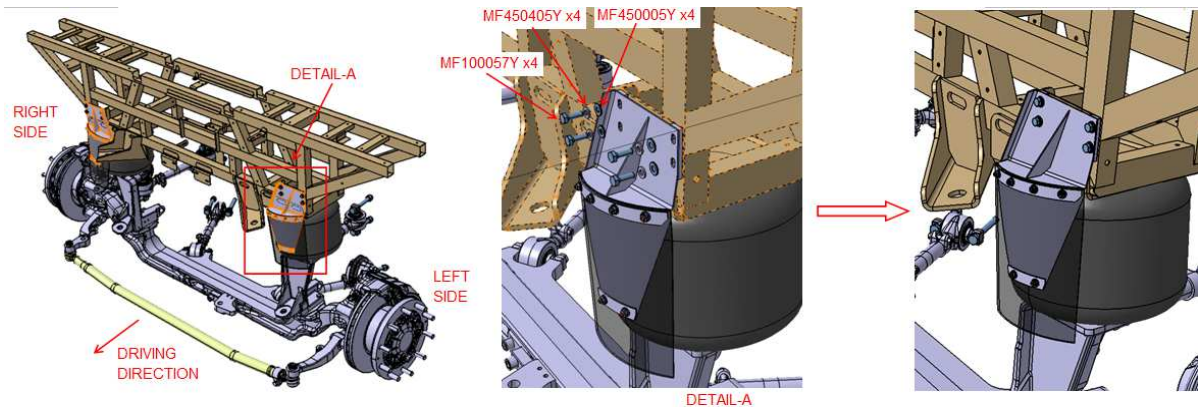
Figure - 5: Fix the protection cover at left side by the bolts given in DETAIL -A (tightening torque is 8 lbft).

Install both air bellow protection covers to the vehicle, see in **Figure-5** and **Figure-6**.

Note: Same installation process is also valid for the one at right side
