Technical Service Bulletin

40 Clicking noise from wheel bearing

40 17 61 2024318/5 April 17, 2017. Supersedes Technical Service Bulletin Group 40 number 16-55 dated June 30, 2016 for reasons listed below.

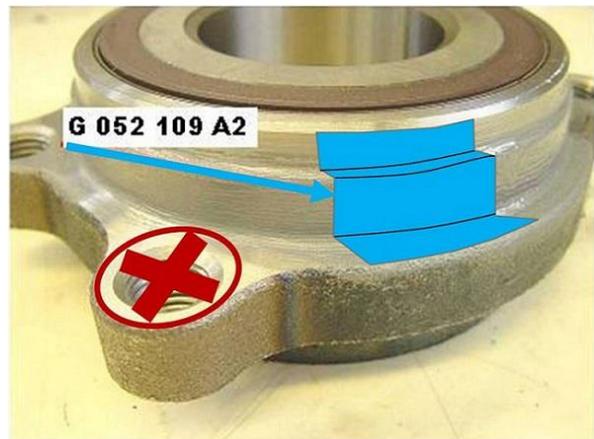
Microscopic movements between the wheel bearing and wheel bearing housing may cause the noise (front left and/or front right bearing can be affected).

Figure 1. Area to apply paste.

1. On the affected side(s), remove any corrosion and dirt from the wheel bearing housing and the wheel bearing.
2. Using a brush, apply a thin coat of paste part number G 052109A2, using about .21 ounces or 6 grams (roughly 1/20) from the tube on the wheel bearing housing as shown (Figure 1). Make sure not to apply any paste on the threads.
