Technical Service Bulletin

46 Clicking noise from front ceramic brakes - R8

46 17 69 2047140/2 March 20, 2017. Supersedes Technical Service Bulletin Group 46 number 17-67 dated March 14, 2017 for reasons listed below.

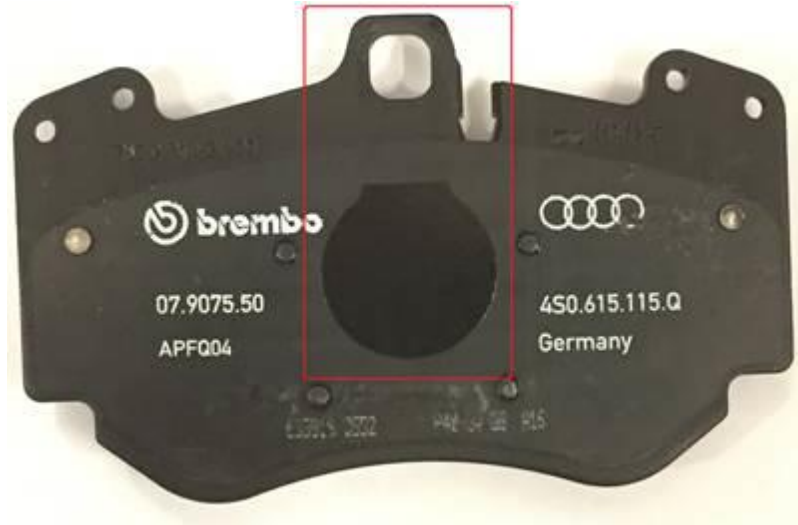
Figure 3. Do not touch the exposed adhesive surface.

- The brake pistons must be clean. Brake cleaner can be used to clean the brake pistons. Ensure that the contact surfaces are free of dust and grease and they are dry.
- Only remove the protective paper from the adhesive foil on the brake pad immediately before installation (Figure 2), and do not touch the adhesive surface. (Figure 3).

After installing the pads, keep full brake pressure for about 5 seconds to ensure that the pads are properly bonded to the pistons.
