# Technical Service Bulletin

## 46 Clicking noise from front ceramic brakes - R8

46 17 70 2047140/3 April 17, 2017. Supersedes Technical Service Bulletin Group 46 number 17-69 dated March 20, 2017 for reasons listed below.

Model(s)	Year	VIN Range	Vehicle-Specific Equipment
R8	2017	All	Ceramic brakes
R8	2018	000001 - 900030	Ceramic brakes

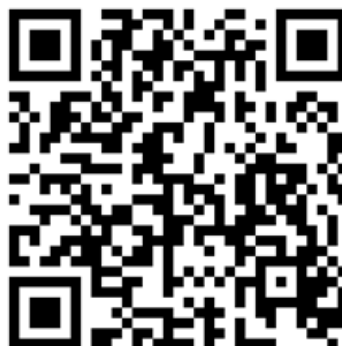
A clicking noise is heard from front brakes when vehicle is being driven at low speeds in either direction. For an example of the sound, see the video located at: <https://audi-external.kzoplatform.com:443/swf/player/334> (Figure 1).

Figure 1. QR code for clicking noise.

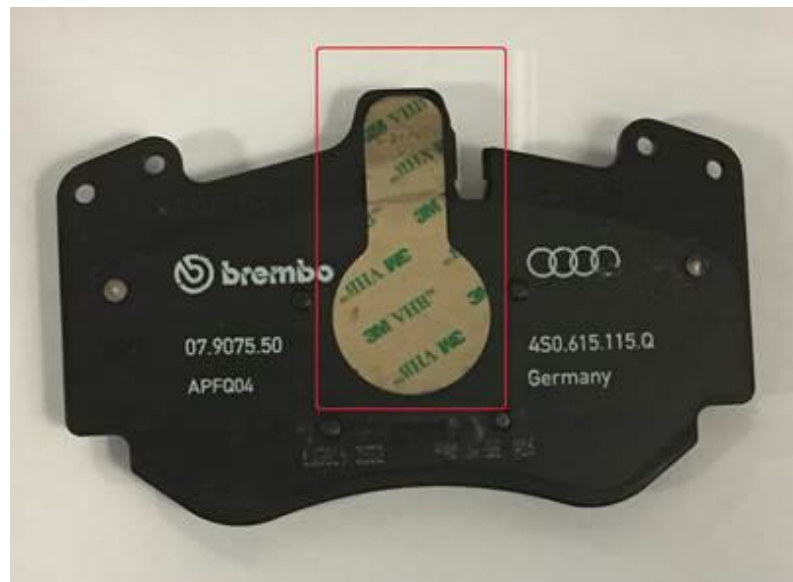
**Figure 2.** Pull of adhesive foil.

- The brake pistons must be clean. Brake cleaner can be used to clean the brake pistons. Ensure that the contact surfaces are free of dust and grease and they are dry.
- Only remove the protective paper from the adhesive foil on the brake pad immediately before installation (Figure 2), and do not touch the adhesive surface. (Figure 3).

After installing the pads, keep full brake pressure for about 5 seconds to ensure that the pads are properly bonded to the pistons.

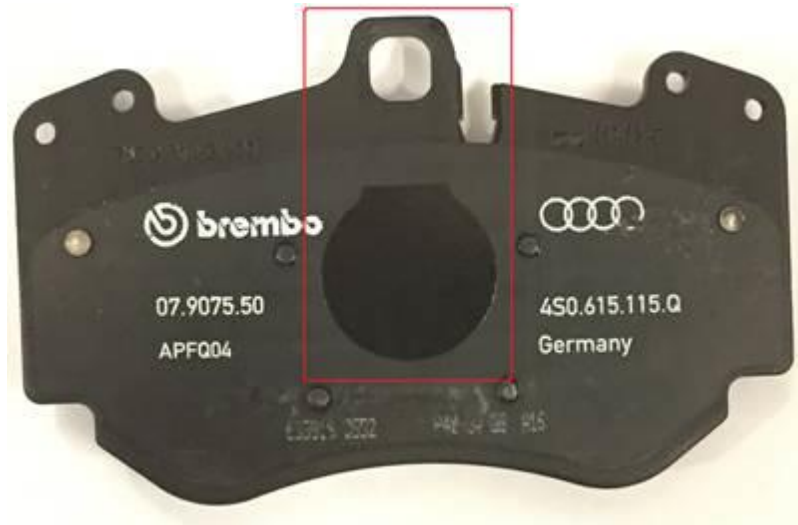
**Figure 3.** Do not touch the exposed adhesive surface.
