Countries: CANADA, UNITED STATES **Document ID:** IK1201404
Availability: ISIS, NotSIR **Revision:** 0
Major System: ENGINES **Created:** 12/8/2017
Current Language: English **Last Modified:** 12/19/2017
Other Languages: NONE **Author:** William Katschke
Viewed: 206

Title: Pilot Bearing Missing

Applies To: LT/RH with X15

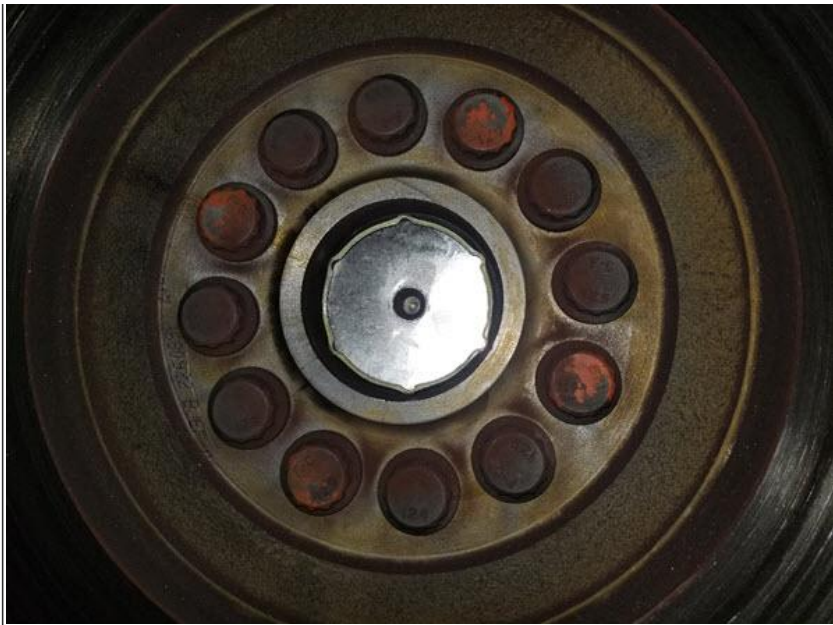
Figure #1: Flywheel Missing Pilot Bearing

1. Immediately order a new transmission.
2. Machine flywheel (if needed) and install pilot bearing.

3. Replace clutch and transmission, refer to proper service manual.

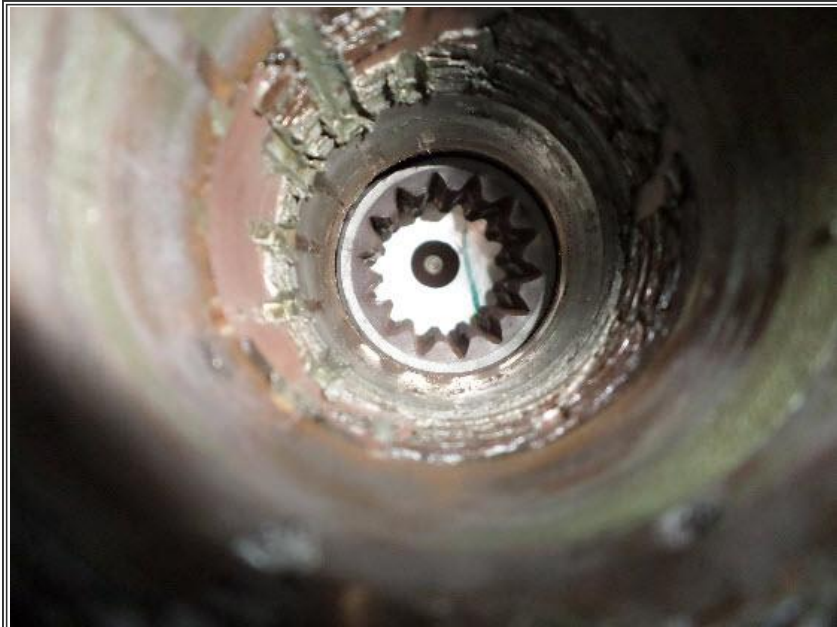
1. Verify that the noise/vibration is coming from the transmission or clutch area.
2. If it is, remove transmission and inspect for missing pilot bearing, refer to figure #2.
3. If pilot bearing is missing follow repair steps below.

Figure #2: Missing Pilot Bearing w/ Clutch Installed

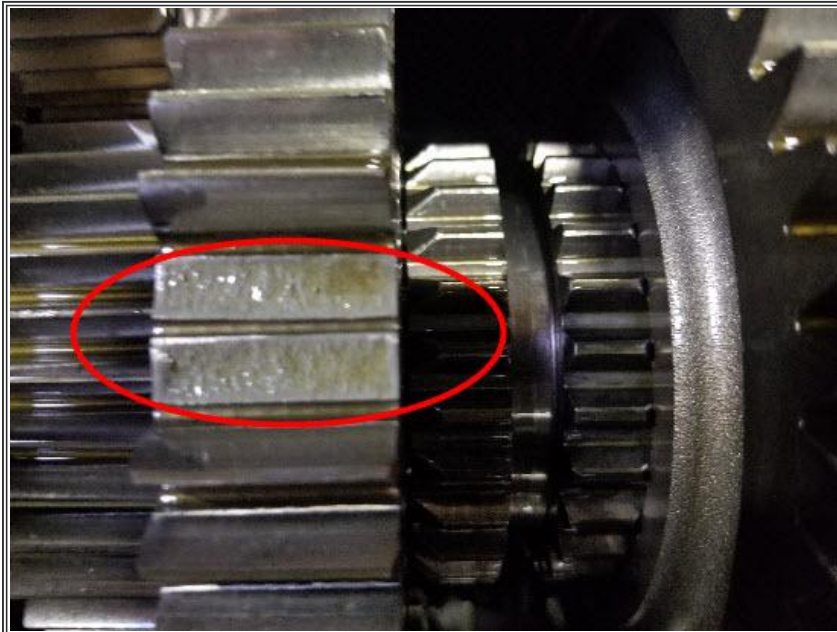
Figure #3: Damaged Transmission Gear
