**Title:** LT Door Mirror Glare**Applies To:** LT Trucks with Chrome mirrors

This document will guide the user through the process of addressing headlight glares coming from the door mirror on certain LT truck configurations.

Driver Experiences light glare coming from headlights.

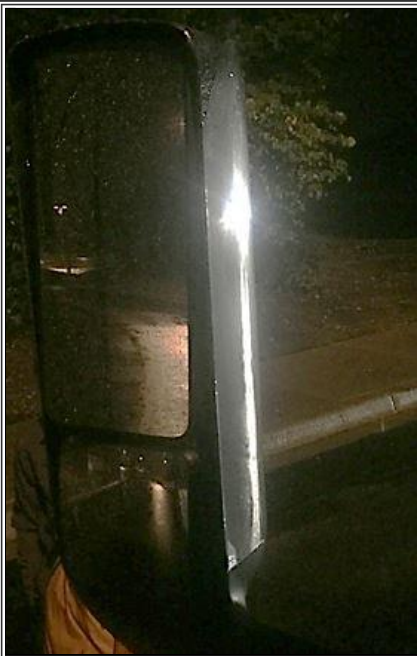
**Figure 1: LT Chrome Mirror Shell**

Verify customer complaint of headlight glare coming from door mirror, see Figure 1. If confirmed, follow instructions under the 'Repair Section' below.

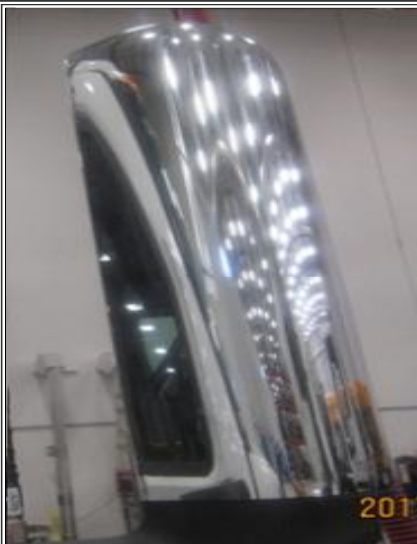
**Figure 2: Driver Side LT Chrome Mirror Shell**

Mirror without Anti-Glare Film Installed

Step 3: Begin with Driver side mirror shell, see Figure 2. Clean off chrome shell with Windex or soap and water

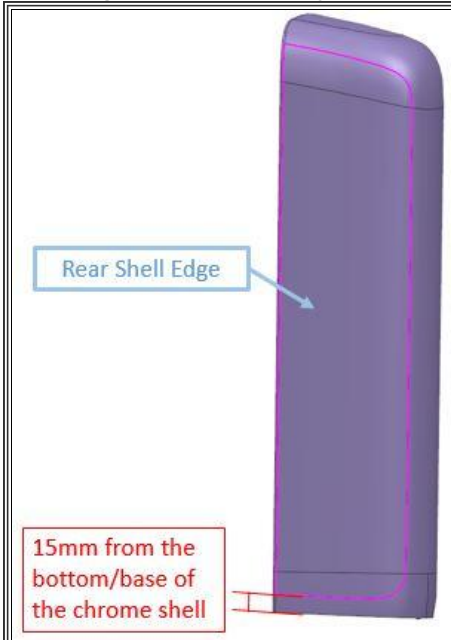
**Figure 3: Rear Shell Edge**

Step 4: See Figure 3. Begin applying film at the **Rear Shell Edge** near the bottom corner of the chrome shell. Guide the placement of the film to the top of the shell.

**Note: Begin at approximately 15mm (0.6") from the bottom of the chrome shell**

Step 5: Rub out any bubbles to ensure film is completely adhered to shell surface.

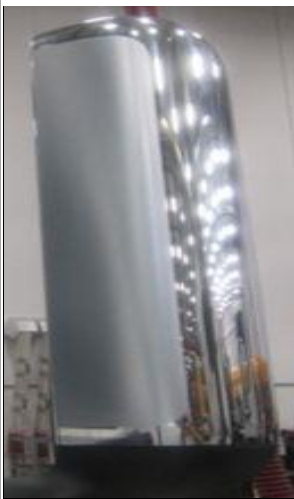
**Figure 4: Driver Side LT Chrome Mirror Shell**

Mirror with Anti-Glare Film Installed

Step 6: Repeat Steps 3-5 for passenger side mirror shell, if needed. See Figure 4 for completed installation.
