**Document ID:** IK1500085

**Title:** LT / ProStar Fuel Tank Unable to Fill

**Applies To:** LT & ProStar Sleeper

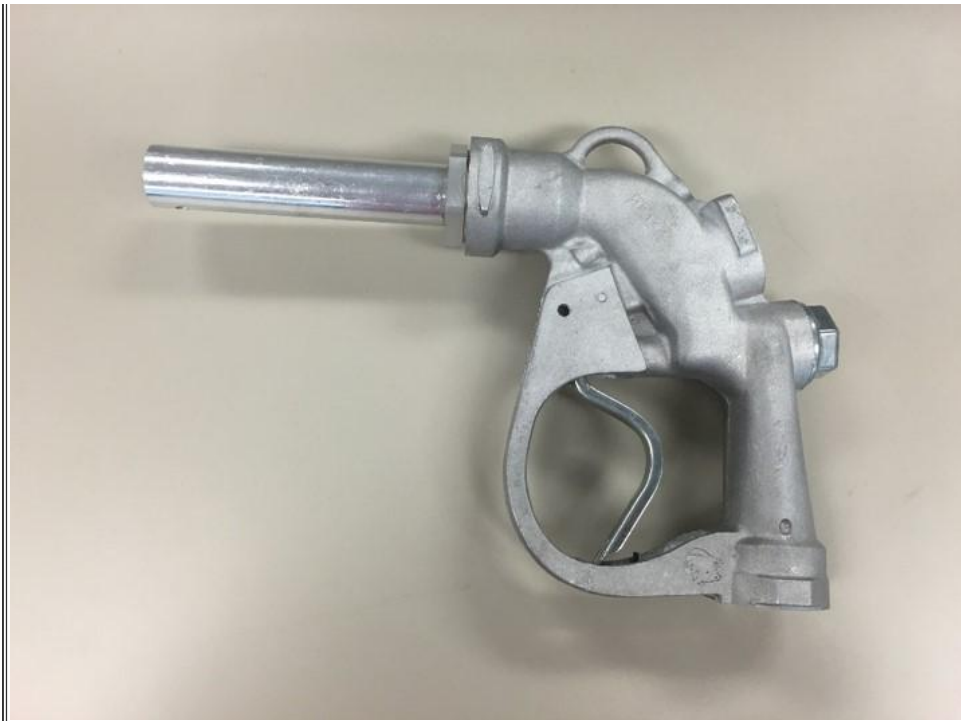
Figure 1: Off Road Type Nozzle

Step	Action	Decision
1	Understand where the customer is fueling the truck and what type of nozzle they are using.  Two types of nozzles are used to dispense diesel fuel : <b>Figure 1</b> refers to an off road type nozzle, and <b>Figure 2</b> refers to the standard high flow fuel nozzle  What type of nozzle is the customer using?	1. <b>Off road type nozzle:</b> Go to step 2
		2. <b>Standard high flow nozzle:</b> Go to step 3

Step	Action
2	<b>Off Road Type Nozzle</b>  If this is the type of nozzle the customer is using, rotating the fuel tanks, or any other adjustments are not covered by warranty.

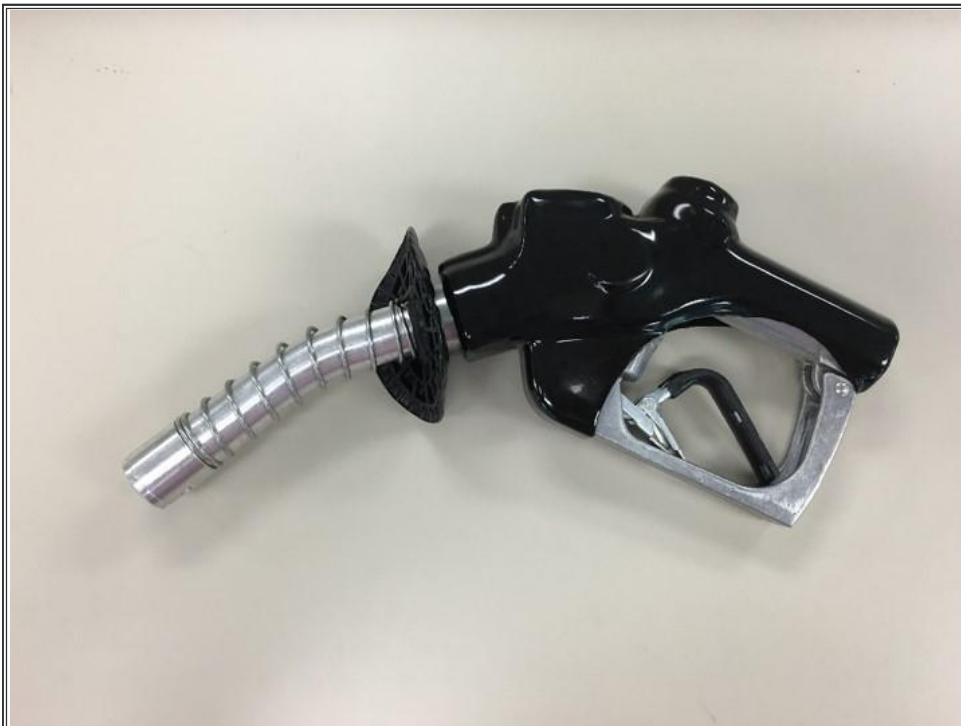
Figure 2: Standard High Flow Nozzle

Step	Action	Decision
3	<b>Standard High Flow Nozzle</b>  Standard high flow fuel nozzles are used at all major fueling stations in North America and Canada.  Is the customer unable to fill the vehicle using a Standard High Flow Nozzle?	Yes : Follow the steps below to repair.

1. Park the vehicle on a flat surface.
2. Shift transmission to Park or Neutral and set parking brakes.
3. Install wheel chocks.
4. Use a digital protractor and zero it on the frame rail between the back of the cab and the forward drive axle.

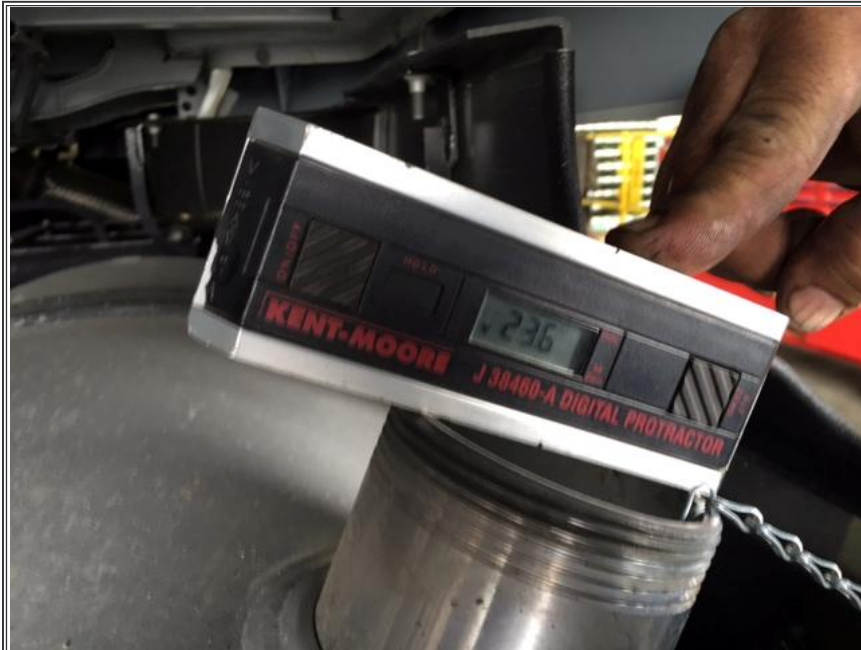
Figure 3: Measuring

5. Remove the fuel tank cap and record the initial angle of the tank at the fuel fill neck (Figure 3) and record the reading. A reading of 26 degrees +/- 1 indicates not action is need for tank rotation. If the initial reading is outside of 26 degrees +/- 1, the fuel tank will need to be adjusted.

6.To adjust the fuel tank, the tank will need to be drained the straps loosed and rotated. For detailed instruction on how the system functions, Refer to the steps outline in manual:

**Ensure final fuel tank position clears all frame mounted items including back of cab suspension.**
