Countries: CANADA, UNITED STATES **Document ID:** IK1600227
Availability: ISIS, IsSIR **Revision:** 0
Major System: CAB / SLEEPER / HOOD **Created:** 7/13/2017
Current Language: English **Last Modified:** 7/14/2017
Other Languages: NONE **Author:** Greg Scheff
Viewed: 103

Title: Loose or Missing Glass in the Hood Mounted Mirror

Applies To: LT Chassis

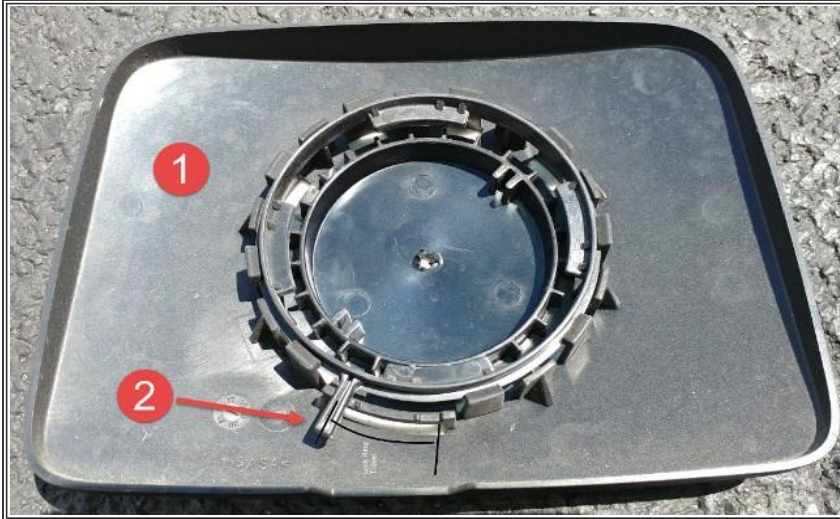
Figure #1: Mirror Housing

Item 1: Mirror Housing

Item 2: Mirror Lock / Release Lever

If the mirror is missing from the housing assembly completely, order the correct replacement mirror and install as outlined below.

1. Install the replacement mirror in the bore of the housing (Figure #1 Item 1), and slide the locking lever (Figure #1 Item 2) fully over to lock the mirror in place.

NOTE: When properly seated and locked in place, you should hear or feel two clicks as you slide the locking mechanism over.

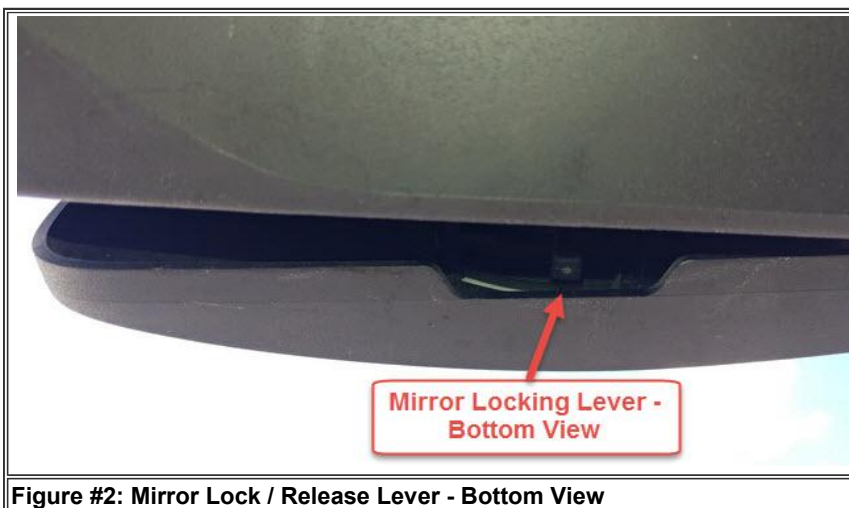
Figure #2: Mirror Lock / Release Lever - Bottom View

2. With the mirror installed in the housing, you can access the locking lever through the bottom of the mirror by tilting the top of the mirror inward (Figure #2).

If the mirror is still in place but is loose, follow the steps below.

- Remove the mirror by utilizing the lock ring on the bottom side (Figure #2).

- Inspect for any damage to the lock ring or mirror mount.
- Reinstall the mirror and pull the lock tab fully to the closed position again, making sure you feel or hear two clicks as you slide the lock over.
- There should not be any movement or wiggle in the mirror if installed properly.
