Title: IC Bus Service Brake Switch Inspection

Applies To: IC Bus built before 6-26-2017

This document will guide the user through diagnosis a customer complaint of brake lights not functioning or parking brake not releasing

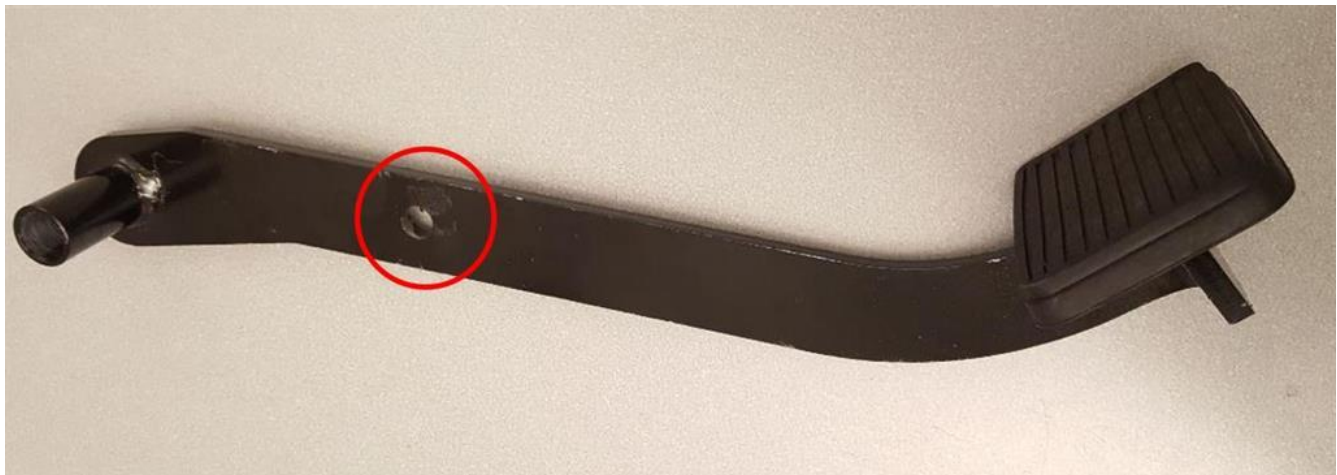
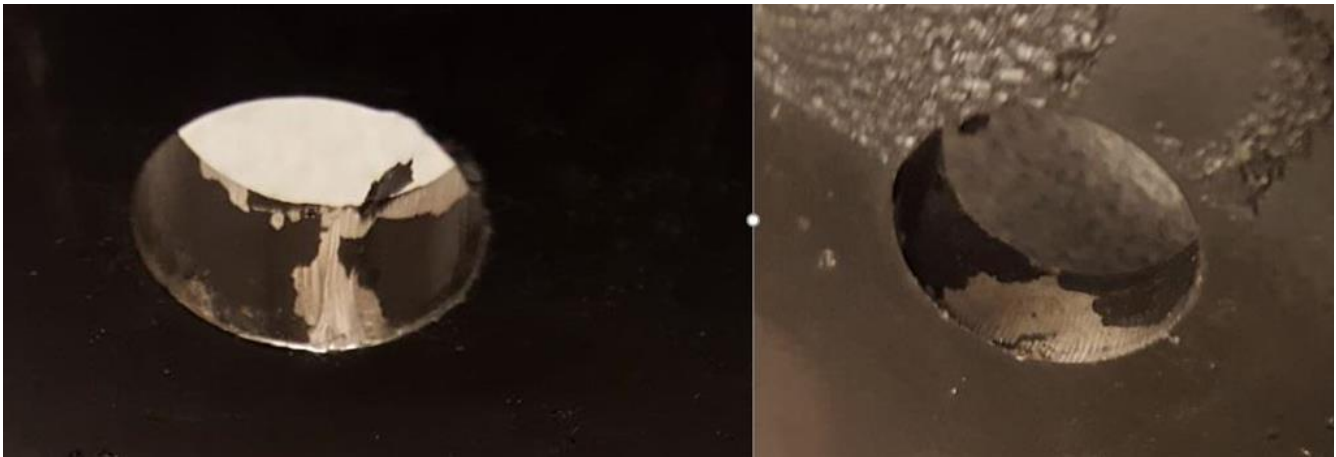
1. Remove brake pedal assembly from vehicle
2. Inspect brake switch clevis pin hole for debris/burrs/pait. See images below:

3. Using hand file or deburring bit, remove any paint, burrs, or debris from clevis pin hole.
4. Insert clevis pin into brake pedal assembly and ensure the clevis pin rotates freely in clevis pin hole. If pin does not rotate freely, more filing may be needed.
5. Inspect clevis pin for damage, if damaged then replace with new pin. If no damage is found on pin, reinstall brake pedal assembly into vehicle.
6. Verify repairs by rechecking for customer complaint.
