**Document ID:** IK1600232  
**Revision:** 1  
**Created:** 9/6/2017  
**Last Modified:** 10/11/2017  
**Author:** Allan Hertko

**Title:** LT Air Deflector / Fairing Vibration at Highway Speeds

**Applies To:** LT

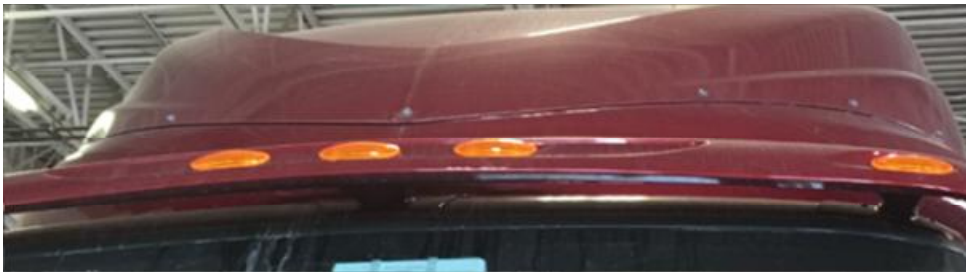
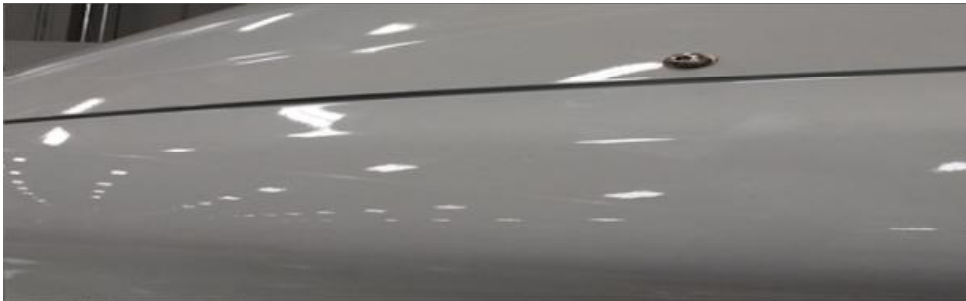
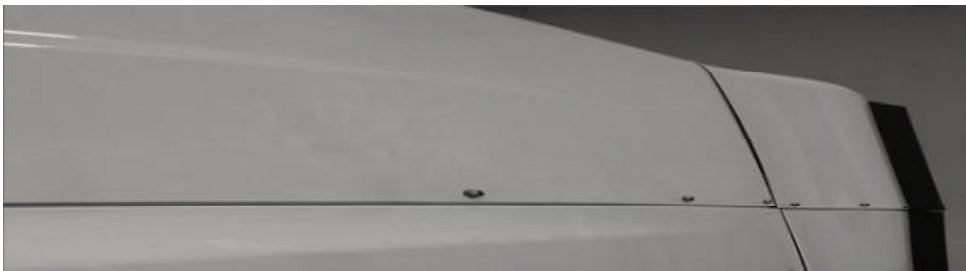
**Air fairing is flush no gaps are present**

Step 1: Inspect the air fairing for excessive gaps prior to road-test. See following four images for examples.

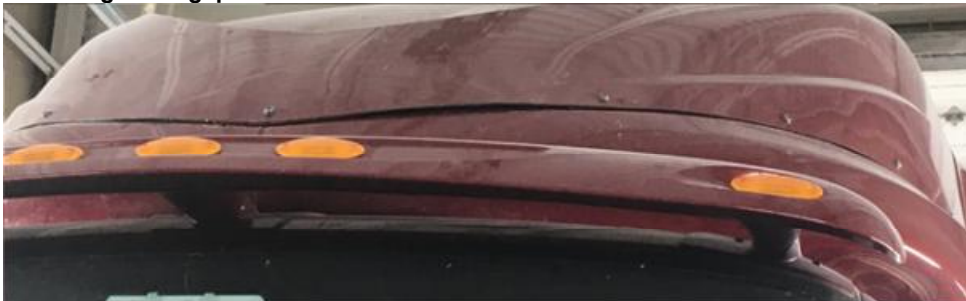
**Air fairing has a gap towards the center**

Step 3: Use soap and water to clean the affected area and air dry.

Step 4: Apply a thin layer of Bostik® SuperTrans to seal the gaps.

**Water drainage is necessary around the air fairing. Do NOT make a complete seal around the air fairing.**

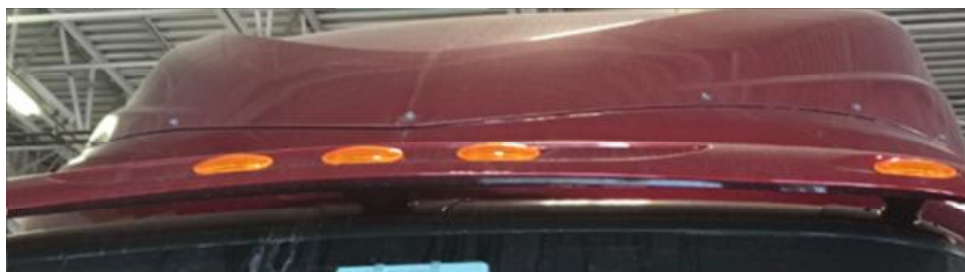
**Repairs have been made sealing the gap**

Step 5: Depending on ambient temperature let adhesive dry for approximately one hour before road-testing.
