43 DRC running gear: DTC(s) stored for front shock absorbers

43 17 27 2049664/1 December 5, 2017.

Model(s)	Year	VIN Range	Vehicle-Specific Equipment	
RS7	2014 - 2017	All	All With sports running gear with variable damping

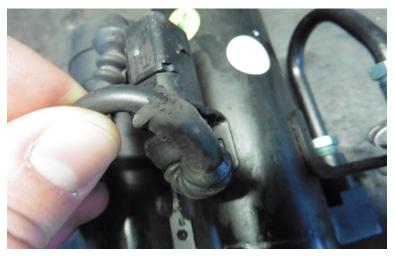
- DTC(s) about a malfunction of the vehicle level sender or the valve for damping adjustment on the front axle are logged in the electronic damping control module, J250 (address word 0014).
- The insulation of the electric cable of the shock absorber is damaged by wear (Figure 1).

Figure 1. Damaged insulation on the electric cable for the shock absorber.

The missing insulation allows water to get to the electronic components in the shock absorber, causing corrosion. As a result the function is restricted.

- 1. Replace the affected shock absorber according to the repair manual.
- 2. When fitting the shock absorber make sure the electric cable is routed correctly. The connector with the labelling must point forward (Figure 2). The cable must also not be twisted or under tension to prevent any damage to the wires in the cable and to the outer insulation (Figure 3). It is recommended to hang cable and connector freely on the absorber first and then to secure it.

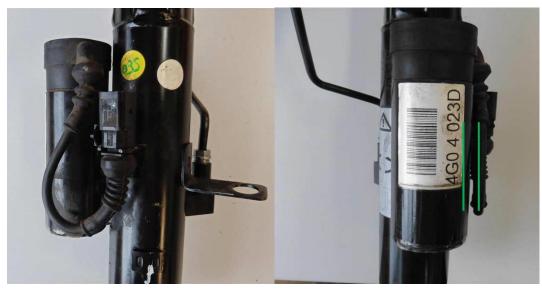
Figure 2. Correct connector alignment and cable routing.

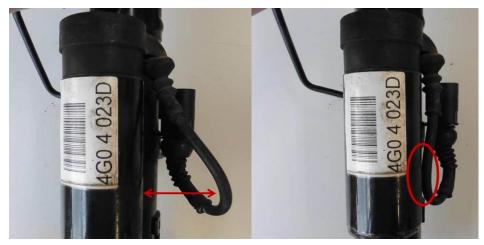
Figure 3. Twisted cables.
