# Technical Service Bulletin

## 46 Clicking noise from front ceramic brakes - R8

46 17 67 2047140/1 March 14, 2017.

Model(s)	Year	VIN Range	Vehicle-Specific Equipment
R8	2017 - 2018	All	Ceramic brakes

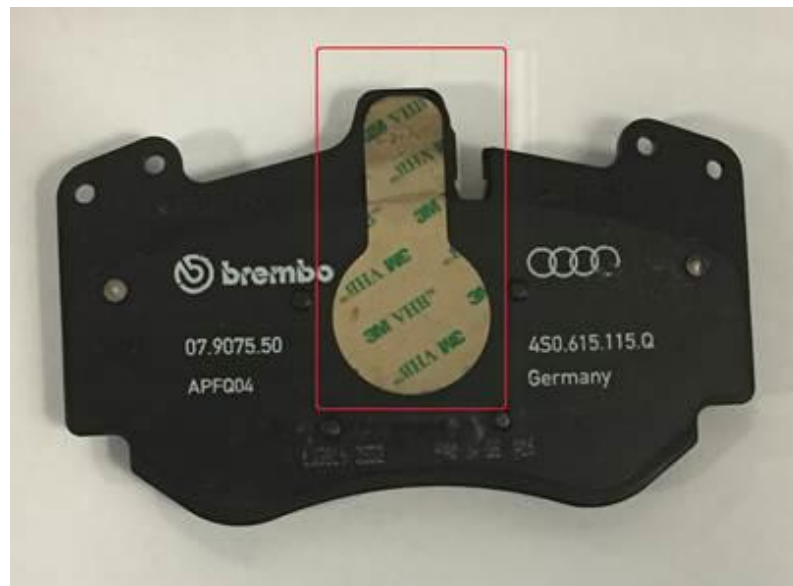
**Figure 2.** Pull of adhesive foil.

- The brake pistons must be clean. Brake cleaner can be used to clean the brake pistons. Ensure that the contact surfaces are free of dust and grease and they are dry.
- Only remove the protective paper from the adhesive foil on the brake pad immediately before installation (Figure 2), and do not touch the adhesive surface. (Figure 3).
