Service Information Bulletin

SUBJECT	DATE
SPN 520296 (MCM) (GHG14) and SPN 520296 (MCM) (GHG17)	January 2017

2 SPN 520296/FMI 31 - GHG14

Exhaust Gas Recirculation Valve Actuator, Learn Cycle Incomplete

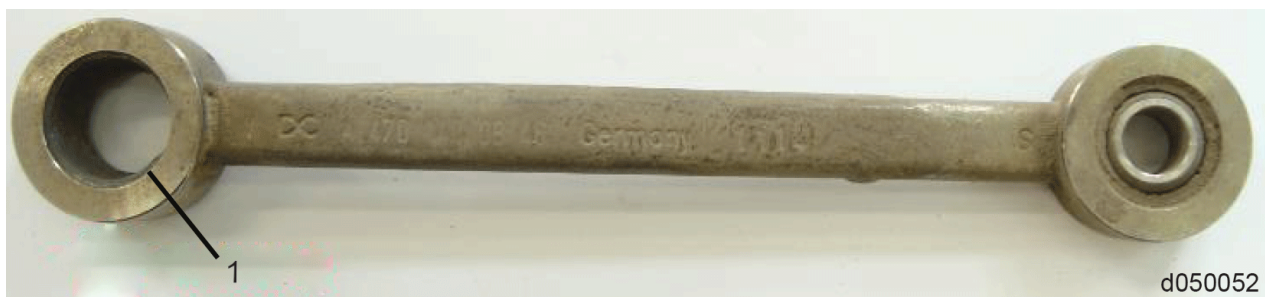
8. Turn the ignition OFF.
9. Disconnect and inspect the pull rod from the EGR actuator and the EGR valve. Are the bearings or inserts in the pull rod missing (1)?

- a. Yes; replace the pull rod. Verify repair.
 - b. No; Go to step 10.
10. Rotate the bearings in the pull rod in the normal direction of movement when installed. Do the bearings move?
